TASER INTERNATIONAL, Inc.  
17800 N. 85<sup>th</sup> St. • Scottsdale, Arizona 85255-6311 • www.TASER.com  
U.S. Phone: 1.800.978.2737 or 1.480.905.2000 • International Phone: +1.480.905.2000  
U.S. Fax: 1.480.991.0791 • International Fax: +1.480.991.0791

**Report:** Analysis of TASER® X26™ electronic control devices (ECDs) with the serial numbers X00-200582 and X00-284820. Three probes with attached wires were also analyzed. The analysis was performed at the TASER International facility in Scottsdale, AZ on October 1, 2009.

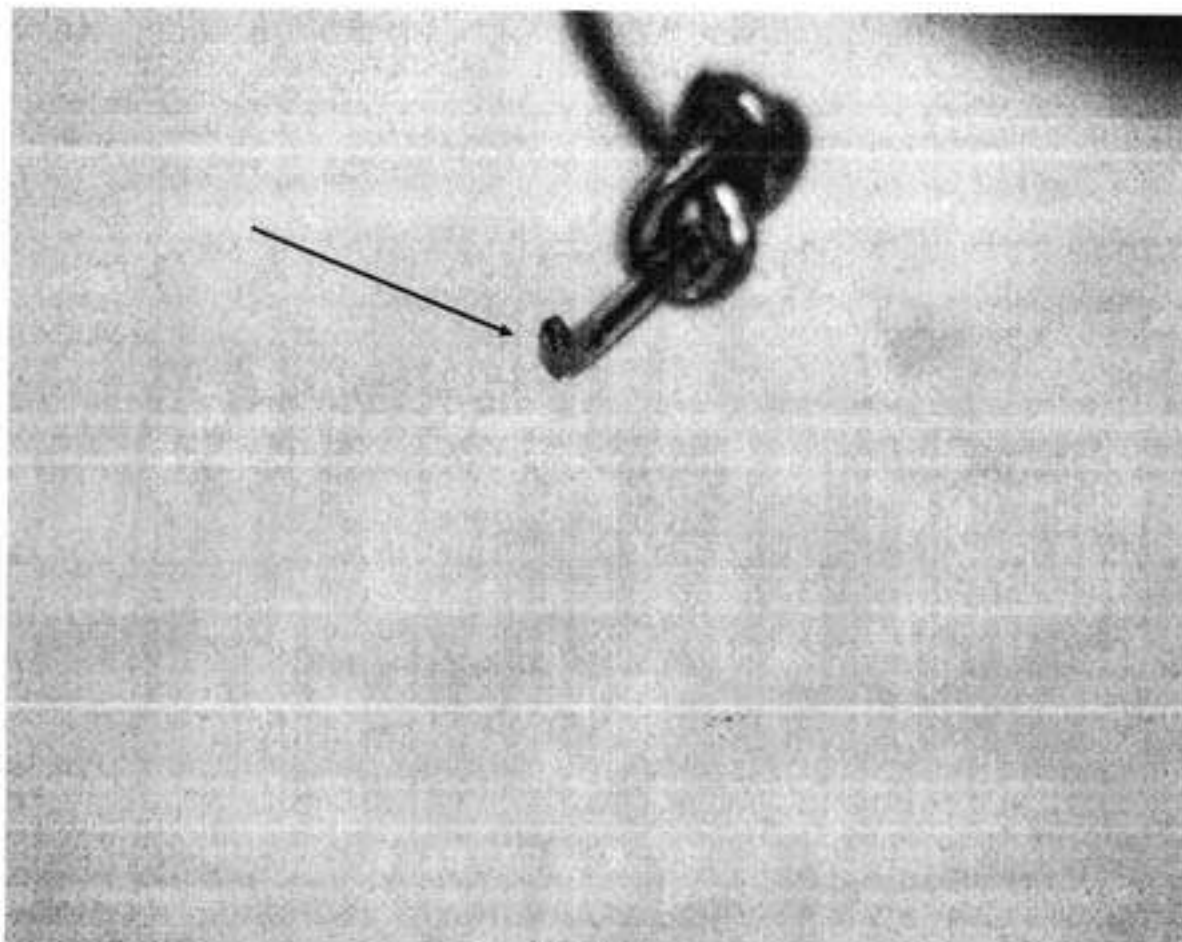
On inspection, TASER probe A showed no indication that a substantial amount of energy was transferred through the probe to indicate a completed circuit or that TASER pulses were being delivered through the probe into the target. Figure 1 below is a photograph of the wire knot from Probe A.

The lack of physical changes to the wire surface from the probe sample provided indicate that current no greater than one pulse traveled through the probe. This is consistent with the firing of the cartridge only. The physical changes therefore indicate that the circuit was not completed and that current did not reach the target.

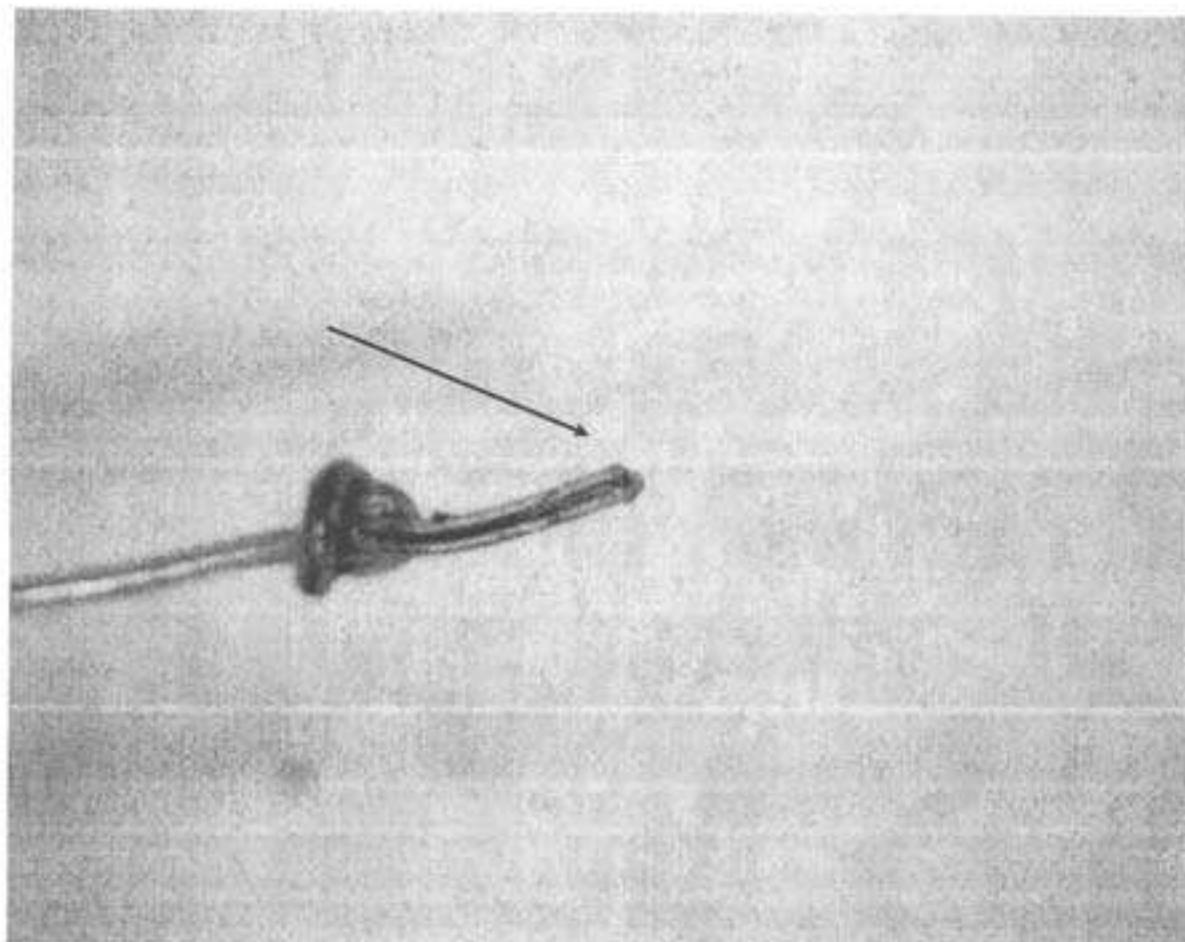
On inspection, TASER probe B showed no indication that a substantial amount of energy was transferred through the probe to indicate a completed circuit or that TASER pulses were being delivered through the probe into the target. Figure 2 below is a photograph of the wire knot from Probe B.

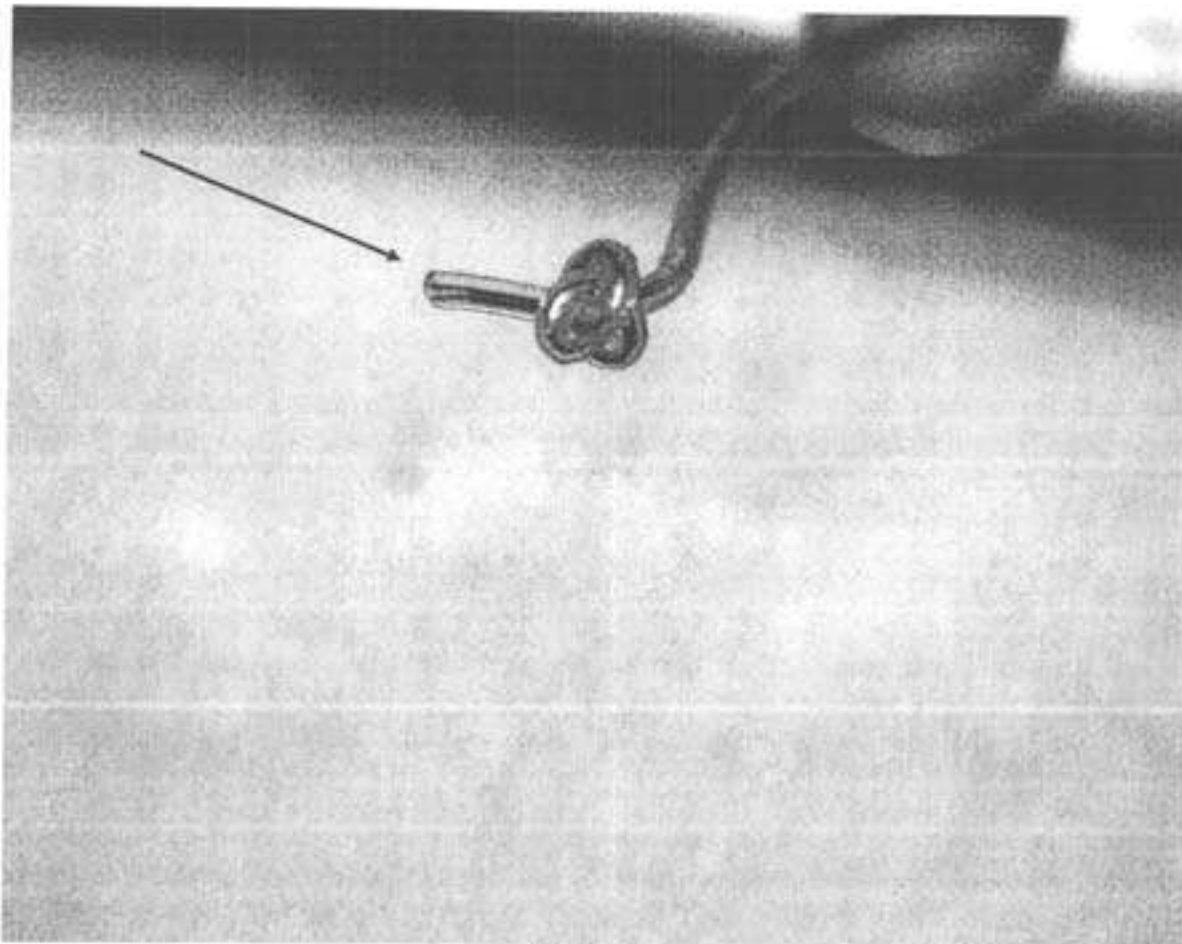
On inspection, TASER probe C showed no indication that a substantial amount of energy was transferred through the probe to indicate a completed circuit or that TASER pulses were being delivered through the probe into the target. Figure 3 below is a photograph of the wire knot from Probe C.

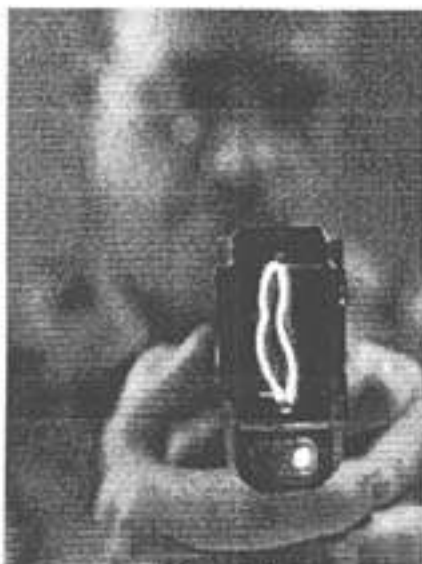
If the probes instead impact on material that is not conductive, then the energy of the TASER ECD will arc in front of the electrodes of the ECD. See Figure 4 below. Energy will then not be delivered into the target.

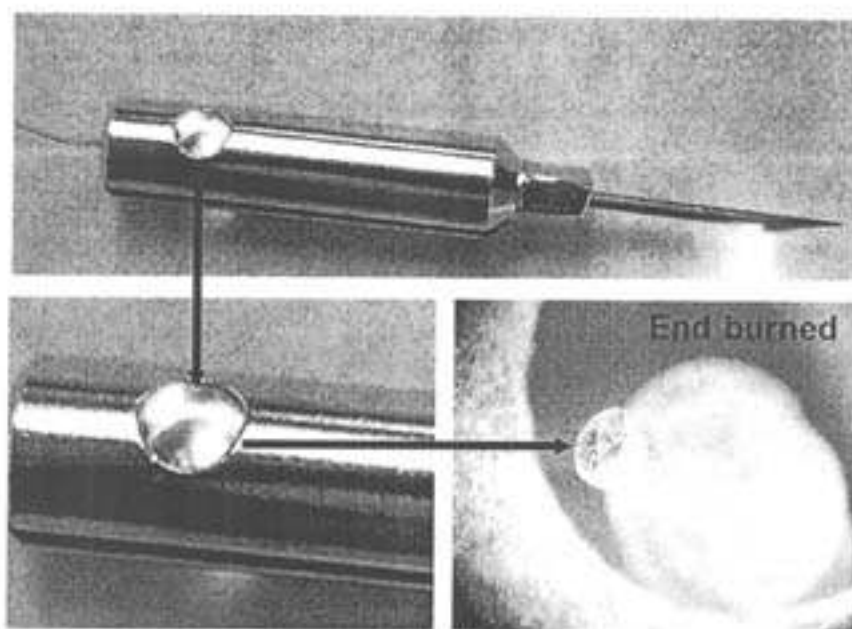
If energy is transferred downrange to the target via a probe deployment, there will be physical changes to the probes' wire air gap that can be verified with a microscope. Where energy is transferred at the point where the wire attaches to the probe, there is an "air gap." When both probes make contact, the probes will have carbon buildup or "scoring" at this air gap, as energy is transferred from the wire to the probe surface and then into the target. There will also be melting of the insulation of the wire attached to the probe. See Figures 5 and 6 below. Figure 5 shows energy arcing thru the probe. Figure 6 shows the carbon buildup and melting of insulation consistent with 5 seconds of energy.

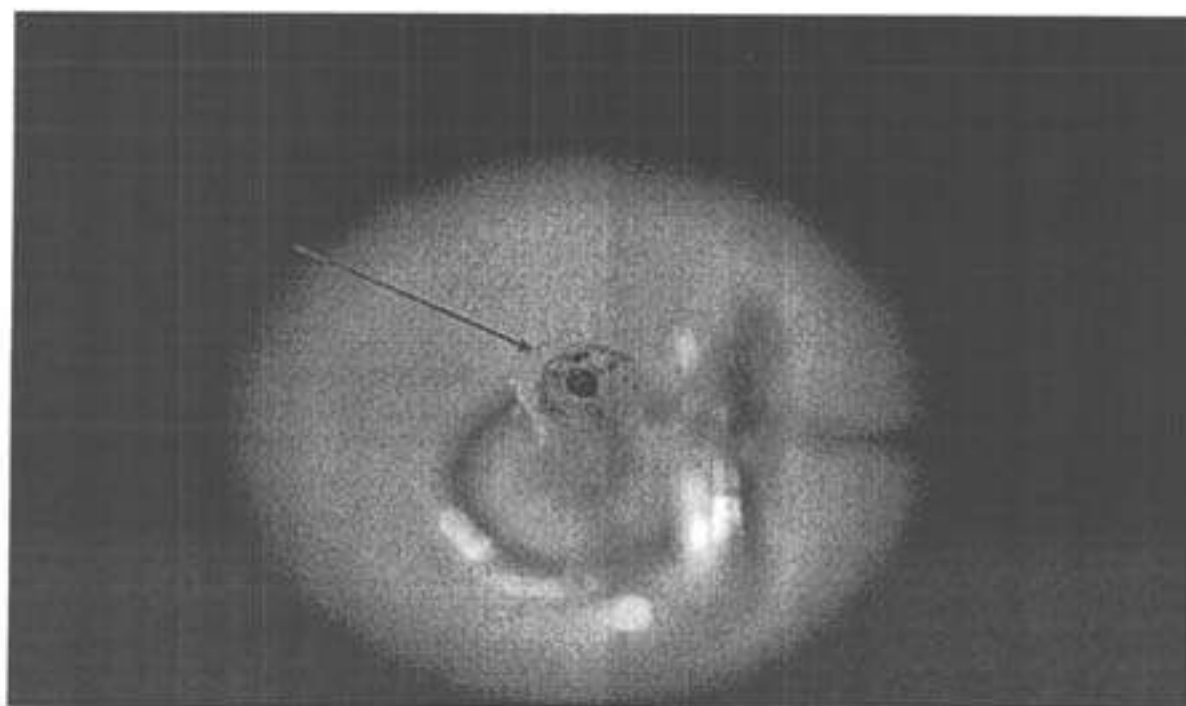
Figure 6 (6 second knot)
