## Flood of June 2008 in Southern Wisconsin

Scientific Investigations Report 2008–5235

By Faith A. Fitzpatrick, Marie C. Peppler, John F. Walker, William J. Rose,  
Robert J. Waschbusch, and James L. Kennedy

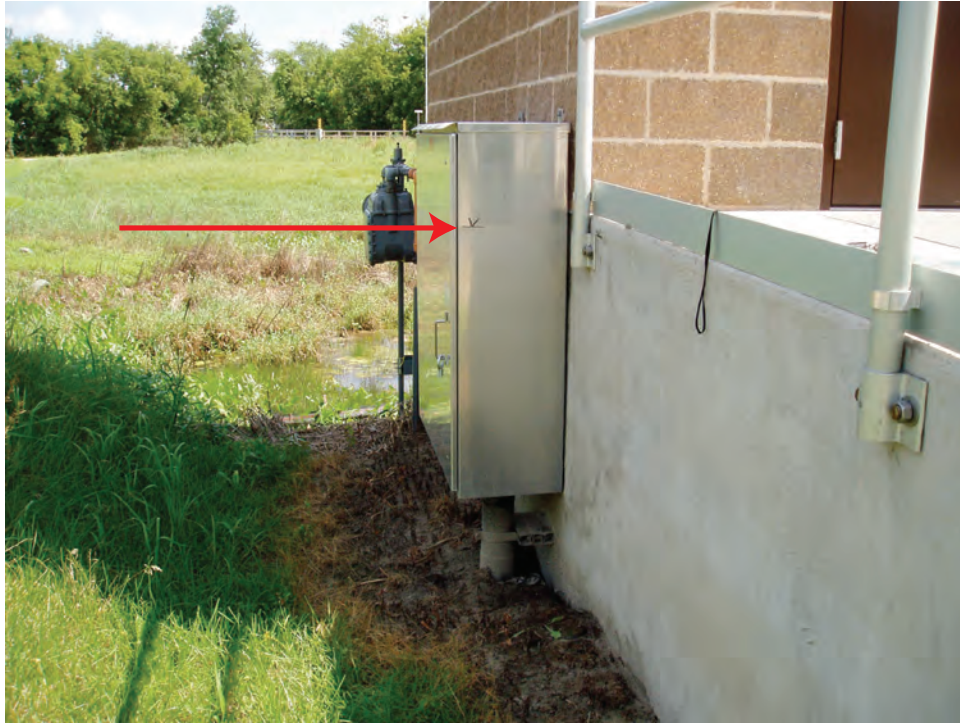
**A.** Reedsburg high-water mark 2, mudline on electrical box of sewage pump station, corroborated with city of Reedsburg mark surveyed in June during high water.

**Figure 4.** Example photographs of high-water marks in August 2008.

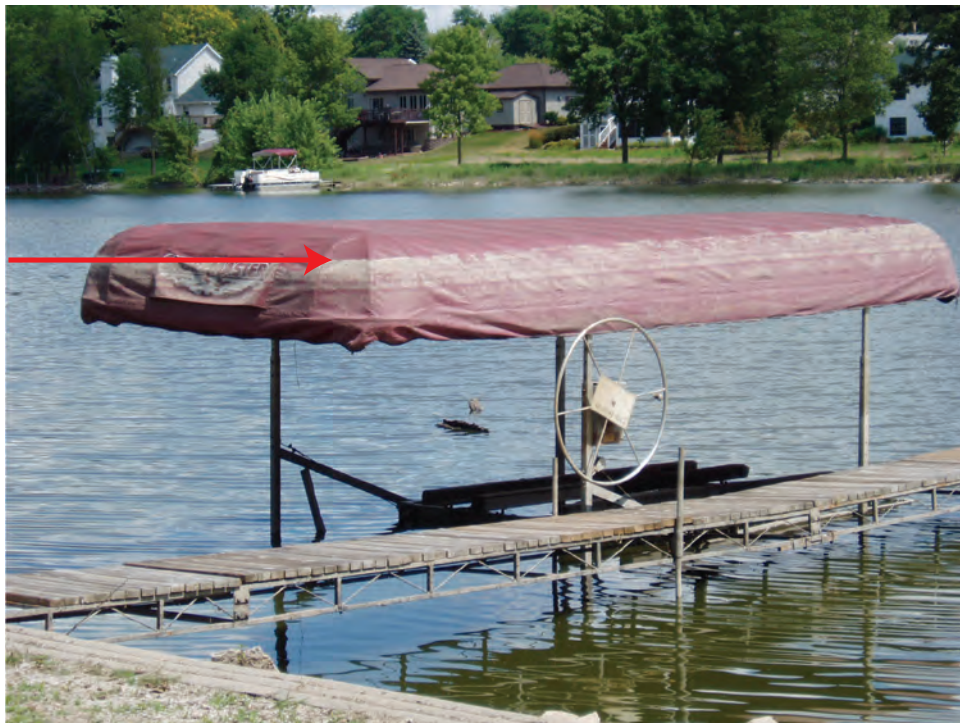
**B.** Jefferson high-water mark 41, corroborated with water-stain/mud lines on nearby step, light pole, and previously surveyed high-water marks by Jefferson County during the June flood.

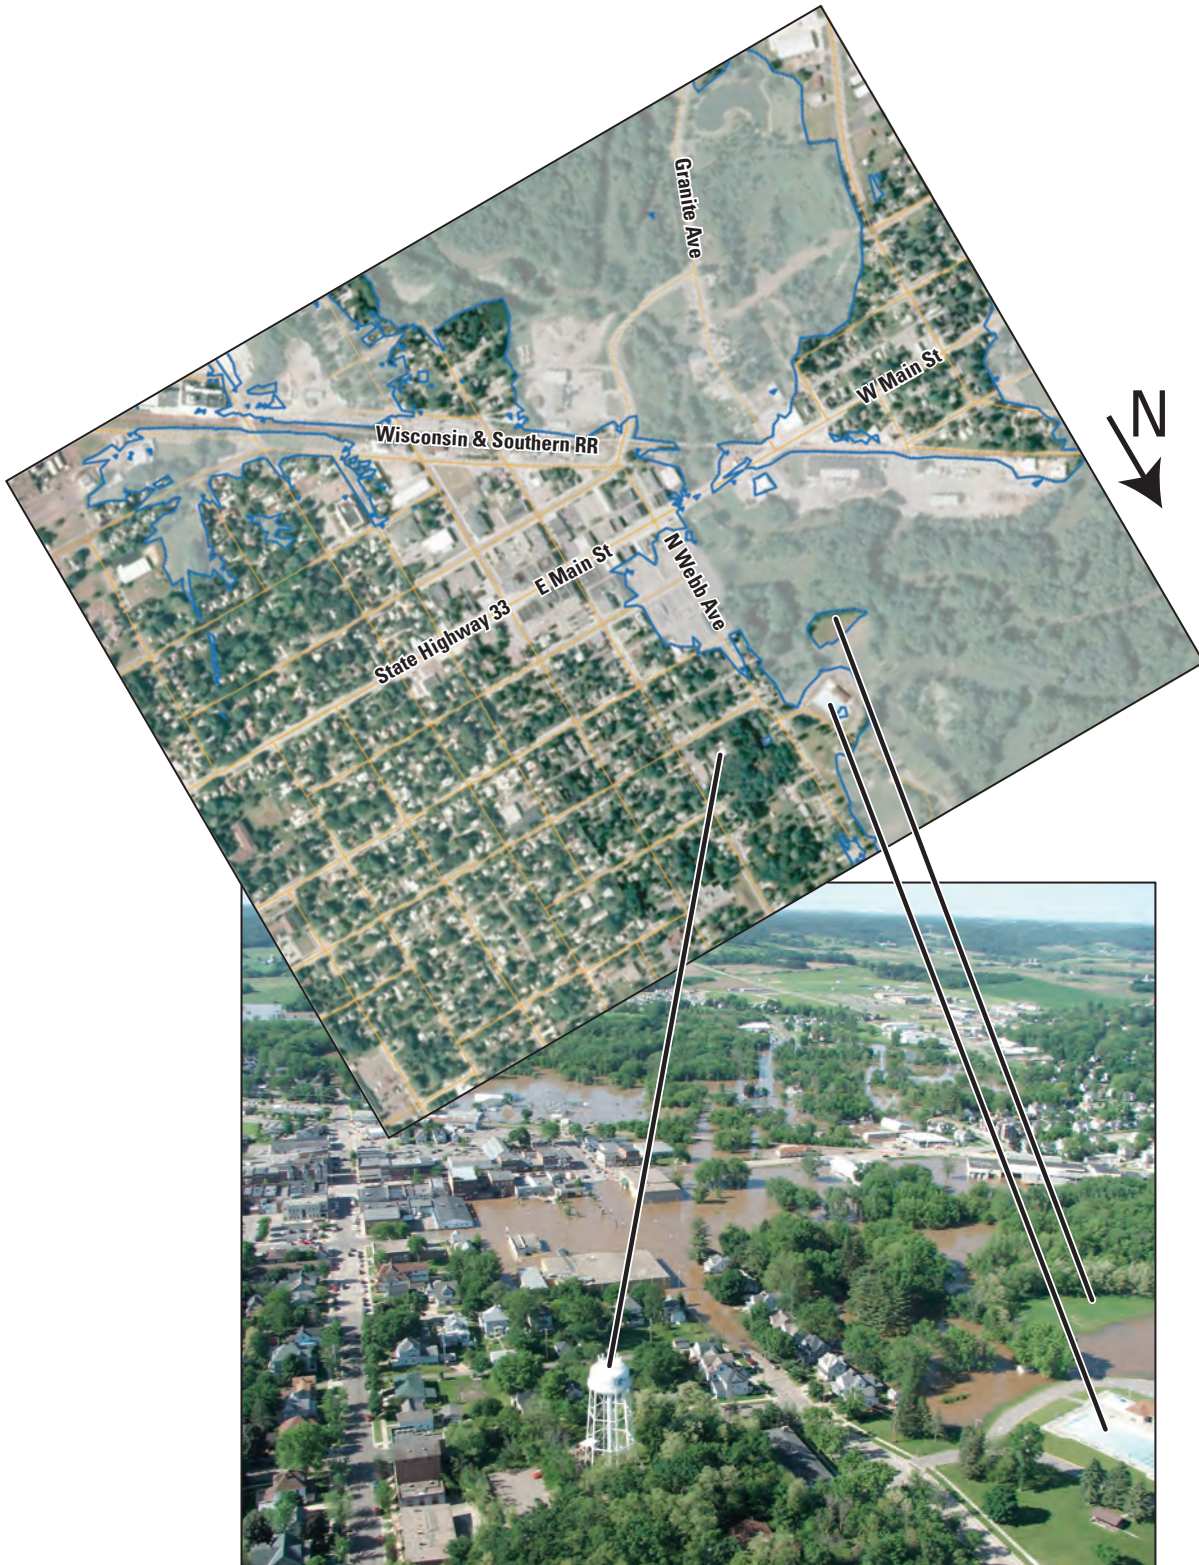
**Figure 7.** Flood inundation map and aerial photograph comparison for the June 2008 flood for north Reedsburg, Wisconsin. Note that the inundation map has been rotated to match the orientation of the aerial photograph. Inundation map base from U.S. Department of Agriculture (2006). Aerial photograph from the city of Reedsburg.
