# Blight Study City of Casper *Work Session Draft*

City of Casper  
Spring 2026  
AVI, PC.

# Conditions Survey - Downtown Casper

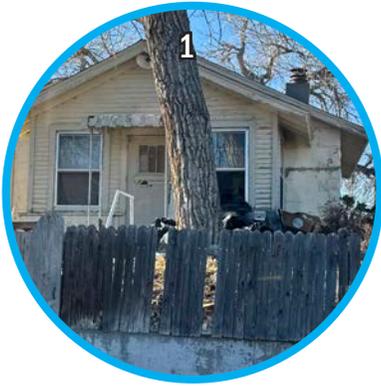
The North Casper Study area exhibited a variety of housing that was dilapidated, which exhibits a criteria of being a slum. The photo shows an example of this housing, and there are a variety of photos that bolster this condition being fulfilled in Appendix A.

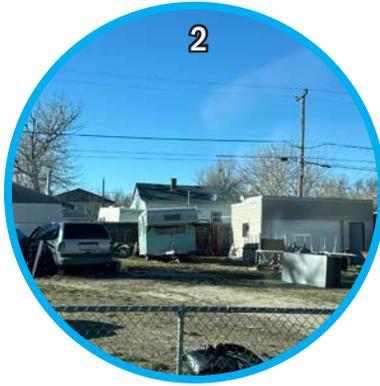
Several buildings and accessory structures (i.e. garages, sheds, and fences) in the study area exhibited poor conditions. Some fences and accessory buildings were verging on collapse. The photo shows an example of some of these buildings.

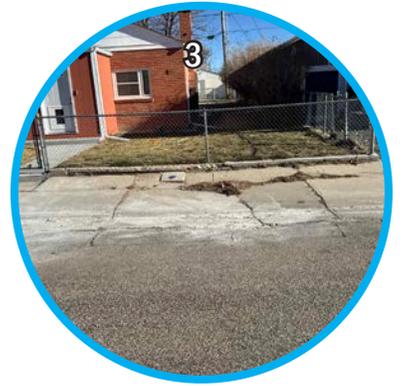
In addition to the deteriorated and deteriorating structures outlined in the previous criteria, the study area exhibited crumbling curb, gutter, and sidewalk as seen in the example photograph.

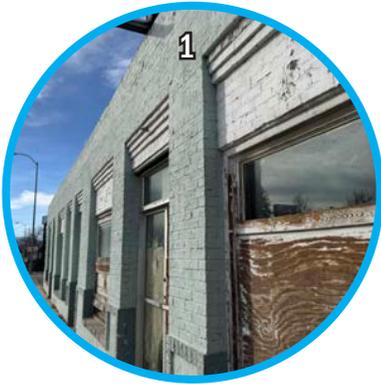
The definition of slum in the Wyoming State Statutes includes nonresidential buildings that are dilapidated and deteriorated. Many commercial buildings along this corridor exhibit this trait. The photo shows boarded up buildings along the corridor.

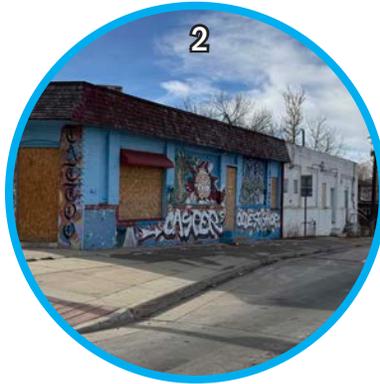
The photo illustrates this condition of blight is achieved by deteriorating buildings. This condition is prevalent along the corridor.

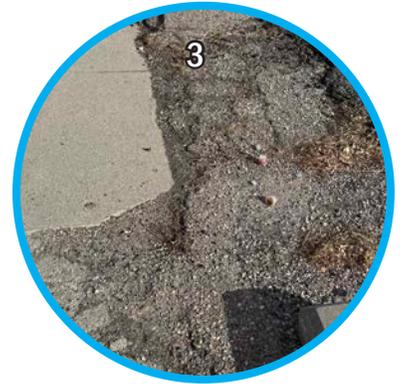
In addition to the deteriorating buildings a variety of site improvements in the study area were found to be in substandard conditions. This included dilapidated curb, gutter, and sidewalk.

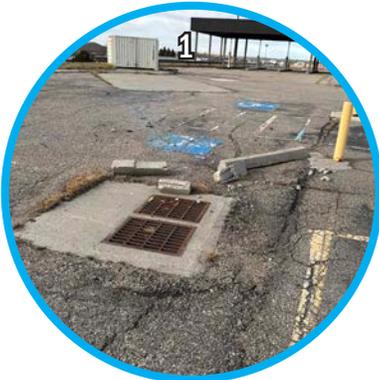
The primary building of the Mall is in sound condition, however many site improvements adjacent to the Mall are deteriorating. The photo shows a drainage structure that is deteriorating, and may continue to, should the area not be redeveloped.

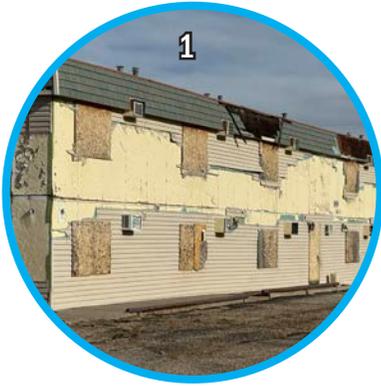
Almost all of the buildings in the study area are abandoned. The photo shows an example of a building that can be seen to be a slum in its current condition.

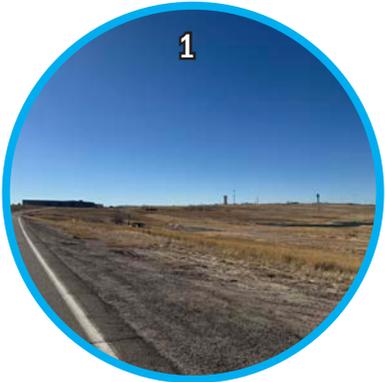
Much of the study area exhibits streets and roads with high design speeds and minimal bicycle and pedestrian facilities. The lack of safety for cyclists and pedestrians is a condition of blight as it endangers life. This photo shows the narrow shoulder adjacent to a high design speed road.
