ROAD SAFETY AUDIT

Route 128 at Route 62

Town of Danvers

December 27, 2013

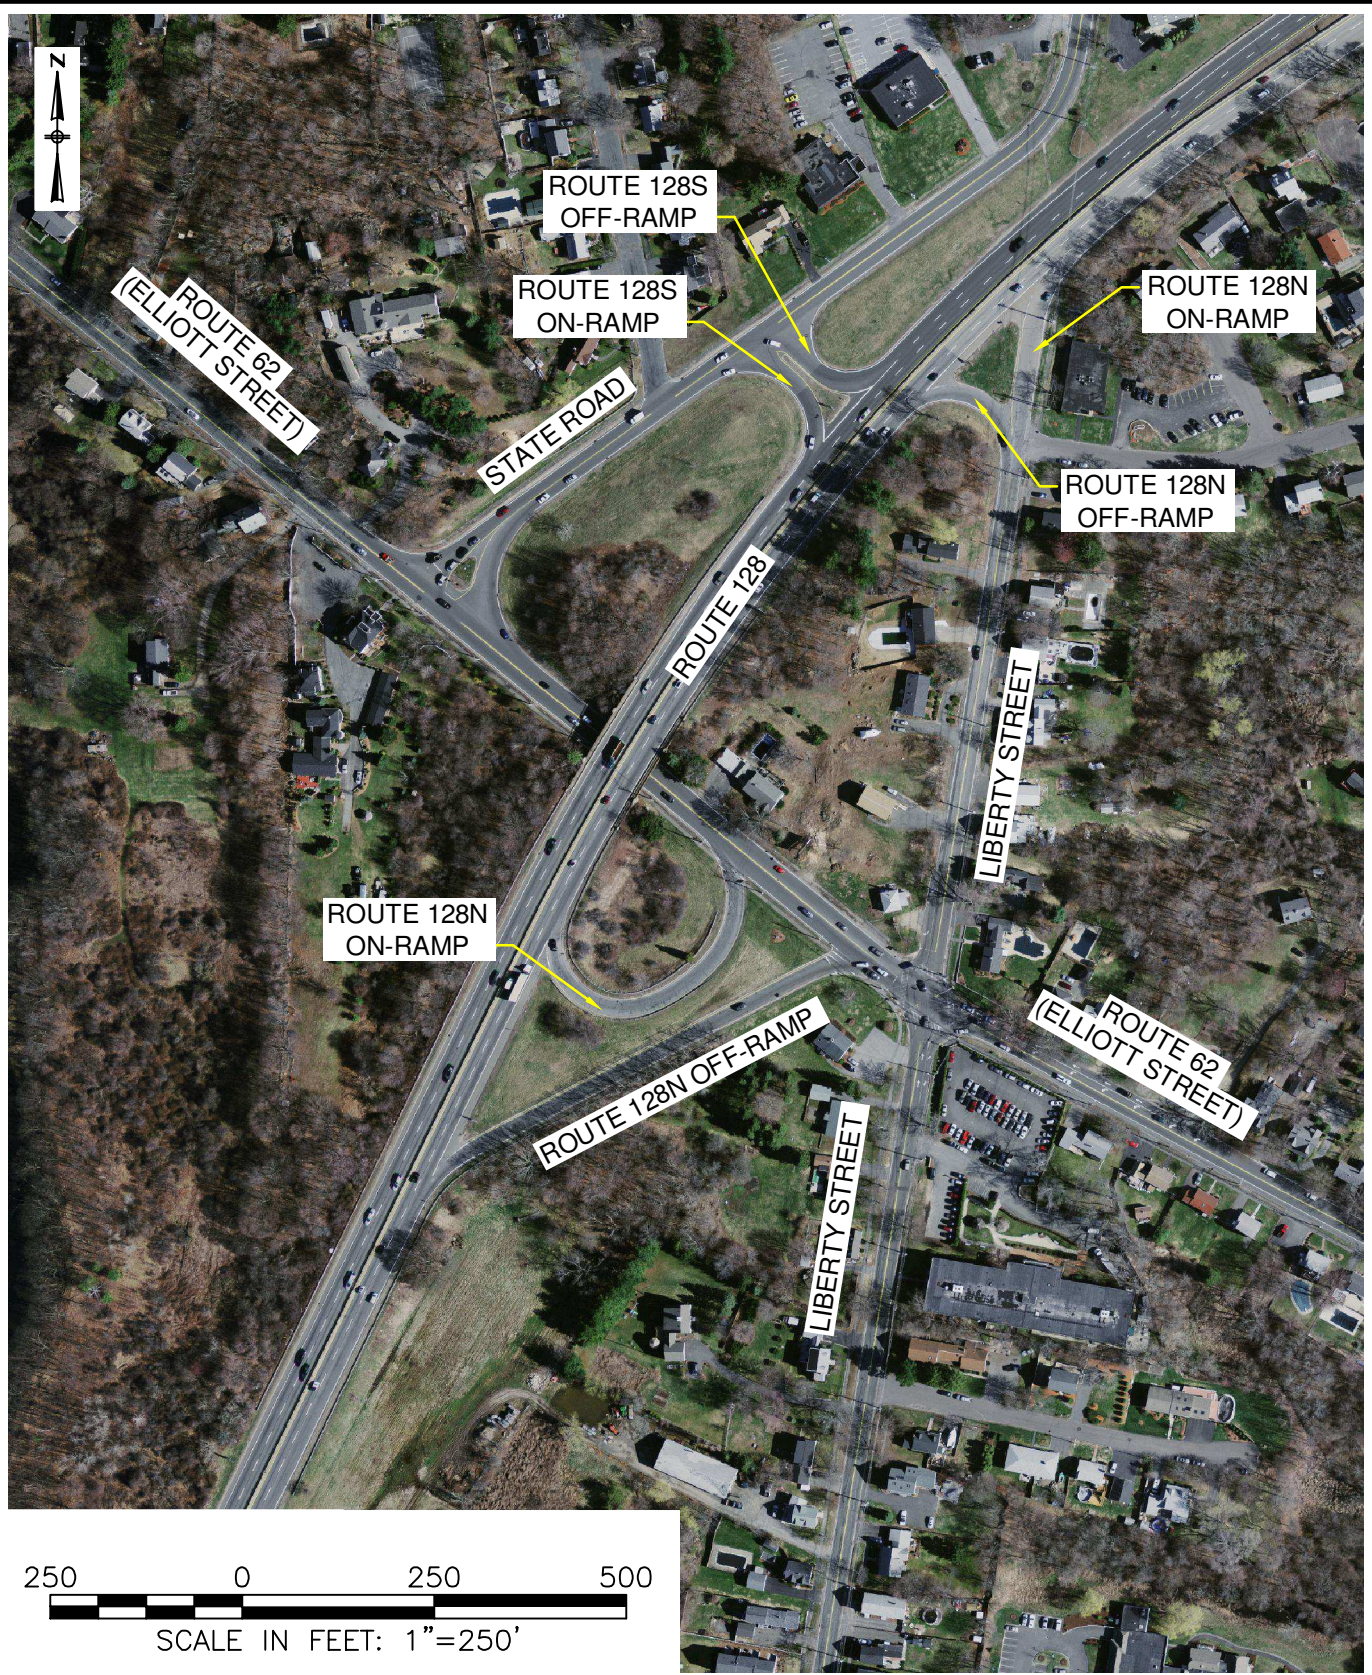
Figure 2
Previous Interchange
Configuration

Audit participants noted that the previous ramp configuration featured very short deceleration and acceleration lanes on Route 128, and that rear-end crashes on Route 128 due to slowing or queued vehicles were common. It was also noted that westbound vehicles which now turn left onto Route 128 southbound at a signalized intersection were previously required to turn right to travel up State Road to enter Route 128 southbound via a short ramp with no deceleration, and that the resultant queued traffic extended to Liberty Street at peak periods.

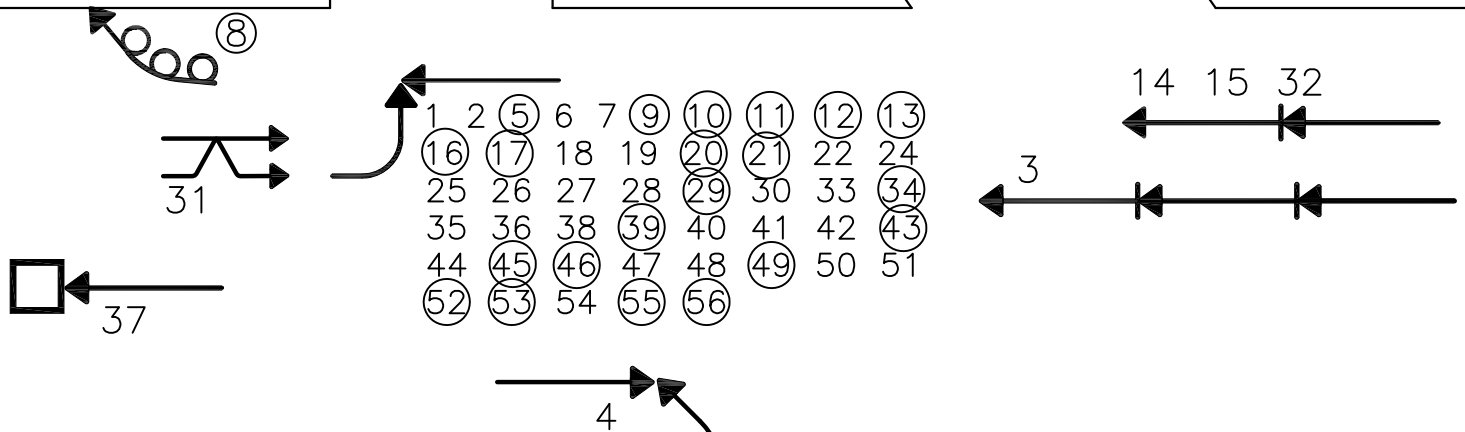
Route 128
NB On-Ramp

Crash data were provided for the intersection of Route 62 and the northbound ramps and show 56 crashes between June 2012 and October 2013. Crash data were provided by the Danvers Police Department and summarized by MassDOT; a collision diagram and crash summary are included in the Appendix. The time period was chosen to show crashes that have occurred since the new ramp configuration has been in place. Forty-seven of the 56 documented crashes occurred between an eastbound vehicle turning left onto Route 128 northbound and a westbound through vehicle. Fourteen of these crashes were noted as “courtesy crashes”, which are defined as crashes which occur when a non-involved mainline driver gives the right of way, contrary to the rules of the road, to another driver. Queues frequently exist in the left lane from the southbound ramp intersection through the northbound ramp intersection. Vehicles in this queue blocking the intersection may wave an opposing left turning vehicle along, only to have that vehicle struck by a vehicle traveling in the westbound through lane.

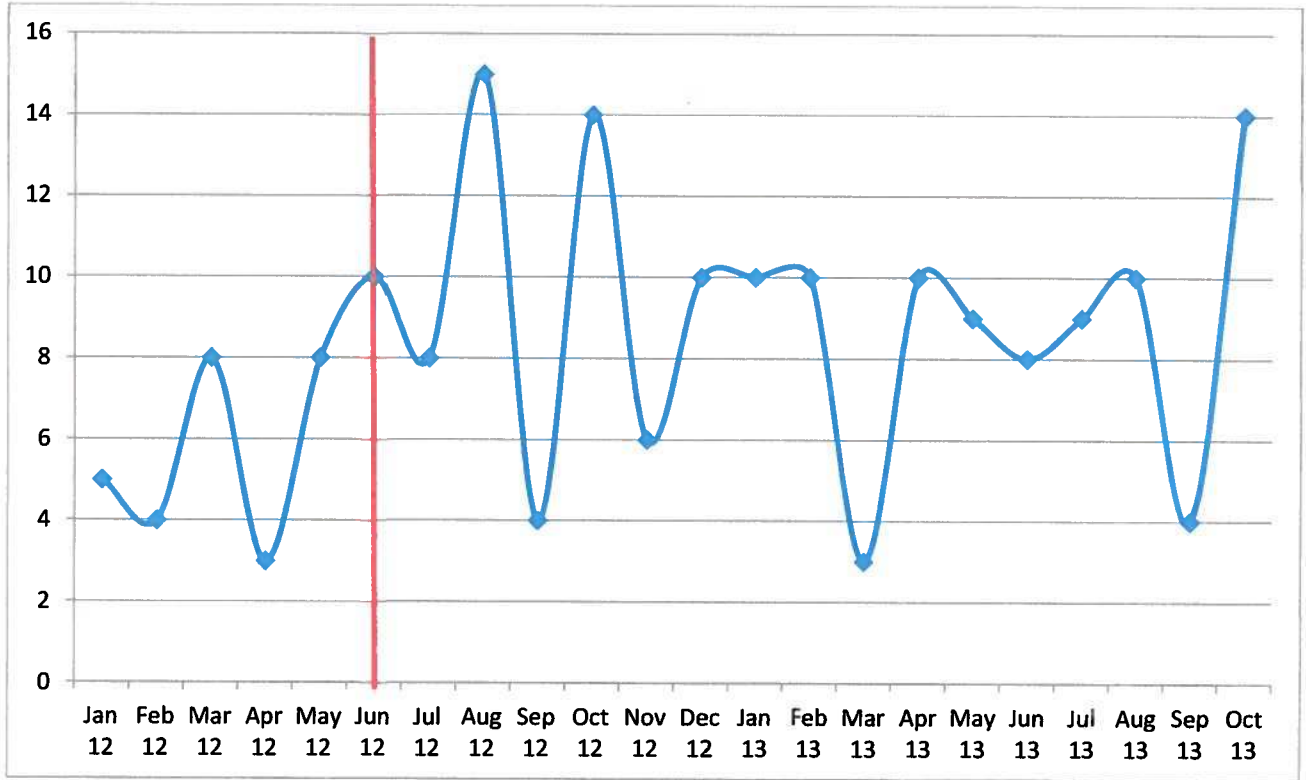
Accidents at Route 128/Elliott St Intersection by Month

Crash data were also presented by Danvers Police on the day of the audit showing 87 crashes were reported to police at the intersection of Route 128 and Route 62 between January 1, 2013 and October 31, 2013. Crashes were not located by ramp intersection location, but it was noted that 35 crashes involved a driver taking a left turn and 6 were identified as rear-end crashes. Police data also show 51 crashes in 2011 and 79 crashes in 2012 for a comparable 10-month period, illustrating an increase in crashes since the interchange was reconfigured.
