REPORT OF SUBSURFACE EXPLORATION AND GEOTECHNICAL EVALUATION CHIEF LADIGA TRAIL SINKHOLE EVALUATION JACKSONVILLE, ALABAMA BUILDING & EARTH PROJECT NUMBER: BH160076

Subject: Report of Subsurface Exploration and Geotechnical Evaluation Chief Ladiga Trail - Sinkhole Evaluation Jacksonville, Alabama Building & Earth Project No.: BH160076

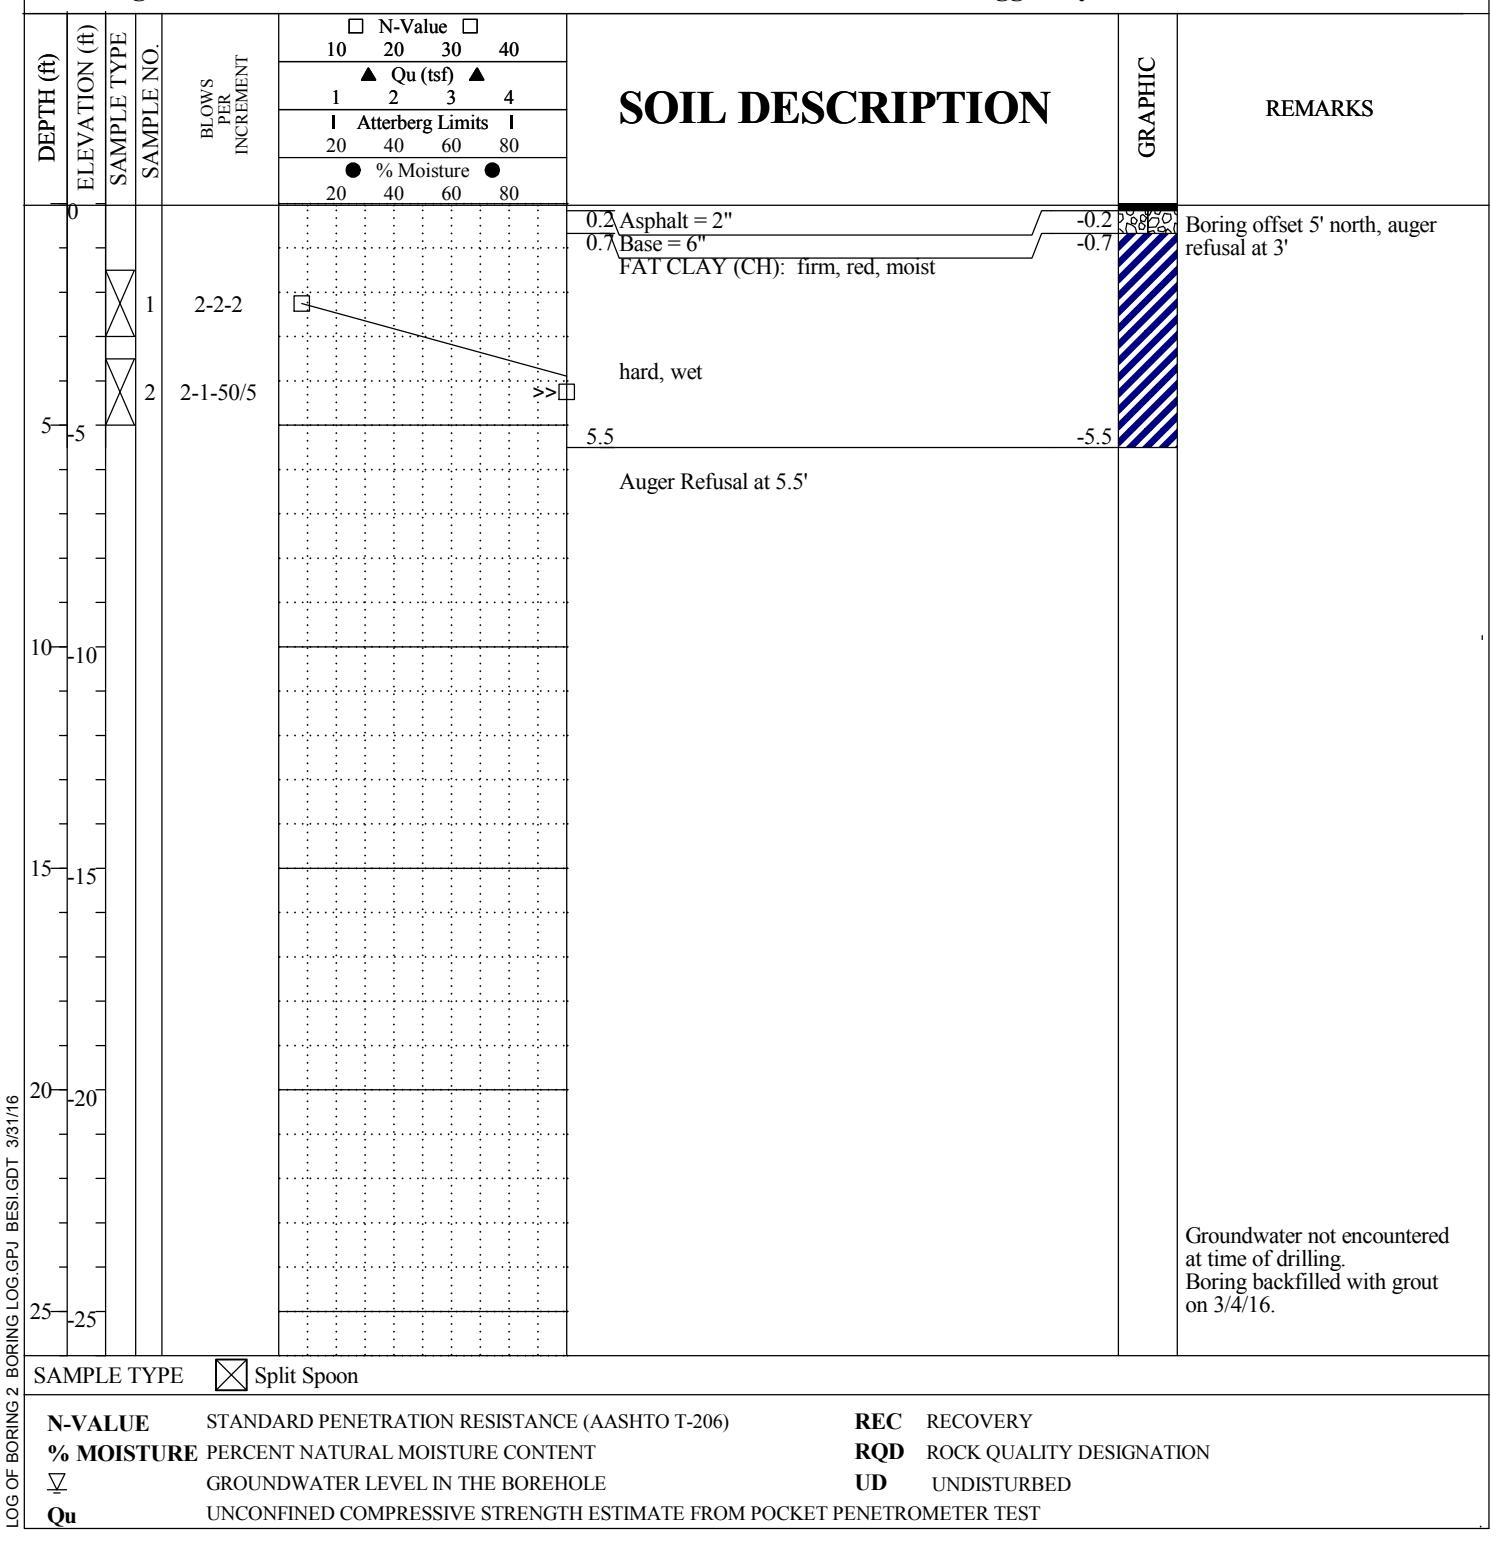
Designation: B-01 Sheet 1 of 1 5545 Derby Drive Birmingham, AL 35210 Office: (205) 836-6300 Fax: (205) 836-9007 www.BuildingAndEarth.com

Project Name: Chief Ladiga Trail Sinkhole
Project Number: BH160076
Drilling Method: HS Auger
Equipment Used: Mobile HD-45 (Truck)
Hammer Type: Automatic
Boring Location: 15' North of Sinkhole 1

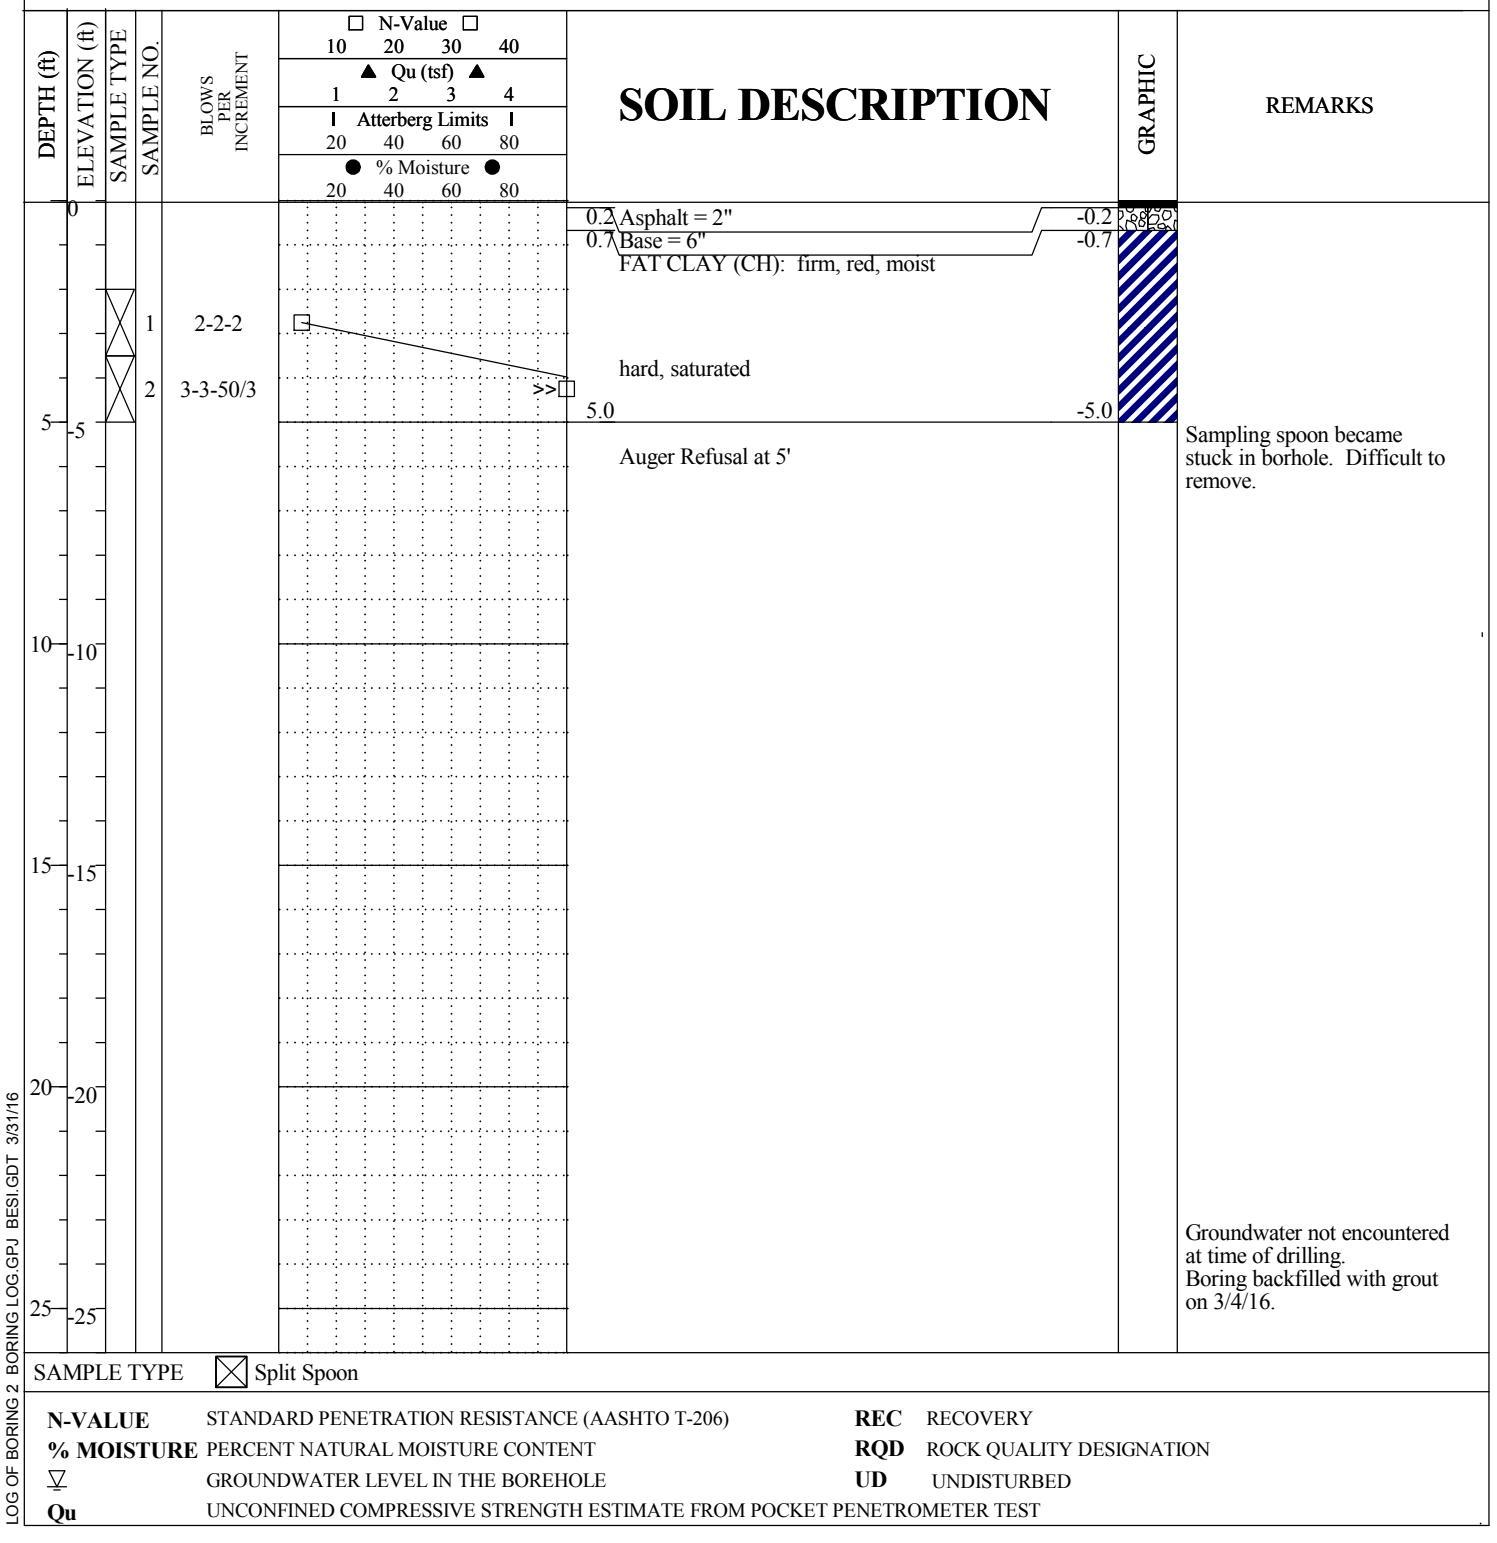
Designation: B-02 Sheet 1 of 1 5545 Derby Drive Birmingham, AL 35210 Office: (205) 836-6300 Fax: (205) 836-9007 www.BuildingAndEarth.com

Project Name: Chief Ladiga Trail Sinkhole
Project Number: BH160076
Drilling Method: HS Auger
Equipment Used: Mobile HD-45 (Truck)
Hammer Type: Automatic
Boring Location: 30' North of Sinkhole 1

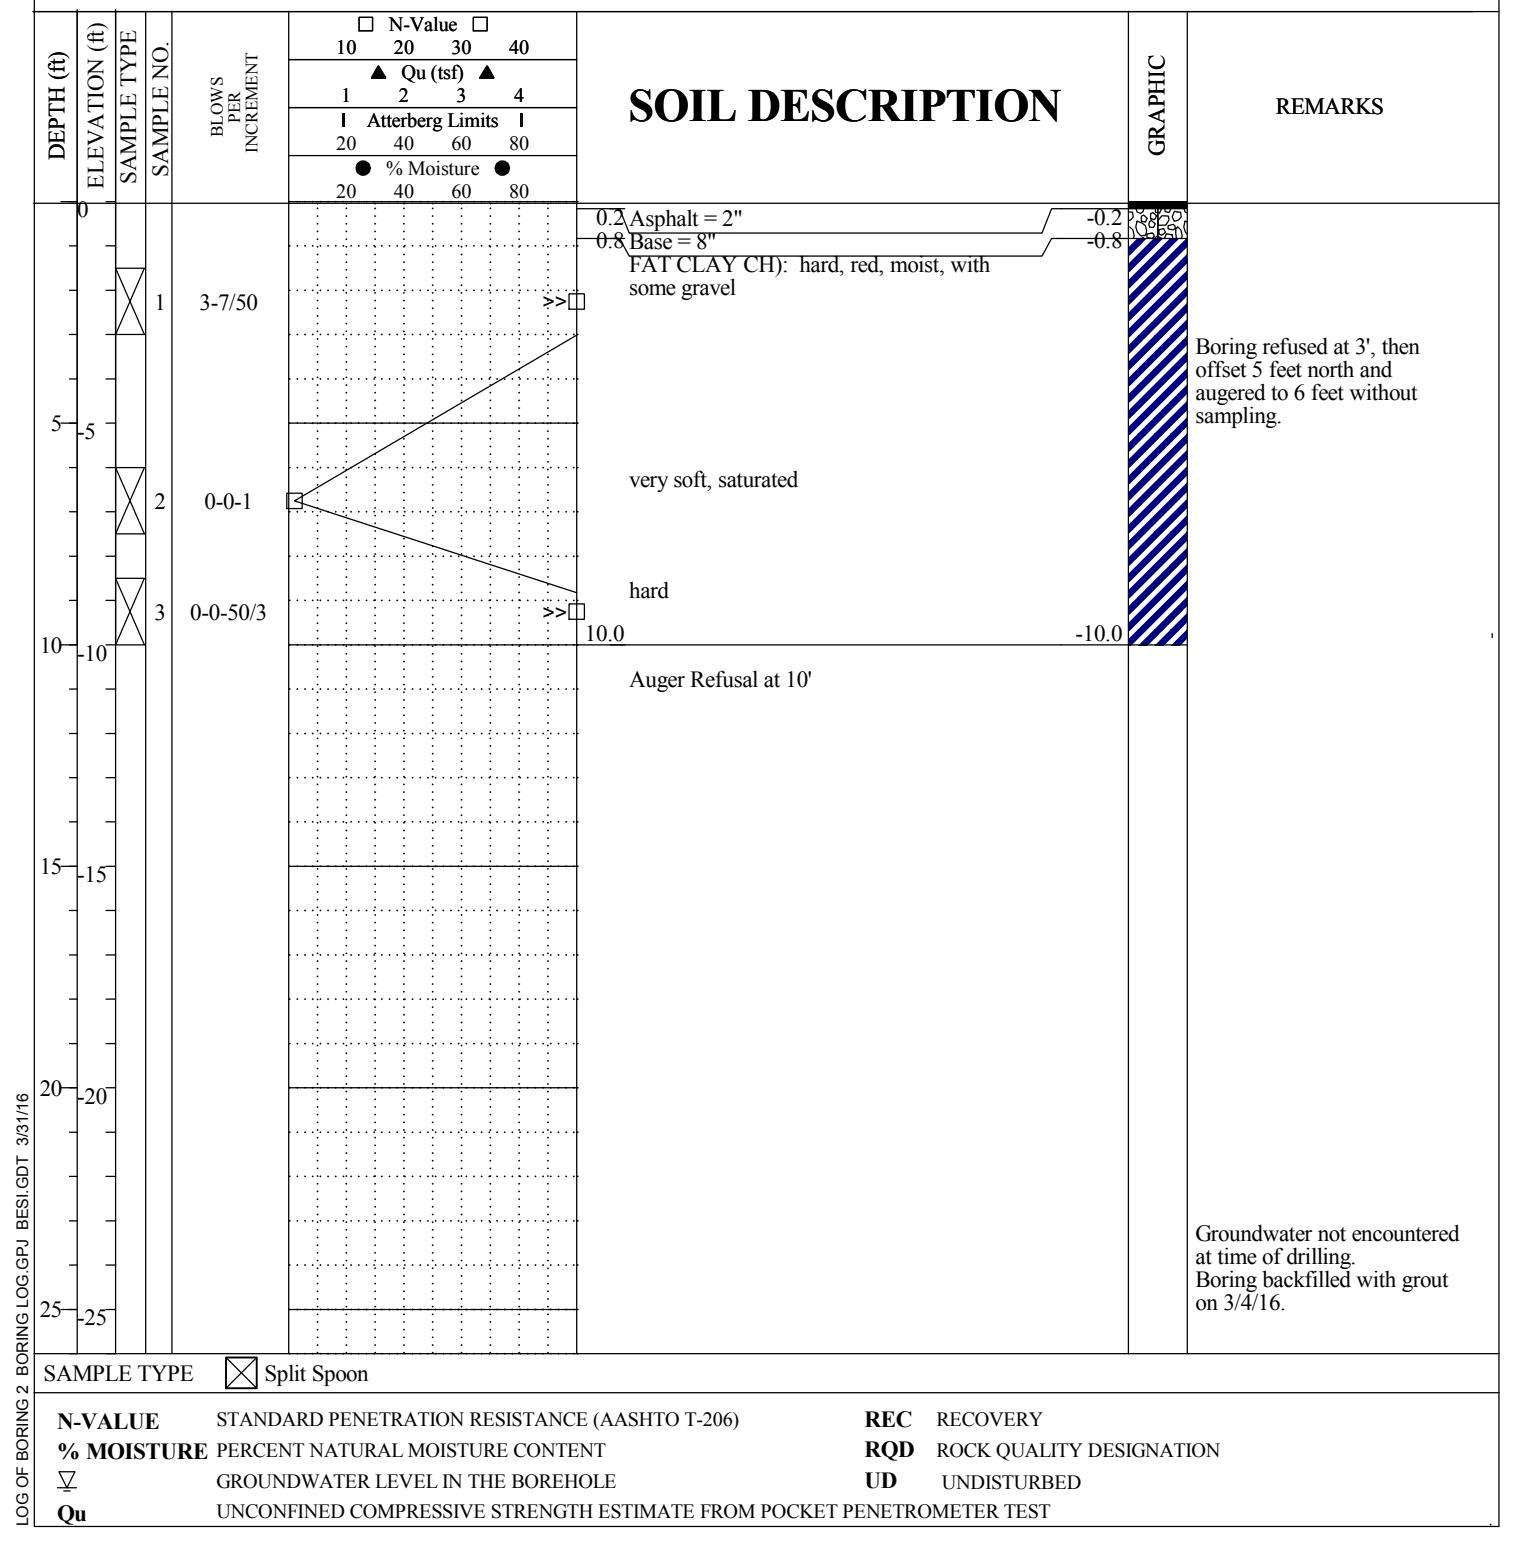
Designation: B-03 Sheet 1 of 1 5545 Derby Drive Birmingham, AL 35210 Office: (205) 836-6300 Fax: (205) 836-9007 www.BuildingAndEarth.com

Project Name: Chief Ladiga Trail Sinkhole
Project Number: BH160076
Drilling Method: HS Auger
Equipment Used: Mobile HD-45 (Truck)
Hammer Type: Automatic
Boring Location: 40' North of Sinkhole 1

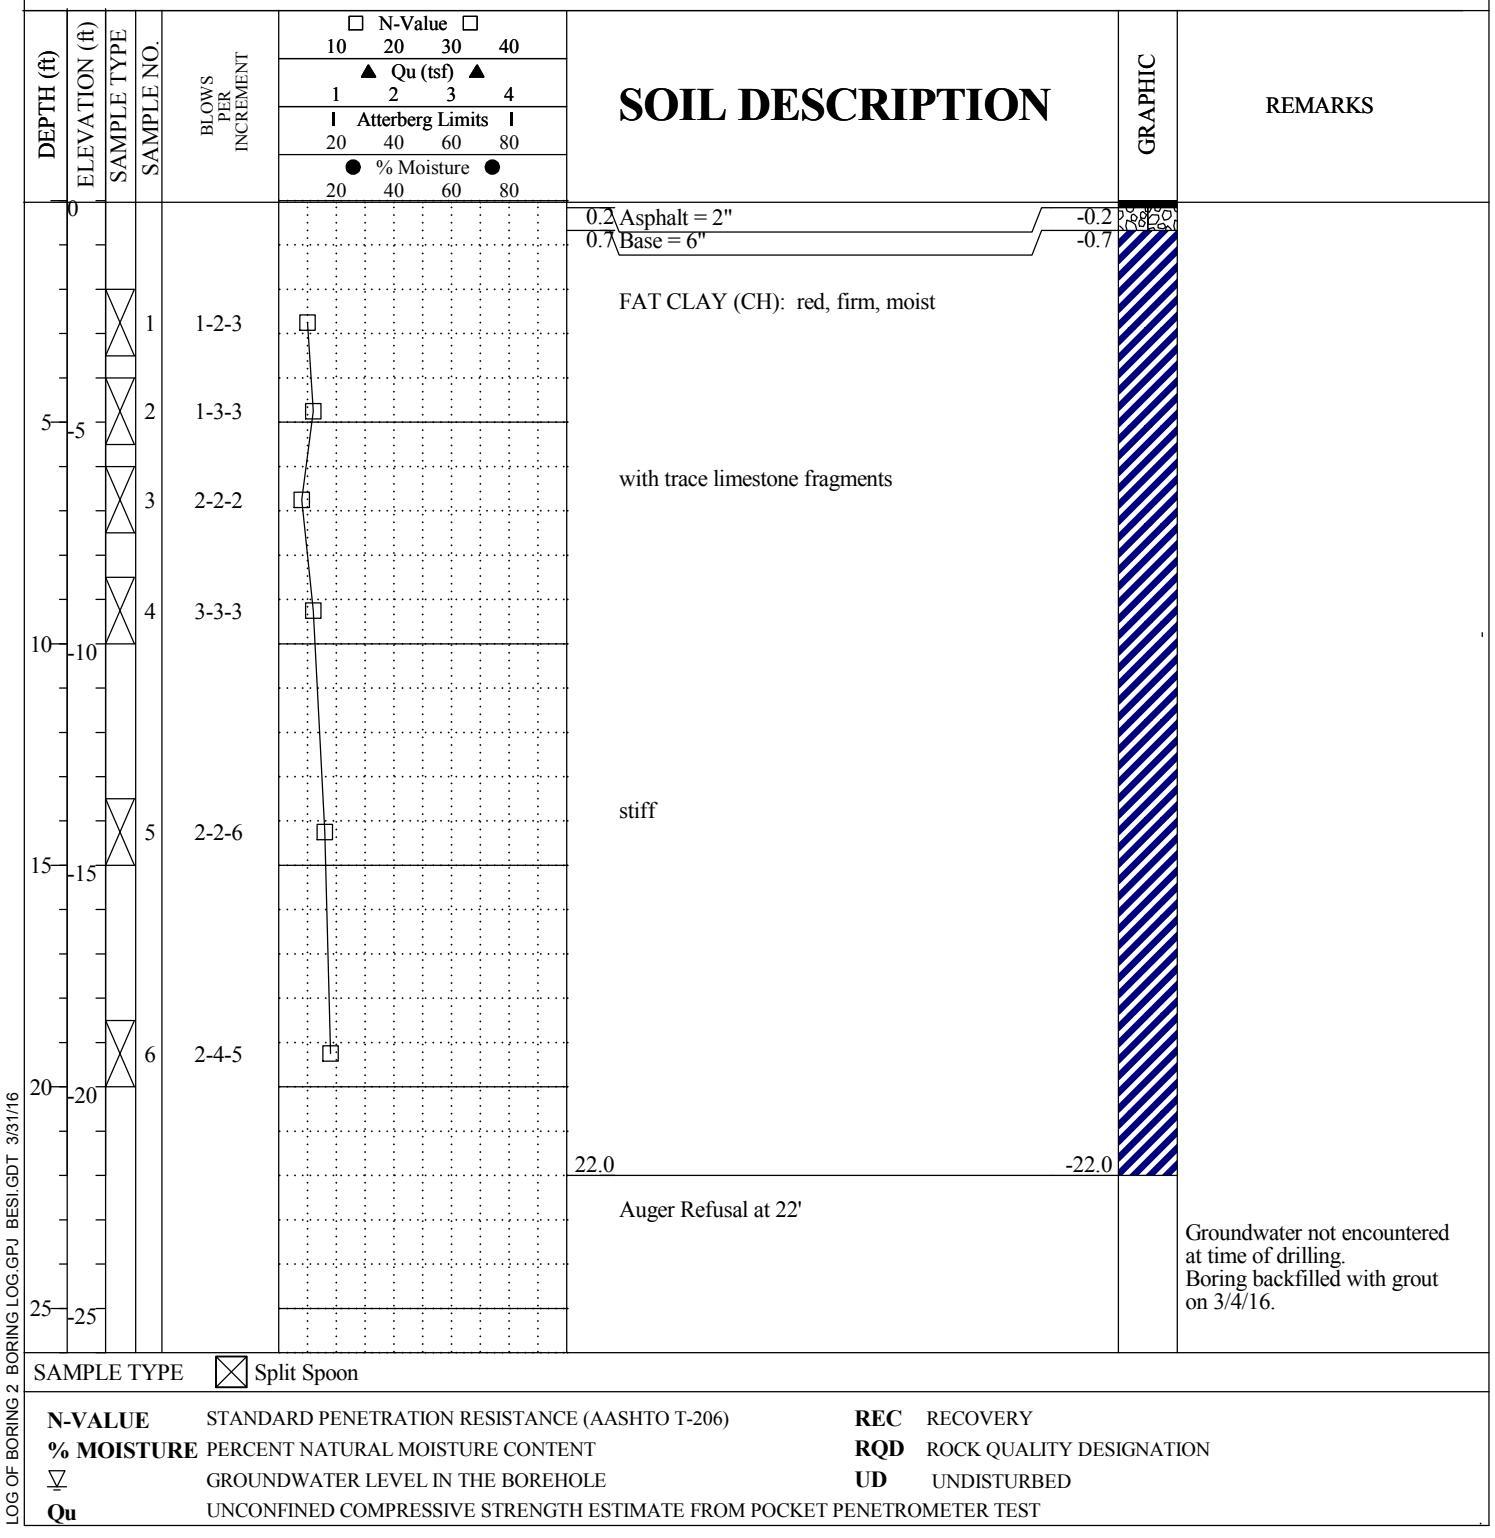
Designation: B-05 Sheet 1 of 1 5545 Derby Drive Birmingham, AL 35210 Office: (205) 836-6300 Fax: (205) 836-9007 www.BuildingAndEarth.com

Project Name: Chief Ladiga Trail Sinkhole
Project Number: BH160076
Drilling Method: HS Auger
Equipment Used: Mobile HD-45 (Truck)
Hammer Type: Automatic
Boring Location: 12' South of Sinkhole 2

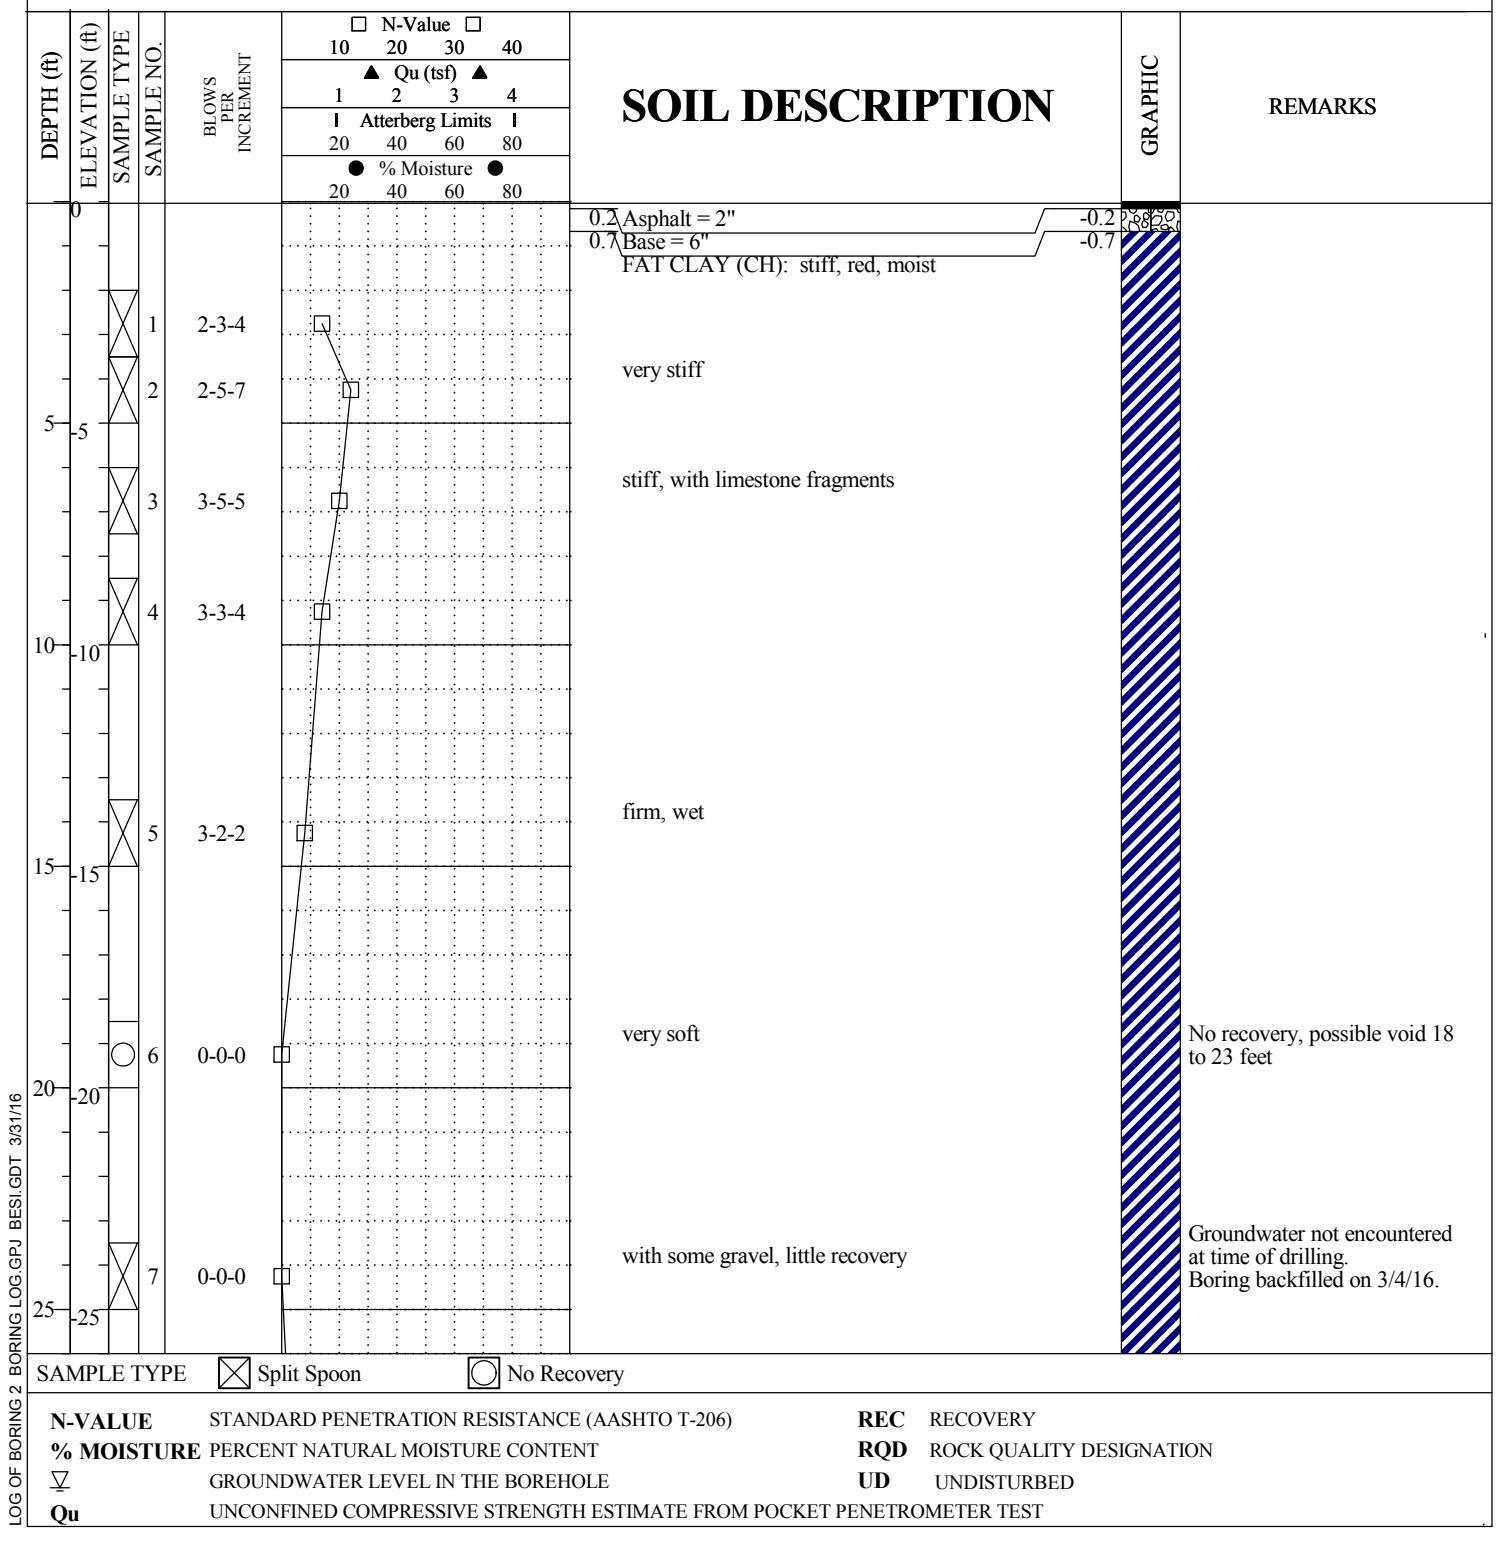
Designation: B-06 Sheet 1 of 2 5545 Derby Drive Birmingham, AL 35210 Office: (205) 836-6300 Fax: (205) 836-9007 www.BuildingAndEarth.com

Project Name: Chief Ladiga Trail Sinkhole
Project Number: BH160076
Drilling Method: HS Auger
Equipment Used: Mobile HD-45 (Truck)
Hammer Type: Automatic
Boring Location: 44' South of Sinkhole 2

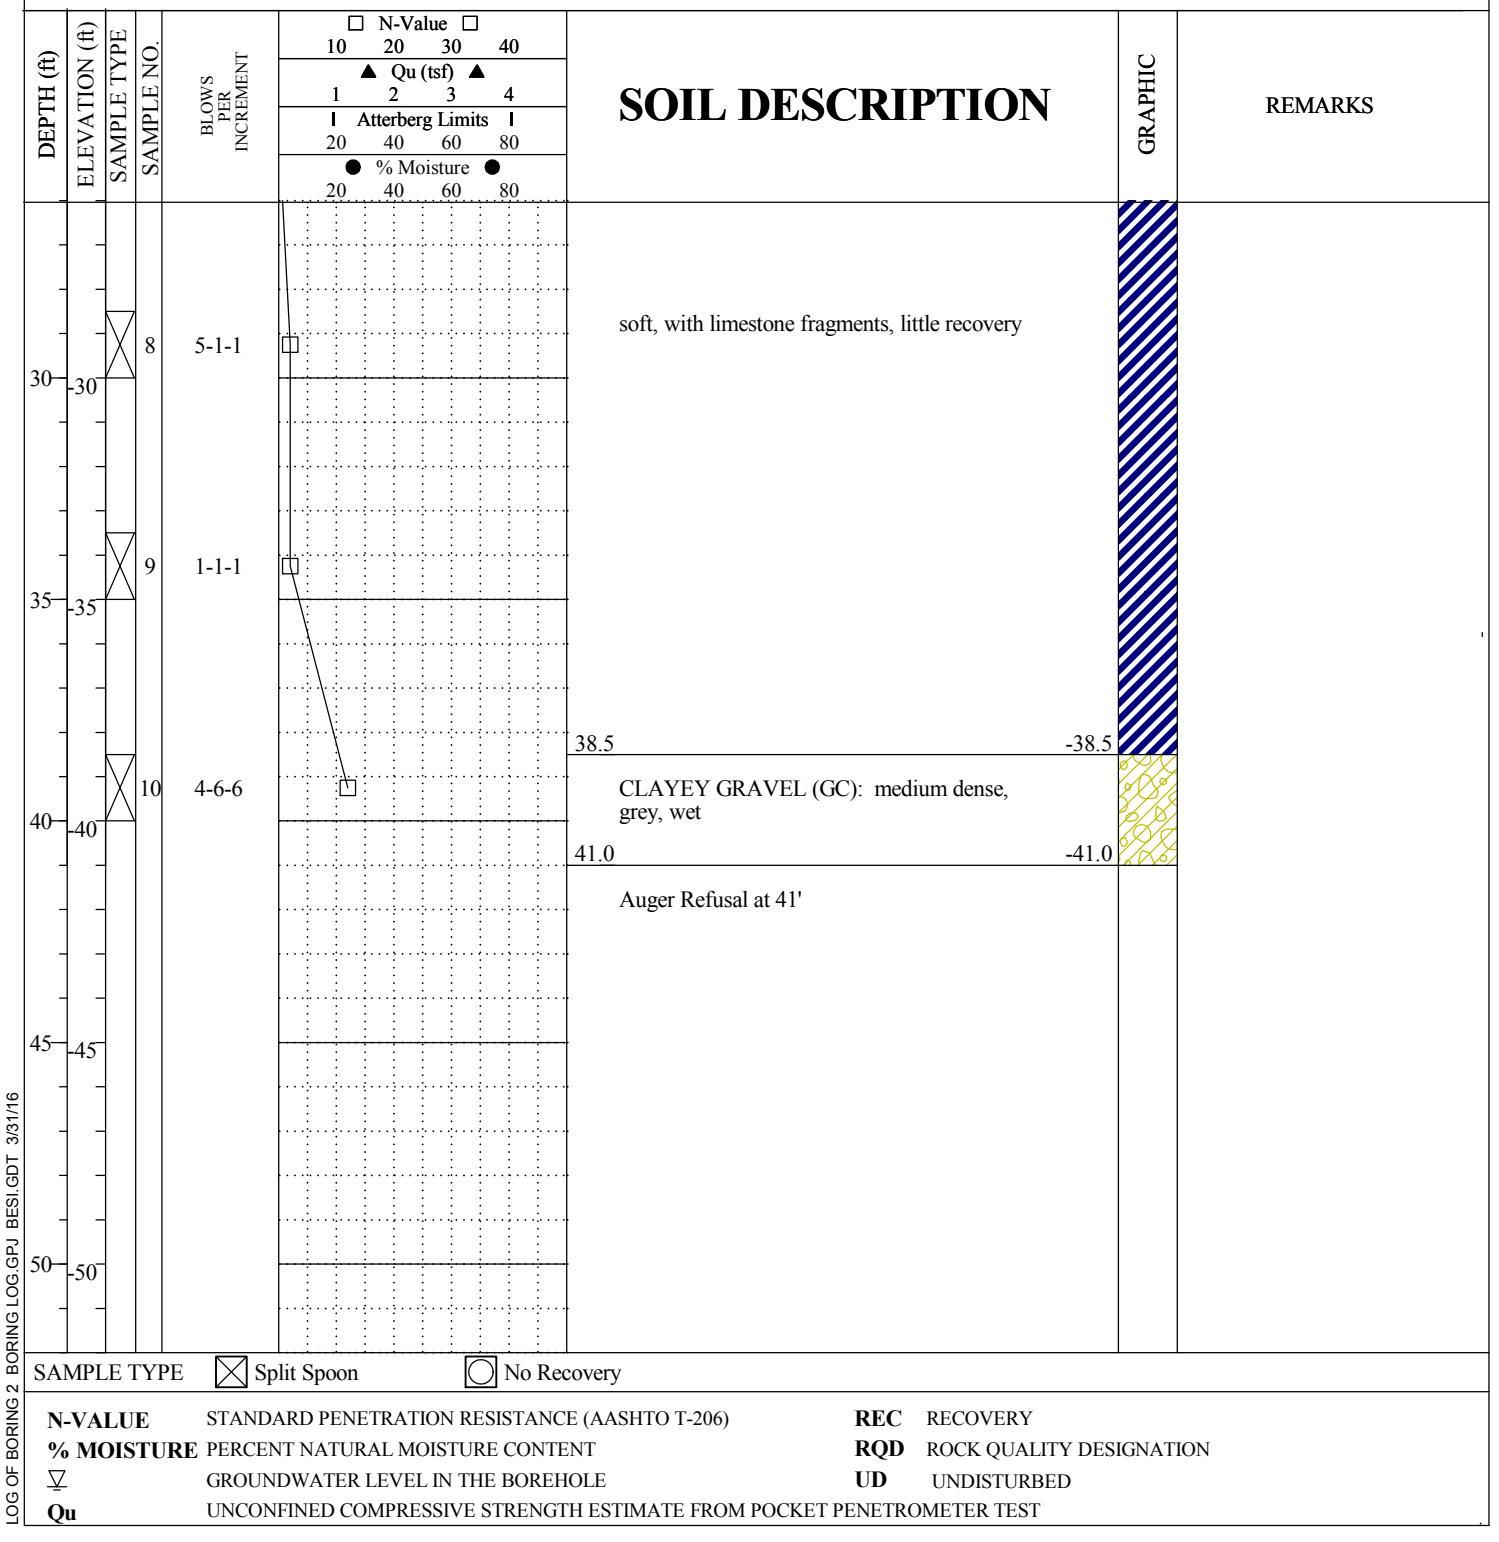
Designation: B-06 Sheet 2 of 2 5545 Derby Drive Birmingham, AL 35210 Office: (205) 836-6300 Fax: (205) 836-9007 www.BuildingAndEarth.com

Project Name: Chief Ladiga Trail Sinkhole
Project Number: BH160076
Drilling Method: HS Auger
Equipment Used: Mobile HD-45 (Truck)
Hammer Type: Automatic
Boring Location: 44' South of Sinkhole 2

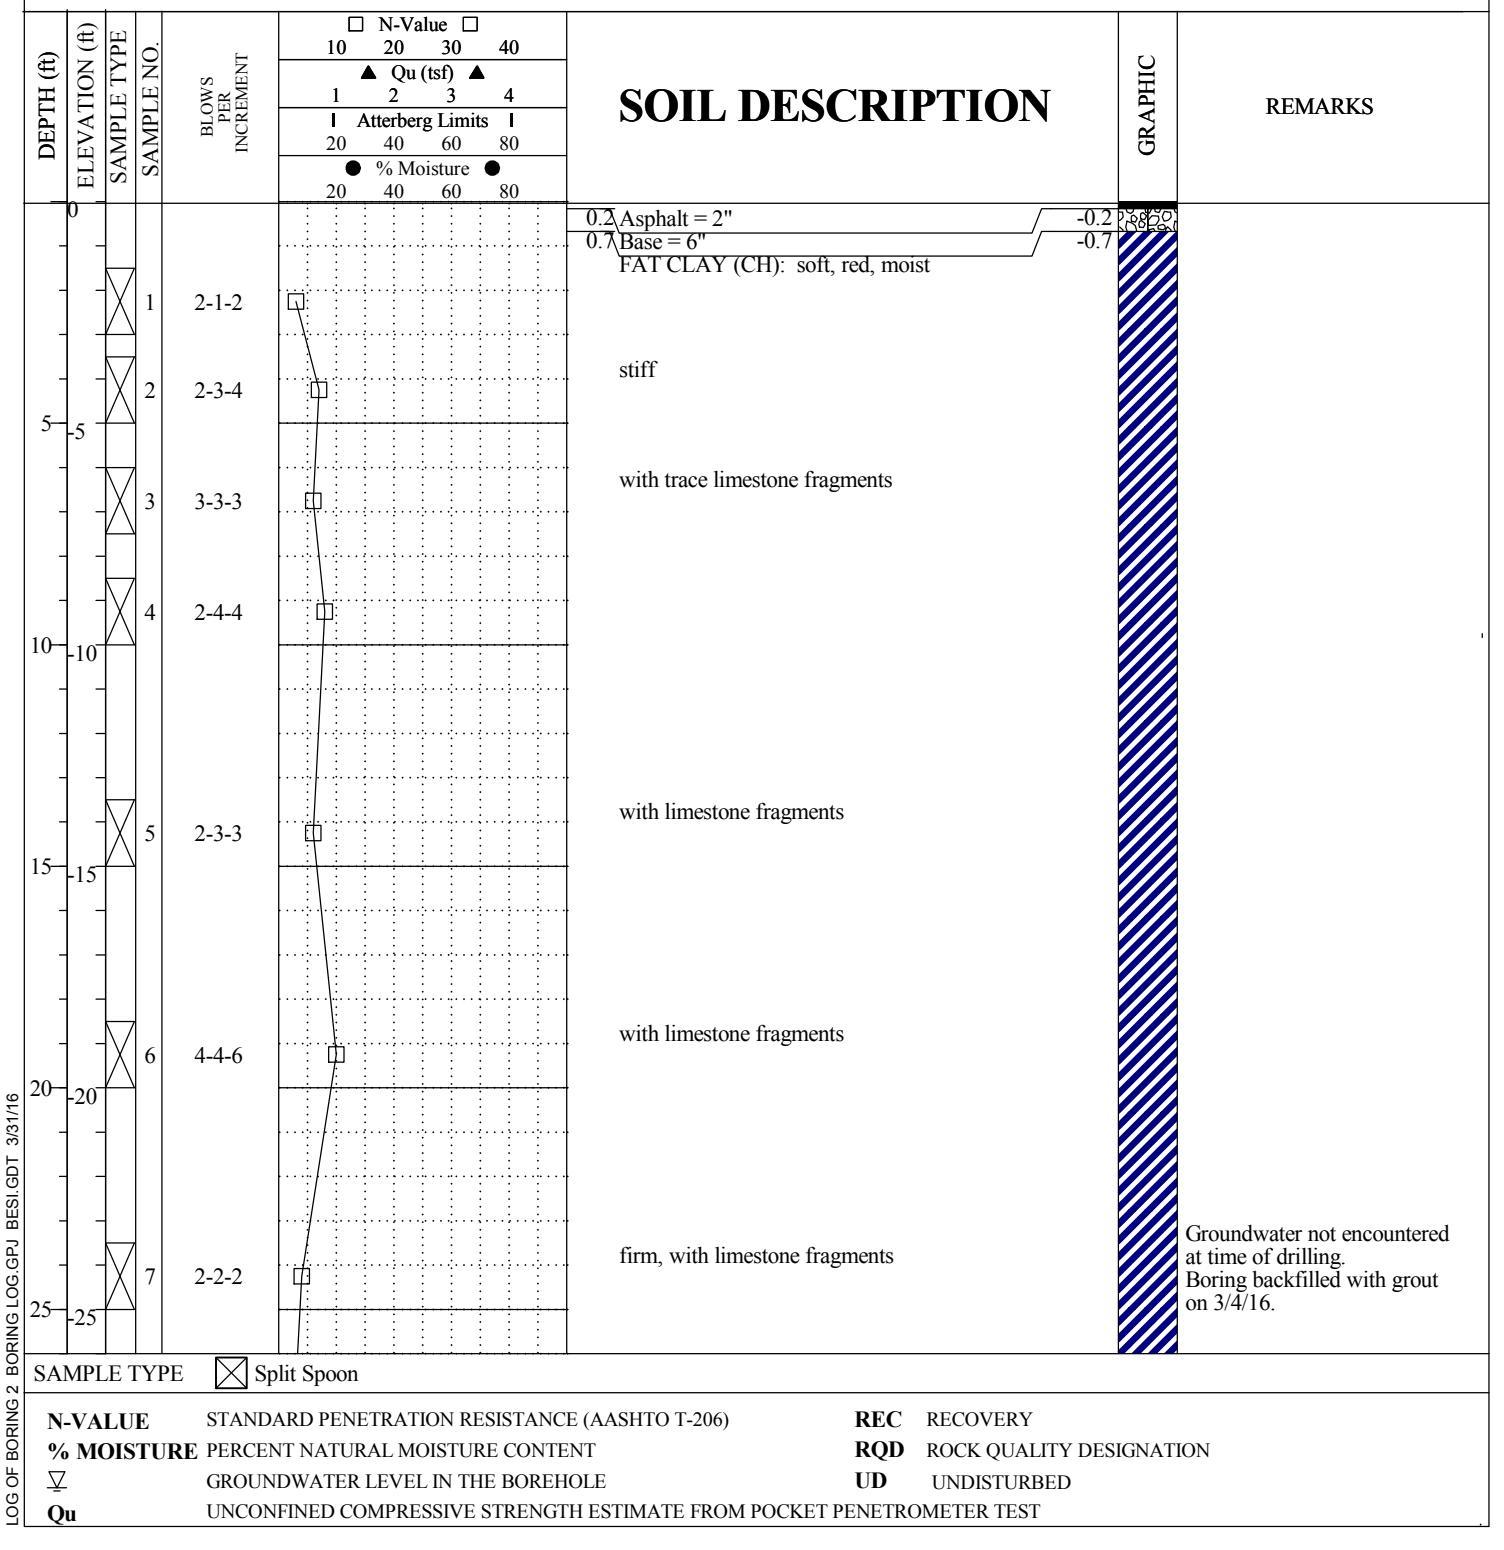
Designation: B-07 Sheet 1 of 2 5545 Derby Drive Birmingham, AL 35210 Office: (205) 836-6300 Fax: (205) 836-9007 www.BuildingAndEarth.com

Project Name: Chief Ladiga Trail Sinkhole
Project Number: BH160076
Drilling Method: HS Auger
Equipment Used: Mobile HD-45 (Truck)
Hammer Type: Automatic
Boring Location: 94' South of Sinkhole 2

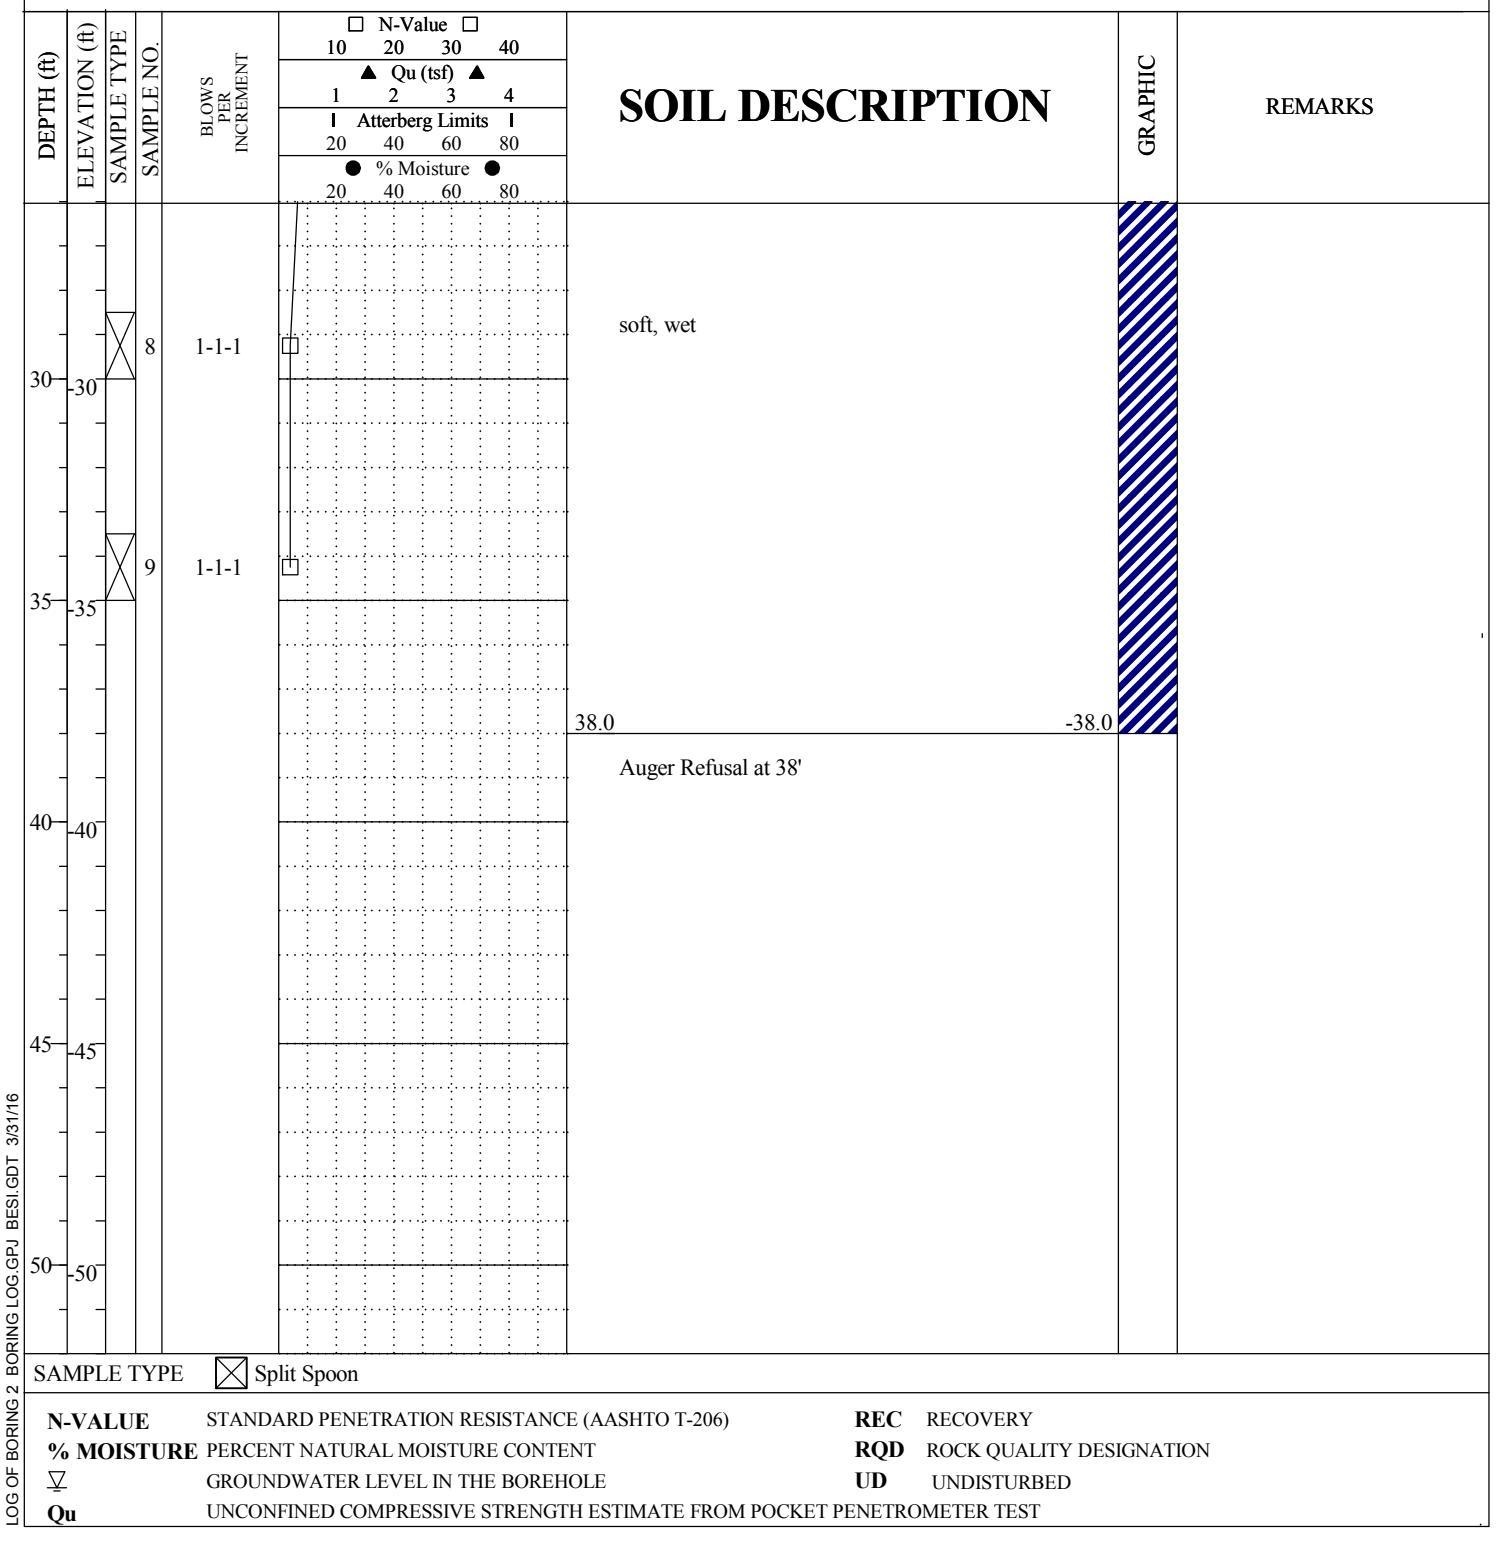
Designation: B-07 Sheet 2 of 2 5545 Derby Drive Birmingham, AL 35210 Office: (205) 836-6300 Fax: (205) 836-9007 www.BuildingAndEarth.com

Project Name: Chief Ladiga Trail Sinkhole
Project Number: BH160076
Drilling Method: HS Auger
Equipment Used: Mobile HD-45 (Truck)
Hammer Type: Automatic
Boring Location: 94' South of Sinkhole 2
