RE: Structural Condition Assessment
20-22 Main Street, Amsterdam, Montgomery County, NY
Ambient Project No. 181107ENVA

**Re: Structural Condition Assessment 20-22 Main Street,
Amsterdam, New York**

20-22 Main Street

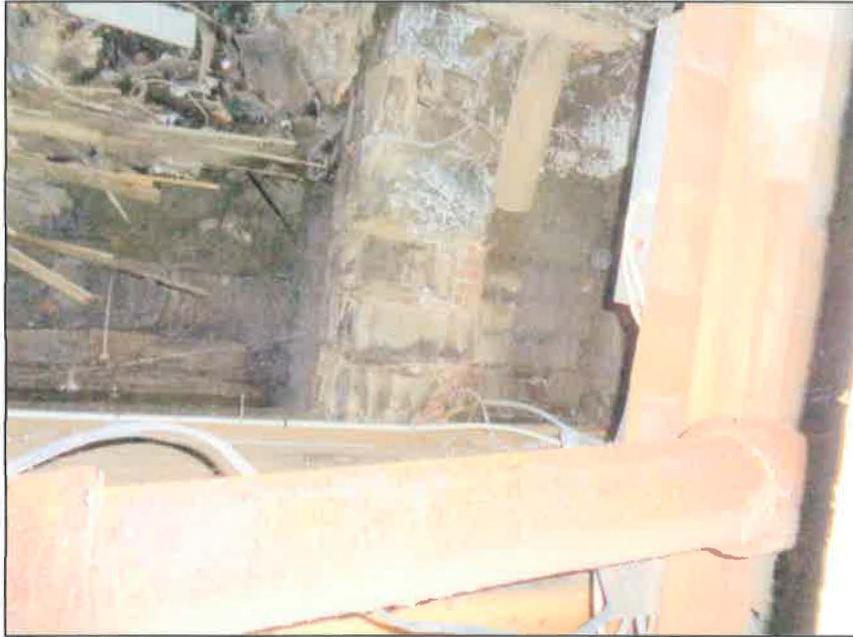
Photograph 17

There is a single access point to the basement area under 20-Main Street. This is located in an opening in the first level floor joist framing on the interior Northwesterly rear portion of the building. It is unknown if there is a basement area under 22 Main Street or a projection of a basement area of 22 Main Street below the front sidewalk which may be a possibility. This can be readily determined at a later date by saw

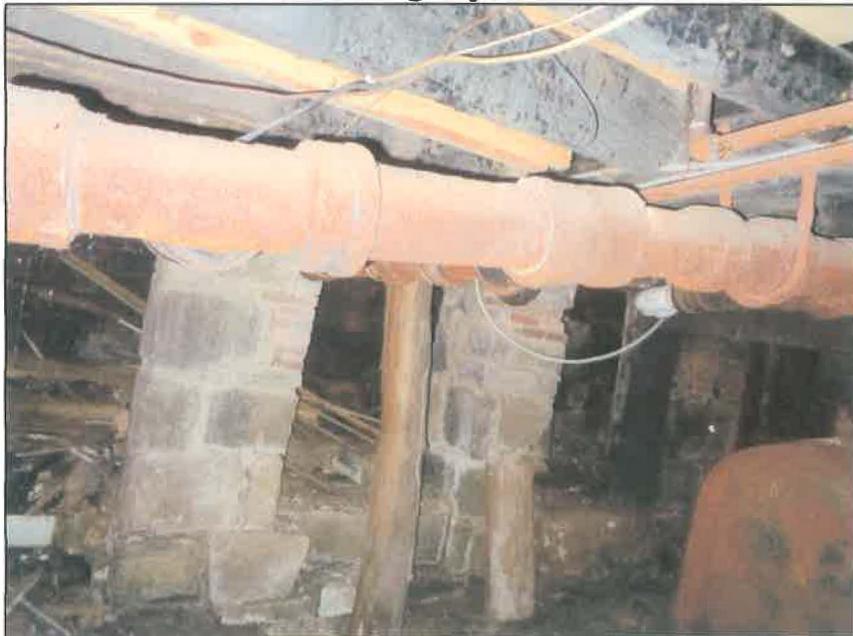
Photograph 18

cutting a sidewalk panel. This will be important to determine at both the Southeasterly and Southwesterly sides of this building. The foundation of the existing basement area at 20 Main Street consists of a combination of laid-up field stone and brick masonry in varying states of deterioration. We found extensive fire damage in rear portions of the basement. Photographs 17 and 18 show deteriorated fieldstone pilasters with supplemental brick masonry repairs having been made at some point. There is a partial collapse zone in the Northwest quadrant of the rear basement area.

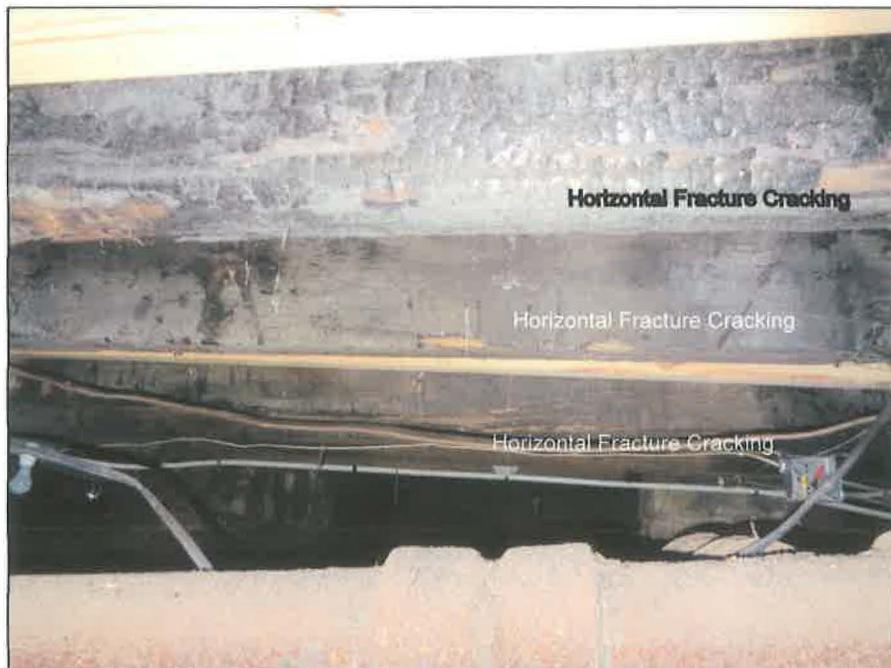
Photograph 19

The existing floor framing in this basement area spans in an East / West direction and is supported by a main timber bearing beam with timber column supports. There is a substantial fire load of garbage and debris found in the basement. Access into the basement area is extremely hazardous. There is a longitudinal fracture crack through the stringers of the basement access stairs and horizontal fracture cracking through the majority of fire damaged floor joists as depicted in Photograph 19. The first level floor framing is fractured and is highly unstable. No personnel shall be permitted to access the basement area. We encountered numerous open electrical junction boxes and deficient electrical fixtures which represent a potential fire hazard. The electrical

service and gas service to the building shall be terminated as soon as practicable to avoid a fire hazard.
