# Cedaredge Golf Club Irrigation System Assessment

Prepared for:

**Mr. Adam Conway  
Golf Course Superintendent  
500 SE Jay Avenue  
Cedaredge, CO 81413**

# **Cedaredge Golf Club Irrigation System Master Plan**

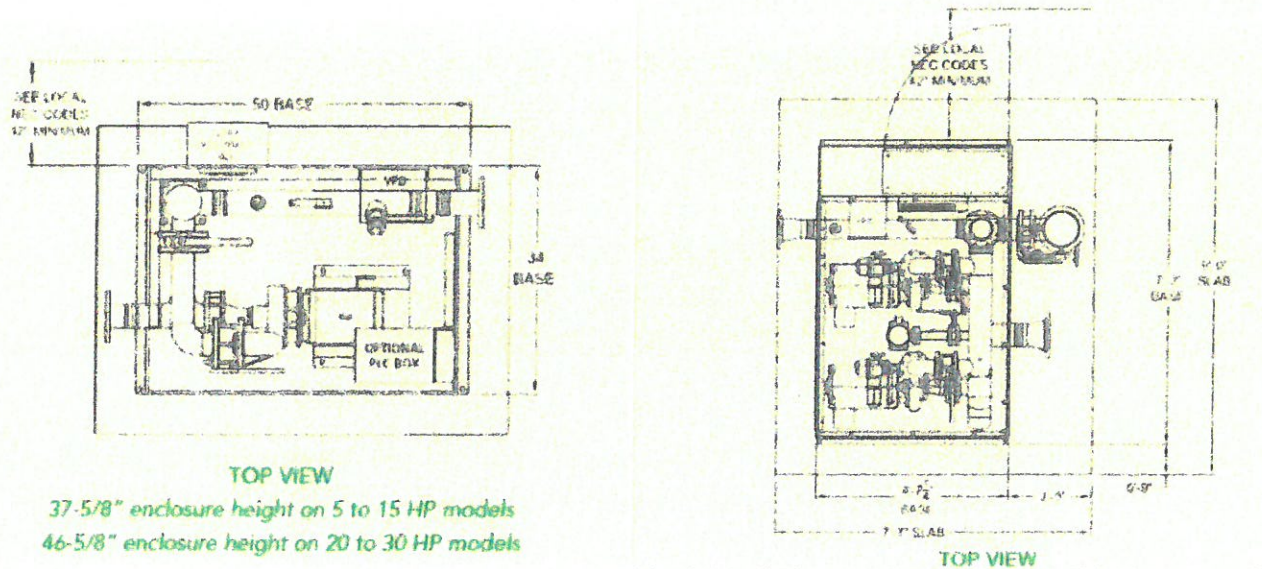
The current pump station configuration supplies water to the cemetery and golf course from one pump station unit. The pump does not have any filtration. The current status has the cemetery pump working but the golf course side of the pump is not working. The golf course irrigation system is irrigated by gravity pressure from an off-site pond. Replacing the pump station is an absolute top priority along with an inline filtration device. The 56 pounds of pressure coming from the pond source is about half the pressure needed to properly irrigate the front nine holes and holes 16, 17 and 18 on the back nine. Holes 10-15 and the driving range have adequate pressure supplied from the gravity supply side of the irrigation system.

Picture 2 & 3. Cemetery Pump Station Typical Foot Print

Golf Course Pump Station Typical Foot Print

Replacing the pump station with two separate pump stations would allow for a complete separation of the golf course and cemetery irrigation operation. Each pump station would be enclosed in a steel, lockable enclosure and have separate electric meters to allow for separate billing.

The estimated cost to replace the two stations is:

Cemetery pump station (picture 2)	\$20,000
Golf course pump station (picture 3)	\$92,000
Inline wye strainer filtration	included in cost of golf course station
Demolition of existing pump building	\$3,000
Installation of pump stations by contractor	\$20,000
Electrical utility upgrades/meters	\$6,000
Pump station plans and specifications	\$6,000
<b>Total:</b>	<b>\$147,000</b>

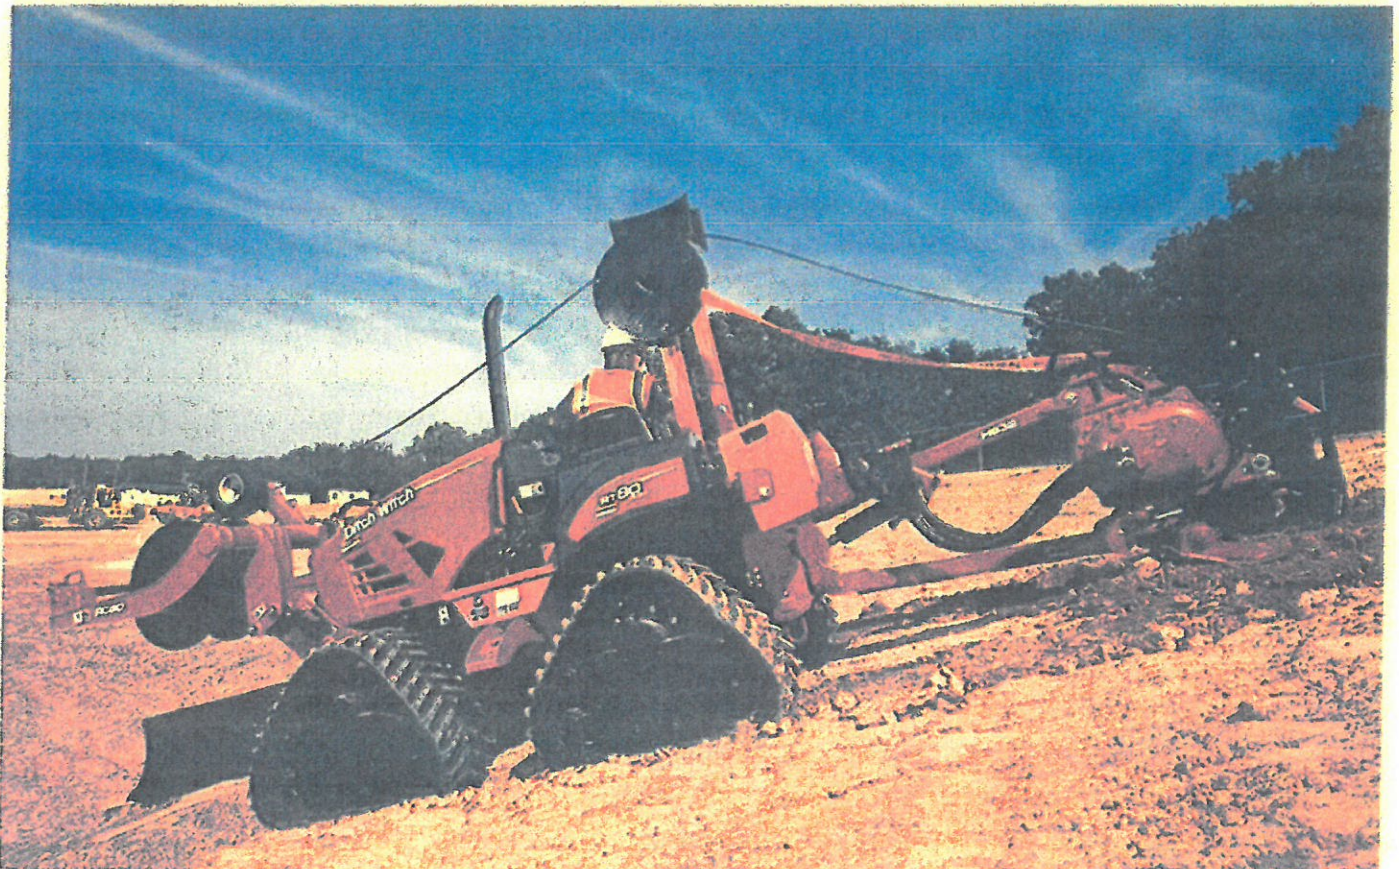
*Picture 4. A vibratory plow capable of installing new communication cable*

Installation of the cable can be achieved by use of a vibratory plow, (picture 4) that lays wire underground without opening a ditch. The cable would be installed parallel to the existing mainline and connected to the existing remote control valves.

The estimated cost to install 27,000' of new cable is about \$2.00 to \$2.50/foot, \$54,000 to \$67,500 total.
