# Bridger Foothills Entrapment and Shelter Deployment

Facilitated Learning Analysis

**September 5<sup>th</sup>, 2020**

Montana Department of Natural Resources and Conservation  
USDA Forest Service, Region 1/ Custer-Gallatin National Forest

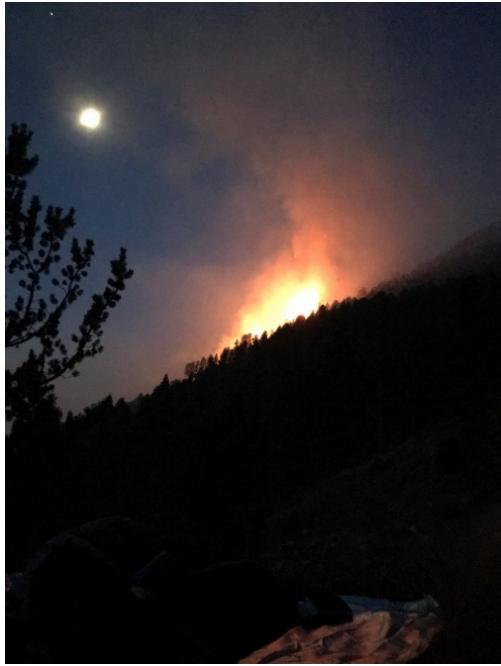
*Figure 5: A photo, taken at approximately 0605 on Saturday morning, of the trees torching above the Helitack Crew's campsite.*

The Helitack Crew woke up Saturday morning at 0600 to the sound of trees torching. These trees, which they could view from their campsite, were likely part of a slop-over outside the handline that the hotshot crew had been digging and burning off all night and into the early morning. Given the approximately 1-acre slop-over, the priority for Division A on Saturday morning was to send the Hotshot Crew back up the handline to contain the slop and continue down the ridge towards the other ground resources working below.

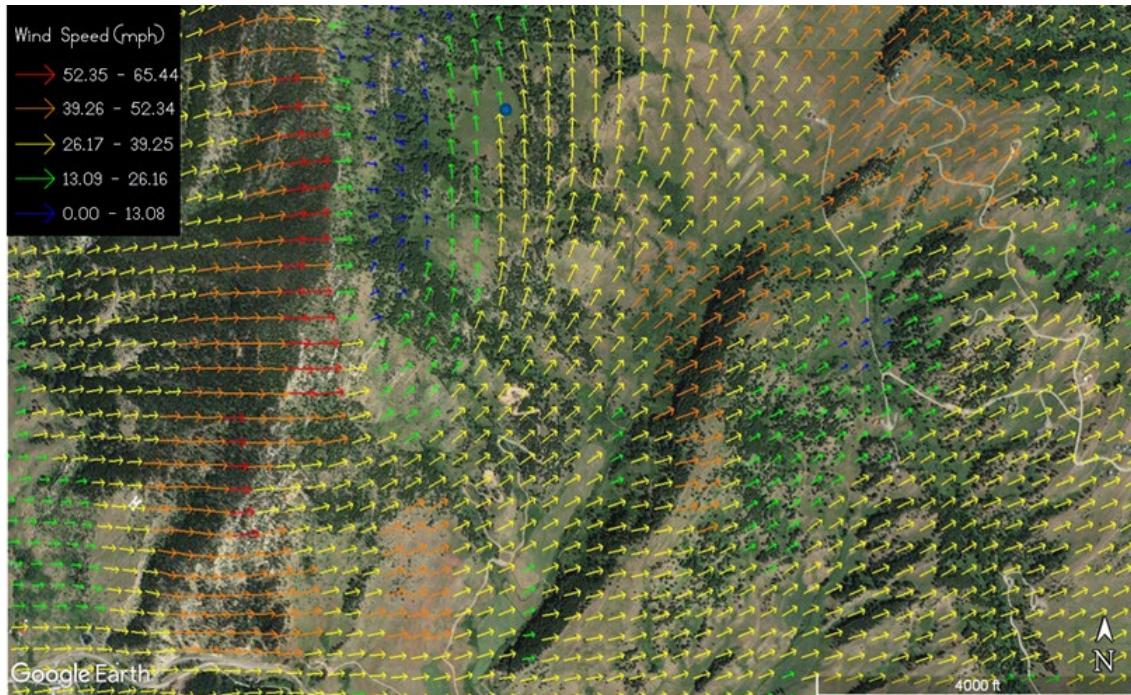
Figure 8: WindNinja model, conducted for Saturday 9/5/2020 for the Bridger Foothills Fire. Arrows display terrain influences on wind direction and color indicates speed. Wind speed used was 30mph from 250° to model forecasted ridgeline winds of 25-35mph out of the west. The helispot is designated by a blue dot.

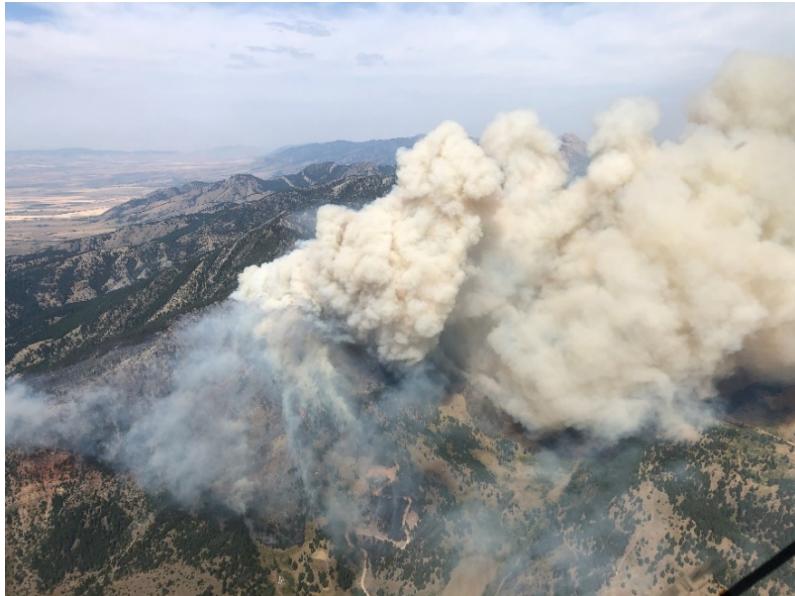
Figure 11: Picture taken from the air attack platform at 1326. The image captures fire activity leading up to the shelter deployment.

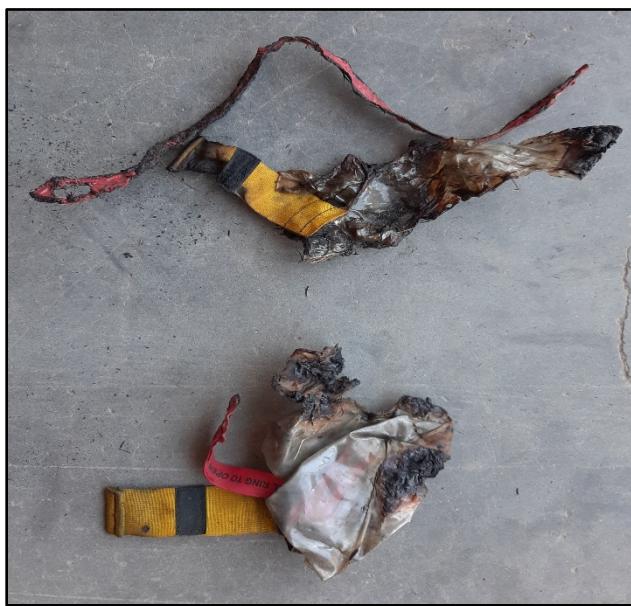
- Firefighter information: FF1 was 71 inches (5 foot 11 inches) tall and weighed 185 pounds.
- Fire shelter information: The regular-sized fire shelter was manufactured according to Forest Service Specification 5100-606C in October of 2016.
- Post-deployment fire shelter inspection observations:
  - Polyvinyl chloride (PVC) bag(s): The fire consumed both fire shelter PVC bags—PVC bags, pull-tab strips, and nylon pull straps. See figure 4.

*Figure 4: Both polyvinyl chloride (PVC) bags, red pull-tab strips, and yellow nylon pull straps.*

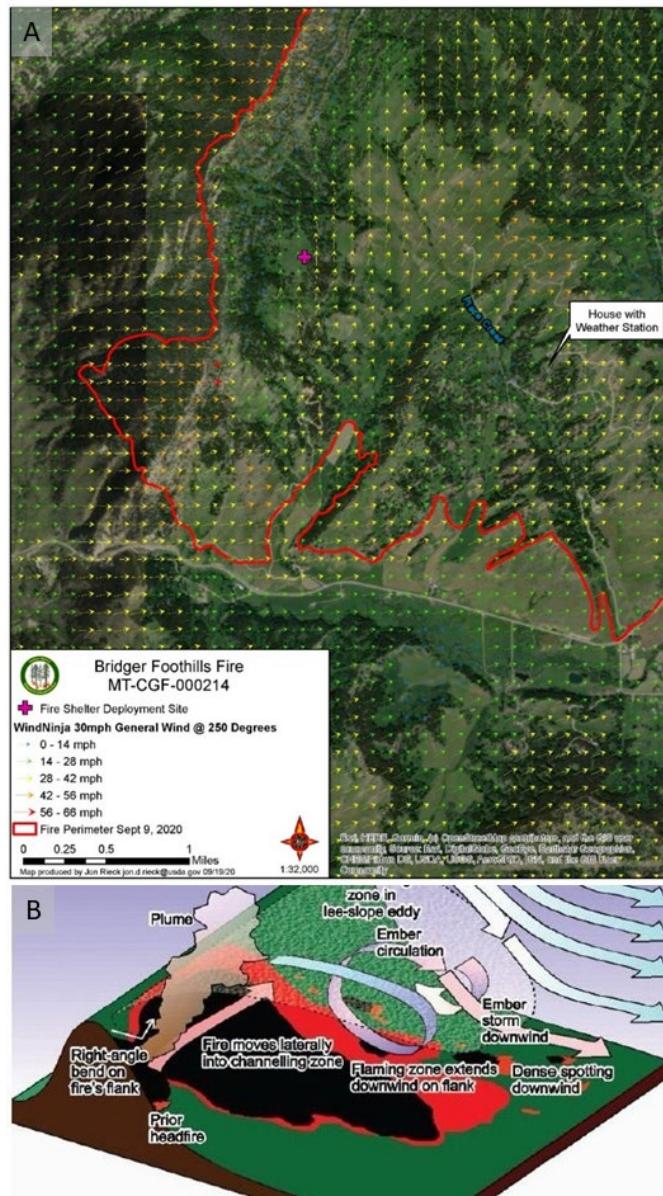
Model outputs from Wind Ninja indicate an expected wind at that weather station to be 14-28 mph from the southwest with stronger winds adjacent to the site. On-site observations of needle freeze on Douglas-fir trees indicates a slope effect, turning surface winds to approximately 168 degrees.

Figure 1A: Results of the Wind Ninja model using a 30-mph wind from 250 degrees and 1B: conceptual diagram of slope effect on wind direction.

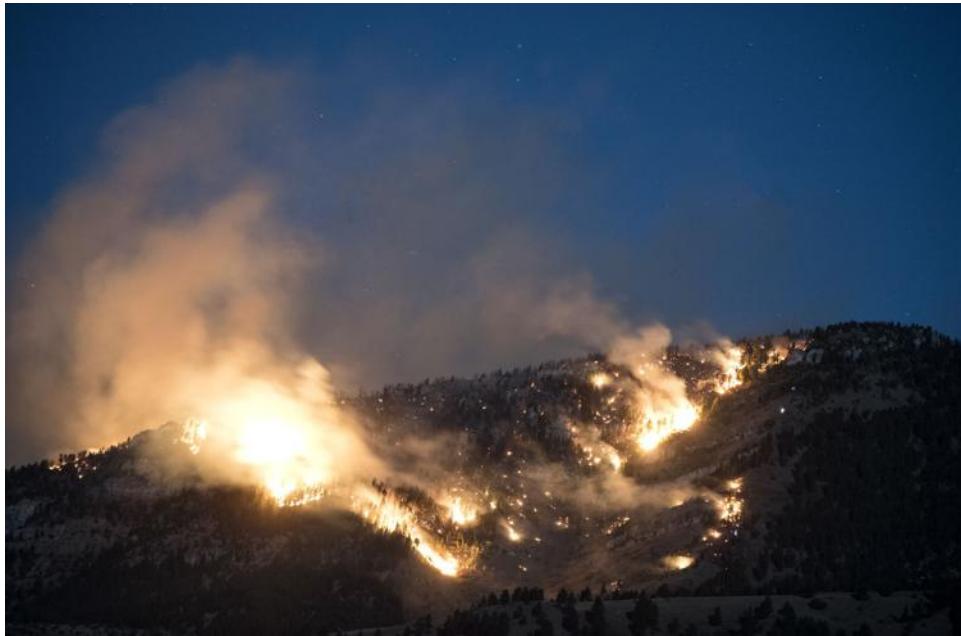
Photos show that the fire was established down to about the 5,900 feet elevation level on the morning of the 5<sup>th</sup>, on the east side of the ridge. Fire behavior was active throughout the previous night.

*Figure 2: Fire activity on the Bridger Foothills Fire for the night of September 4<sup>th</sup>. Photo credit: Rachel Leathe, Bozeman Daily Chronicle.*

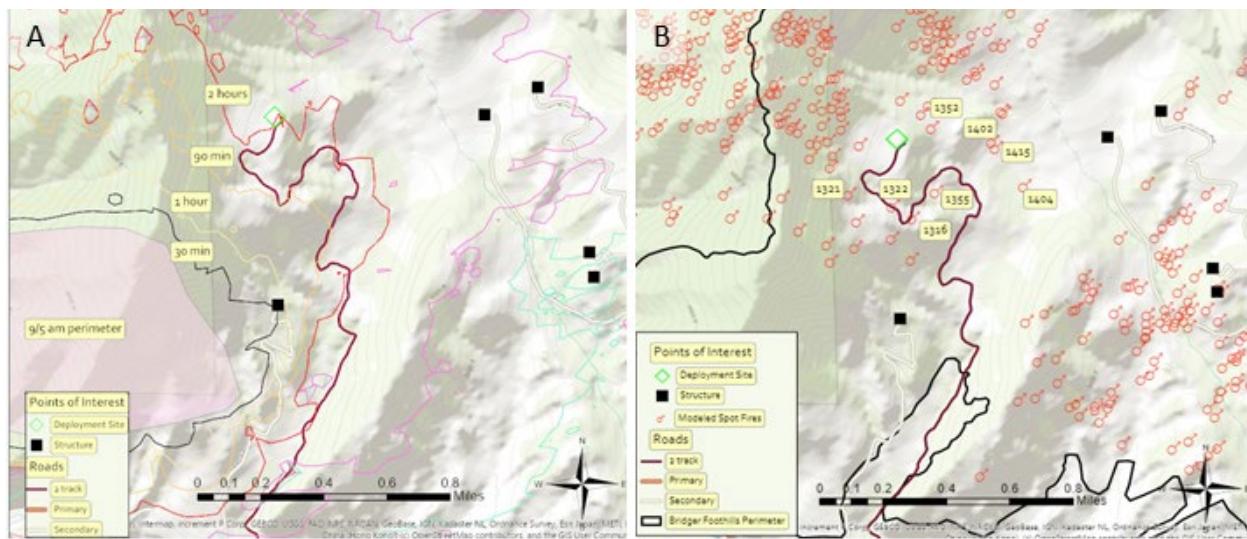
Figure 3A: Fire perimeter progression for the Bridger Foothills Fire, beginning approximately 1200 hours and 3B: modeled spot fires around the deployment site with approximate time of ignition

Several spot fires are expected to have impacted the site. The two of most interest are modeled to have occurred at about 1315 hours and 1320 hours, both downhill from the site. Two other spots are modeled to have occurred somewhat later and may have impacted the site in the second wave. Two more modeled spots are validated by actual observations, giving confidence in the model.
