REPORT ON THE COLLISION BETWEEN USS JOHN S MCCAIN (DDG 56)  
AND MOTOR VESSEL ALNIC MC

23 OCT 2017

## **1. EXECUTIVE SUMMARY - USS JOHN S MCCAIN**

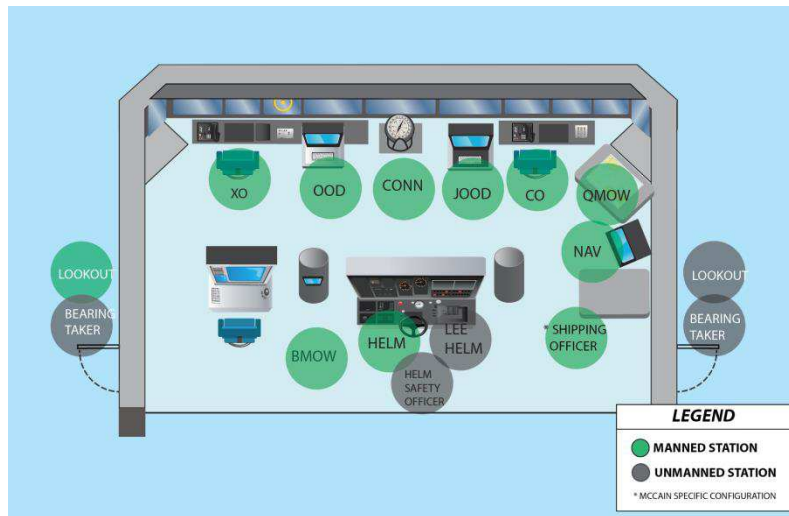
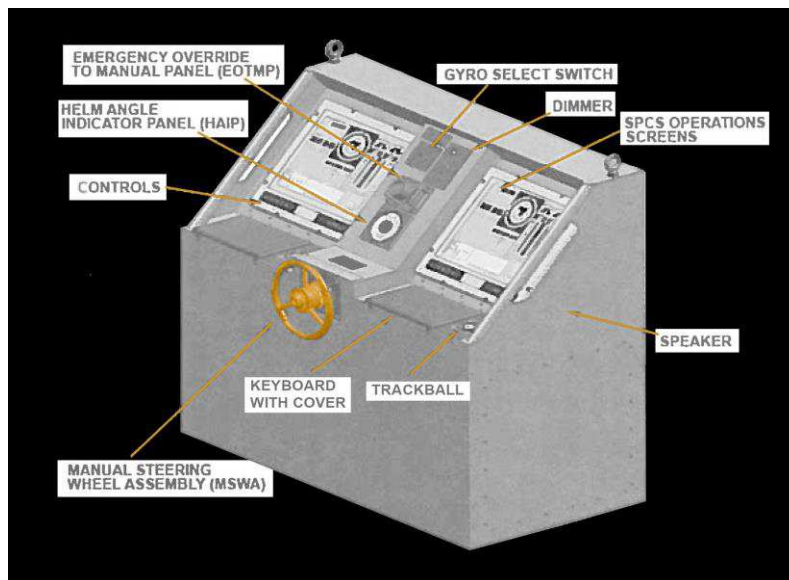
Figure 5 – Illustration of Ship Control Console on JOHN S MCCAIN

Steering was never physically lost. Rather, it had been shifted to a different control station and watchstanders failed to recognize this configuration. Complicating this, the steering control transfer to the Lee Helm caused the rudder to go amidships (centerline). Since the Helmsman had been steering 1-4 degrees of right rudder to maintain course before the transfer, the amidships rudder deviated the ship's course to the left.

Additionally, when the Helmsman reported loss of steering, the Commanding Officer slowed the ship to 10 knots and eventually to 5 knots, but the Lee Helmsman reduced only the speed of the port shaft as the throttles were not coupled together (ganged). The starboard shaft continued at 20 knots for another 68 seconds before the Lee Helmsman reduced its speed. The combination of the wrong rudder direction, and the two shafts working opposite to one another in this fashion caused an un-commanded turn to the left (port) into the heavily congested traffic area in close proximity to three ships, including the ALNIC. See Figure 5.

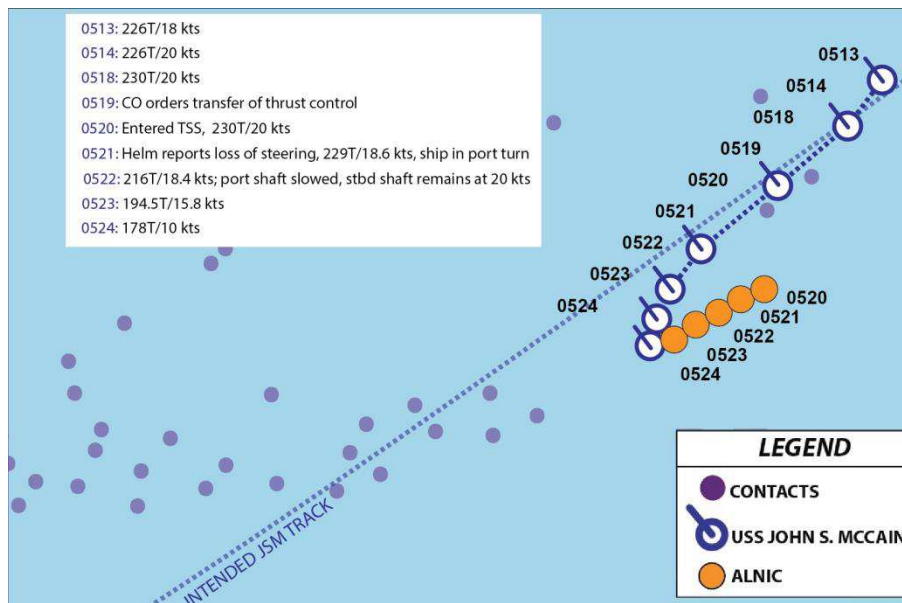
**Figure 6 – Illustration Map of Approximate Collision Location**

Approximately three minutes after the reported loss of steering, JOHN S MCCAIN regained positive steering control at another control station, known as Aft Steering, and the Lee Helm gained control of both throttles for speed and corrected the mismatch between the port and starboard shafts. These actions were too late, and at approximately 0524 JOHN S MCCAIN crossed in front of ALNIC's bow and collided. See Figure 6.

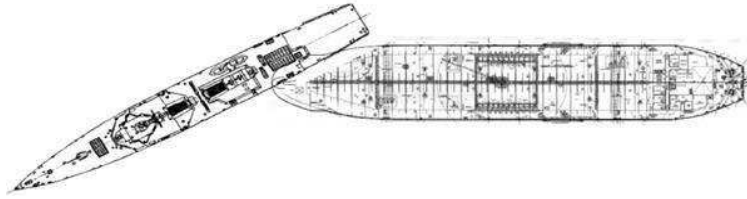
**Figure 7 – Approximate Geometry and Point of Impact between USS JOHN S MCCAIN and ALNIC MC**

The bulbous bow of ALNIC MC impacted JOHN S MCCAIN on the port (left) aft side. The impact created a 28-foot diameter hole both below and above the waterline of the JOHN S MCCAIN. See Figures 7, 8, and 9.

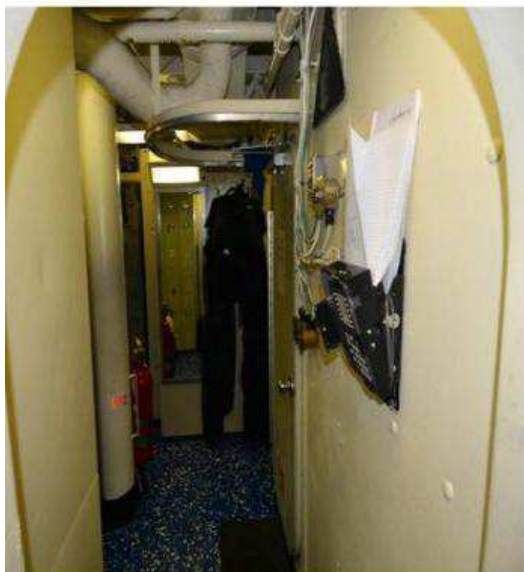
**Figure 15 – Berthing 3 facing port**

At 0530, the DCA began receiving reports of a ruptured fire main and water and fuel flooding into Berthing 3. The port side of Berthing 3 suffered substantial damage, including a large hole in the bulkhead. See Figure 13. Racks and lockers detached from the walls and were thrown about, leaving jagged metal throughout the space. Cables and debris hung from the ceiling.

Hearing reports that Sailors were trapped in Berthing 3, the Executive Offer and a group of Sailors, including some who evacuated Berthing 7, went to check on their shipmates. Several Sailors were pinned in their racks as a result of the collision, but, as the two ships pulled apart, the twisted metal shifted and most of the Sailors in Berthing 3 were able to escape as the debris moved. One of these Sailors was pinned in his rack underneath two racks that had collapsed and a number of lockers that became dislodged during the collision. He was able to escape after ALNIC MC detached. See Figures 14 and 15.
