# Pavement Evaluation Report

**West Klein Road**

**New Braunfels, Texas**

Terracon Project No. 90201363

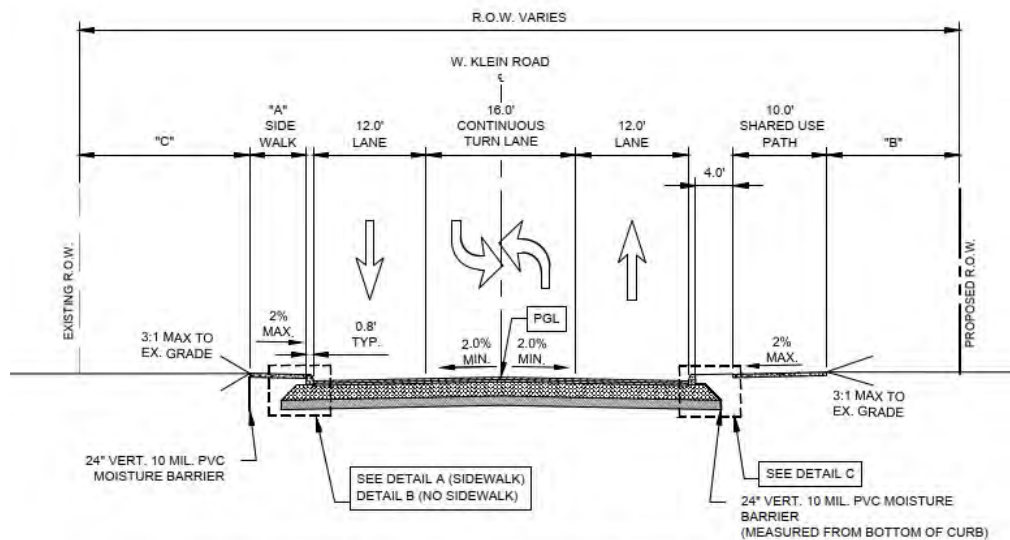
### 3.3 Pavement Details from Civil Drawings (Sheet 34, Plans dated April 10, 2019)

In cases where a sidewalk is constructed adjacent to the edge of the pavement, the 10 mil PVC moisture barrier is not specified.
