The following is an existing conditions study focusing on the old grocery store property located adjacent to the Greenville City Hall. The site of focus is located on roughly a city block bounded by Washington Street, Oak Street, Pickett Street, and King Street in Greenville, Texas. KSA has provided this report upon request of the City of Greenville, Texas for informational purposes only. This study is based solely on site observations, photographic documentation, and digital information available online. Potential adaptive reuse functions for the building include Fire Administration Offices, Emergency Operations Center/Training Room, Council Chambers, Finance Department, City Manager, City Secretary, and Human Resources.

November 8, 2018

City Annex Johnson SA - : also call Suann Hardin  
Steve Methin / Brandon Jamison

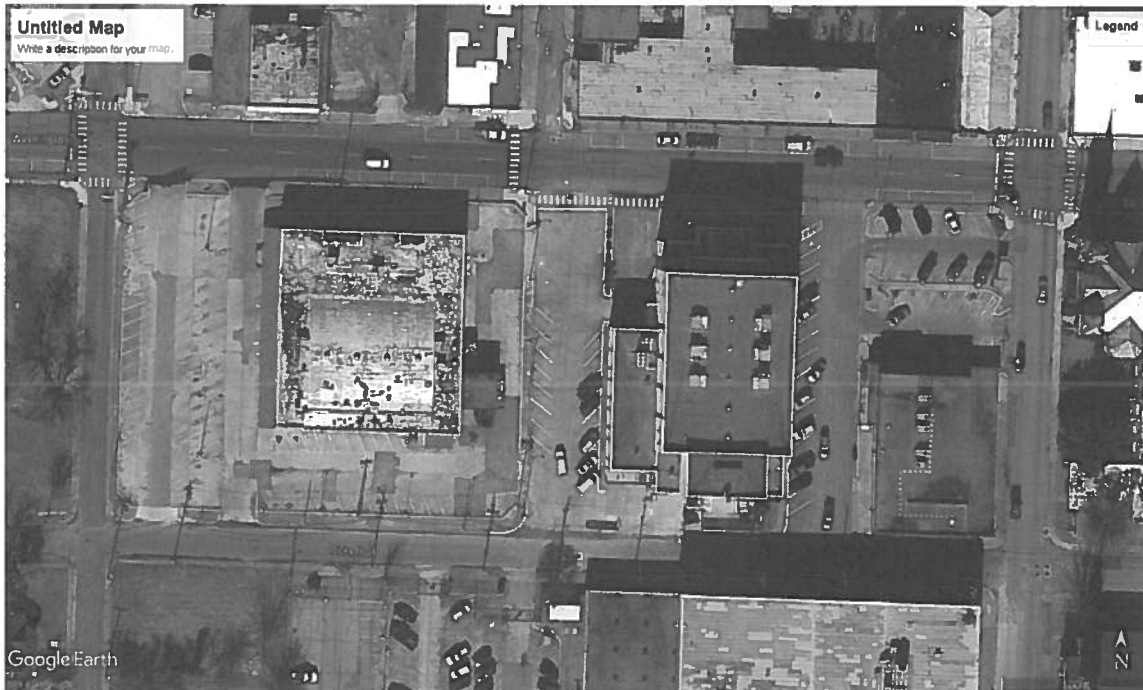
The 213.53' x 273.38 city block is bounded by public streets on three sides with an implied alley that is actually the drive of the parking lot for the Municipal Building directly to the east. The site has existing utilities running to the building for water, sewer, electricity and gas. This existing infrastructure, utilities, and vehicular access to the site is adequate to serve the requirements of the existing use, as well as, potential municipal uses.

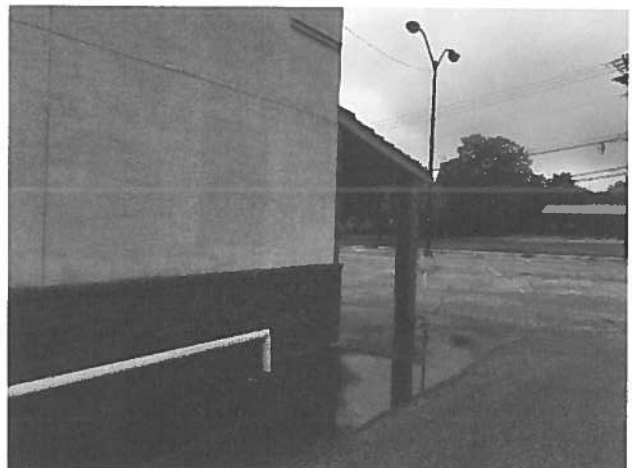
Ponding along north elevation due to lack of positive drainage away from building

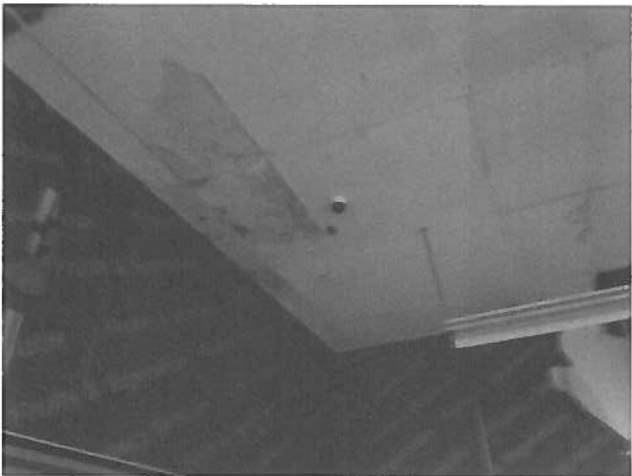
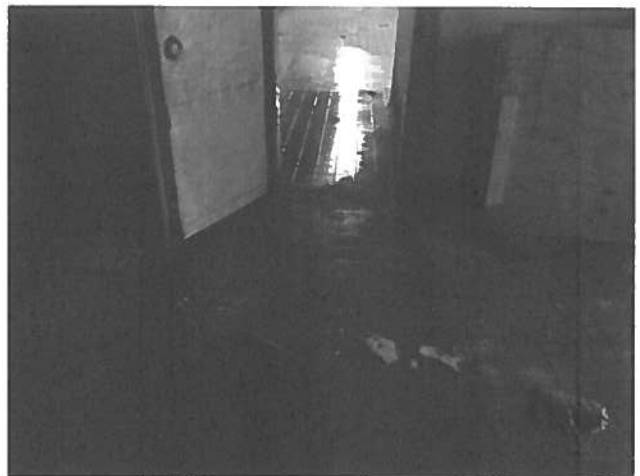
It is obvious from the review of the building interior that the roof has major issues. There are multiple roof leaks and the roof itself is suggested to be removed completely including the structural framing and decking. This will be discussed in detail in the following section.

Numerous signs of leaks through roof membrane, deck and down to slab

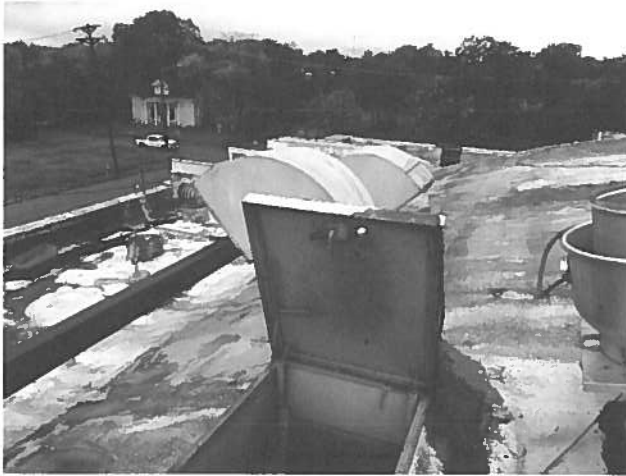
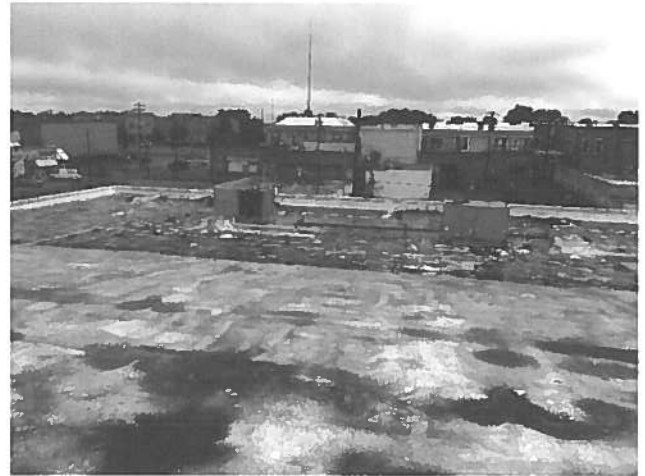
Access to the existing roof is via a roof hatch and ladder system from the mezzanine area. The existing roof is in extremely poor condition. It is not possible to visually determine what the original roof system is/was. Whatever the original roof system was, it was installed over a wood deck on wood framing. It is apparent from the mezzanine level that no insulation is provided on the underside of the roof deck.

It is unclear what the actual, current roof system is. However, the current condition has an added layer of closed cell spray foam with an elastomeric coating. Upon visual inspection of the current roofing conditions, major defects can be found in the elastomeric coating system throughout the entirety of the roofing system. The defects are significant and numerous leaks are evident on the inside of the building. Multiple patches have been applied by various systems and none of resulted in a sealed, watertight roof condition.

**Roof Replacement Complete (Framing, Deck, Supports, Membrane and Parapet Cap)**
