MEMORANDUM

DATE: January 24, 2022

SUBJECT: Inspection of Generally Hauling Sanitary Landfill (aka Interstate Disposal Systems Inc. Sanitary Landfill), Permit #107104

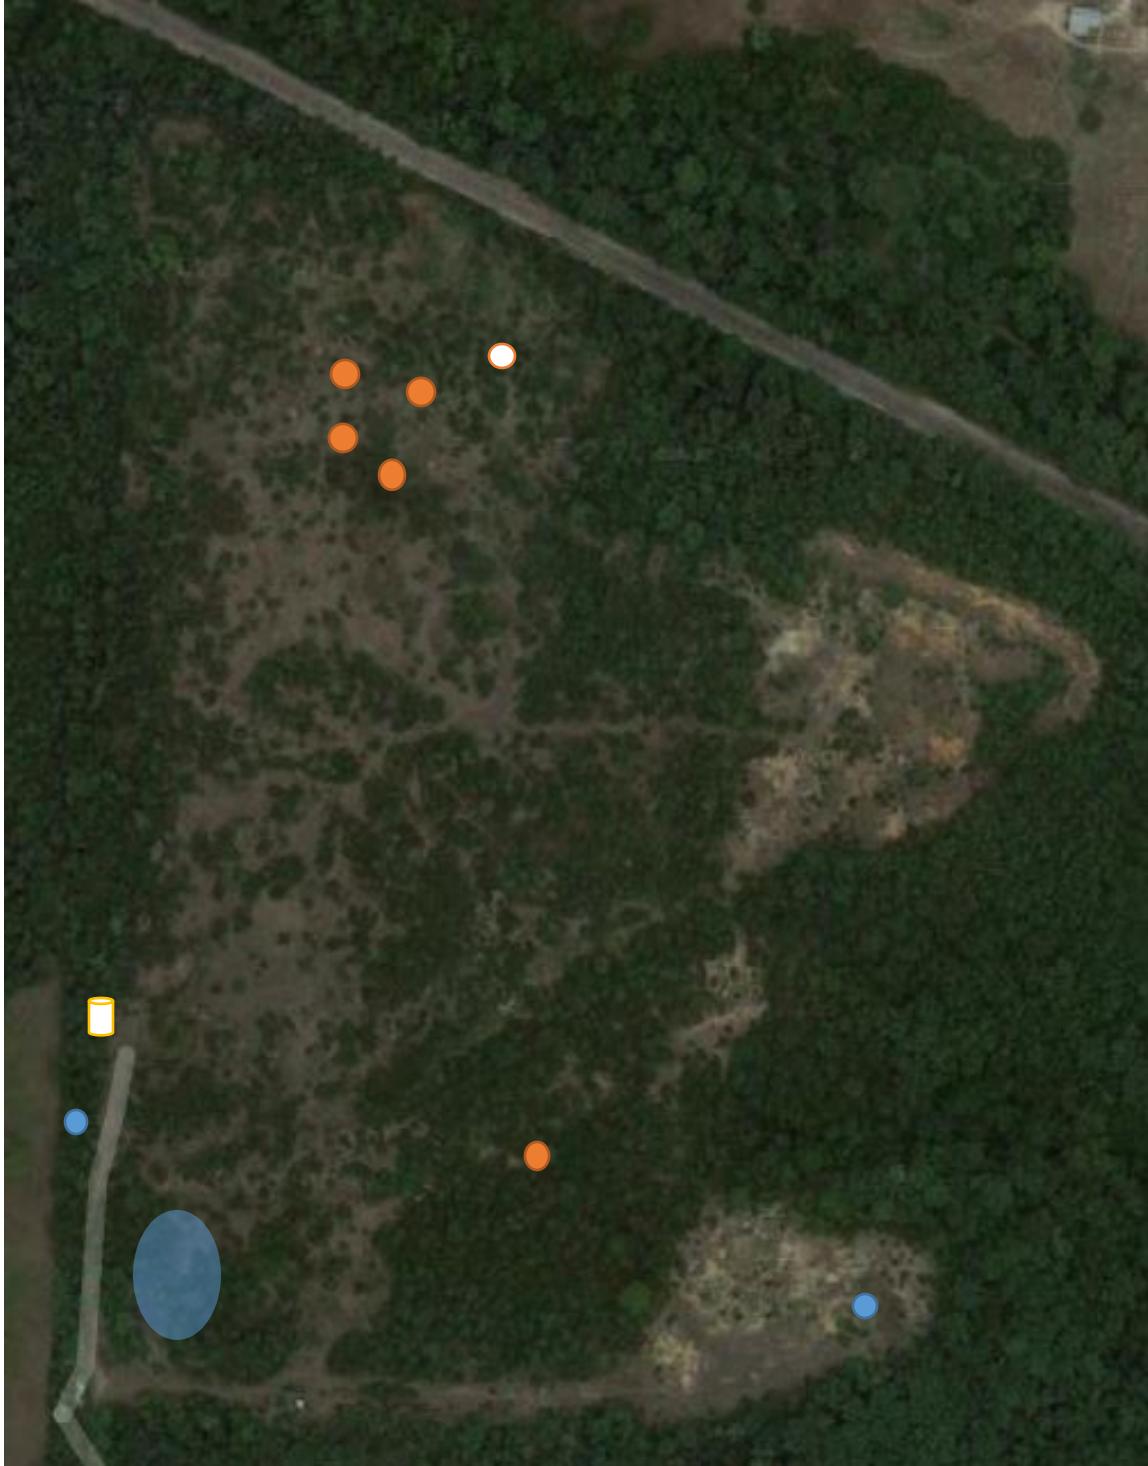
Attachment #3  
Generally Hauling Sanitary Landfill

- - Leachate outbreak
- - Leachate collection sump
- - Leachate storage tank
- - Piezometer
- - Depressed/excavated area with ponded water
- - Leachate flow
