Alliant Gas GAS LINE FORM

Town: Payson

Address: 106-108 N Pinecrest Dr

GAS LEAK INSPECTION & REPAIR REPORT

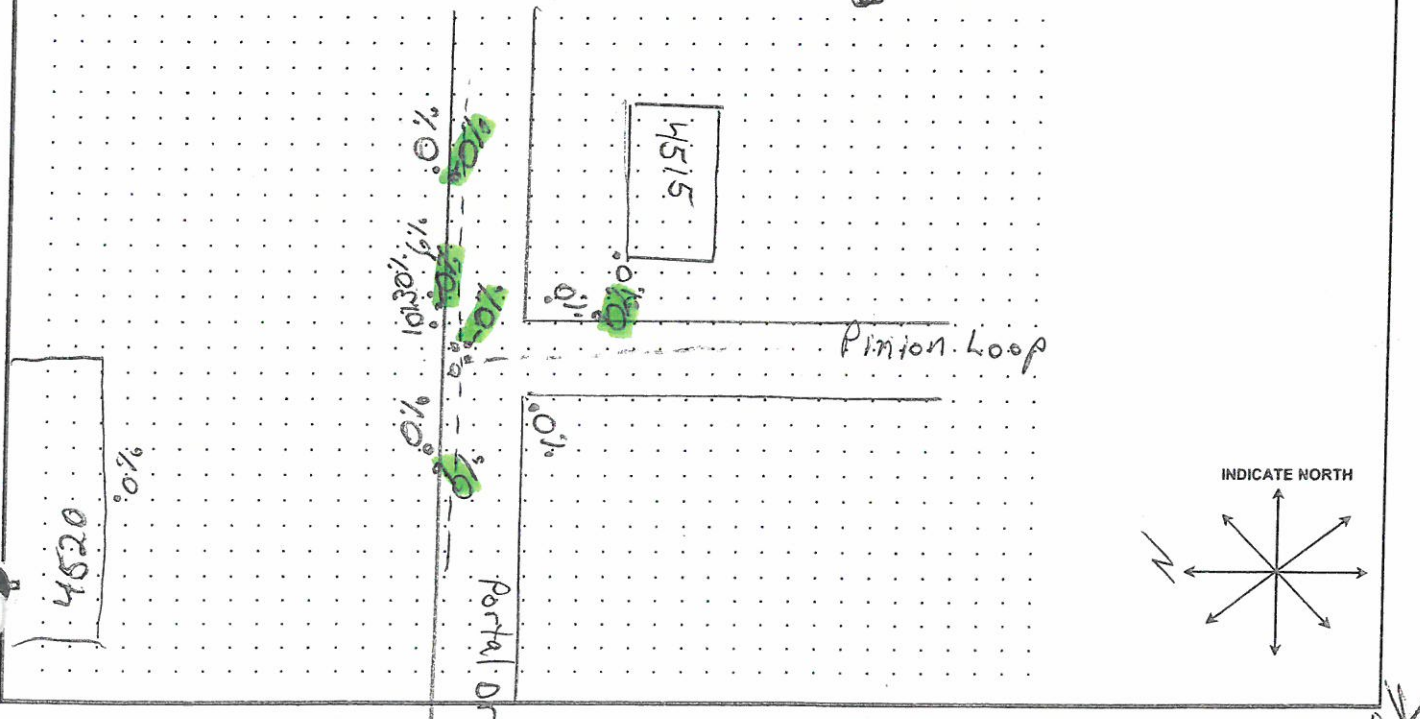
(REFER TO INSTRUCTIONS FOR COMPLETING)
 DISTRIBUTION SYSTEM LOCATION SKETCH (include all measurements from fixed reference points)

REMARKS: I zeroed out leak repair on 9-21-15 I used CGI #6485 on 9-21-15 all boots checked were O.K. on Leg 5094 Chris 9-21-15
 SIGNATURE (OF ONE WHO REPAIRED): Chris Bahr DATE: 9-3-15
 SUPERVISOR'S SIGNATURE: Dave Sutton DATE: 10-14-15

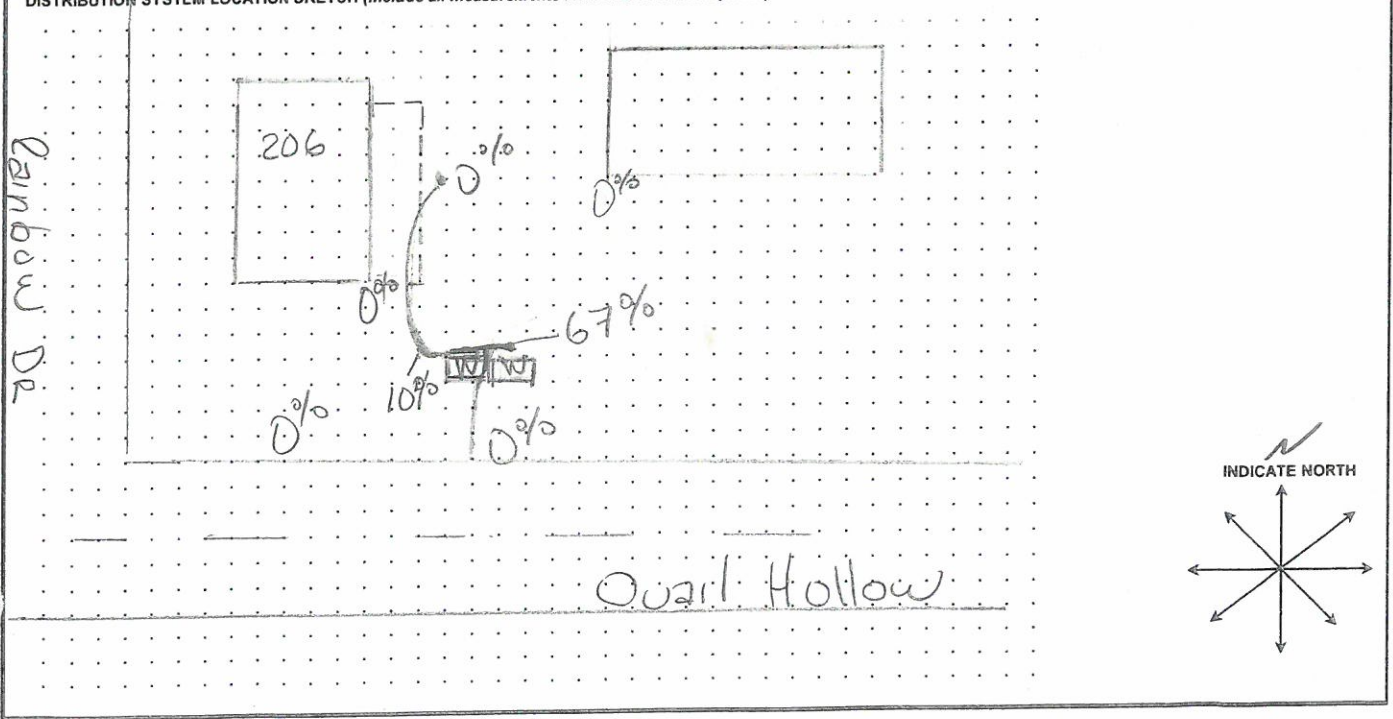
(REFER TO INSTRUCTIONS FOR COMPLETING)
DISTRIBUTION SYSTEM LOCATION SKETCH (include all measurements from fixed reference points)

Pipeline Type (Check one): Distribution Main Describe specific location: (See instructions) by water box
Service Line leak was next to 3/4" fusion tee behind water boxes (see map)

INSTRUMENT USED: FI Unit CGI Description of Leak / Investigation Performed: Manny got some reads with FI so I brought CGI out we allowed out leak spread pinpointed and graded leak.
Highest Reading: 67 % Gas
(Indicate on sketch below) _____ % LEL
_____ PPM
_____ Negative
SIGNATURE OF LEAK INVESTIGATOR: Chris Becher
(first person on site of leak)

SOIL CONDITIONS: Gravel Sand Granite Clay Gumbo Other _____
SOIL MOISTURE: Dry Damp Wet
CAUSE OF LEAK: Corrosion Natural Force Excavation Outside Force Materials/Welds Equipment Operations Other small crack next to 3/4" fusion Tee
Internal Condition of Steel: Good Fair Poor Wet Dry
External Condition of Pipe: Good Fair Poor Wet Dry
Tracer Wire Condition: Good Fair Poor Wet Dry
Pipe-to-Soil Potential: _____ Anodes Installed (#): _____

Method of Repair: Replaced entire service
Date Repaired: 8-19-15 Service Order #: _____
Date of Follow-up Inspection (if needed): _____
If DOT Reportable, Date and Time of telephone report: _____
To Whom was leak reported: _____

REMARKS: We dug up and clamped line below Tee on 8-18-15 MPL came out on 8-19-15 and replaced Tee and service to 206 S Rainbow Dr
SIGNATURE (OF ONE WHO REPAIRED): Chris Becher DATE: 8-19-15 SUPERVISOR'S SIGNATURE: Don Becher DATE: 8-19-15

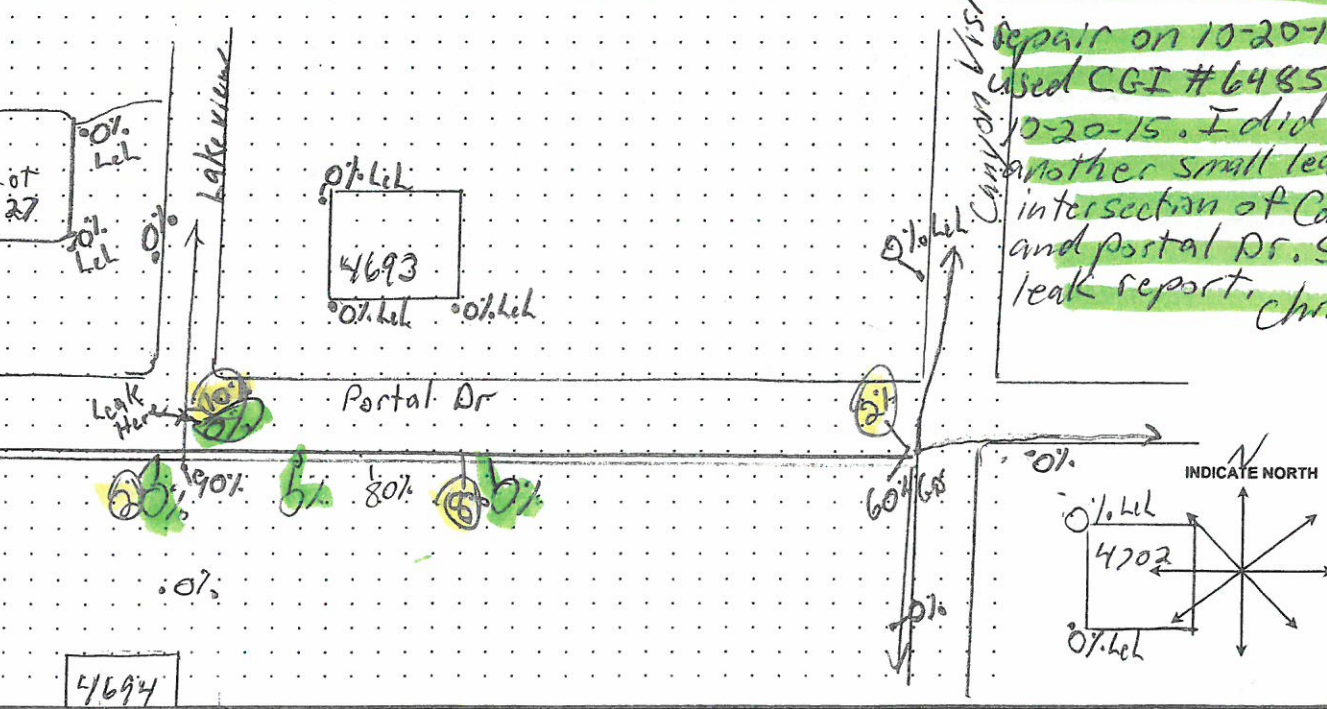
(REFER TO INSTRUCTIONS FOR COMPLETING)
DISTRIBUTION SYSTEM LOCATION SKETCH (include all measurements from fixed reference points)

REMARKS: I rechecked leak repair area on 9-21-15 with CGI #6485 cal 9-21-15 all readings have gone down I still get 10% high read where leak was repaired. Chris 9-21-15
Chris Beuhr Dan Hector 12-1-15
SIGNATURE (OF ONE WHO REPAIRED) DATE SUPERVISOR'S SIGNATURE DATE

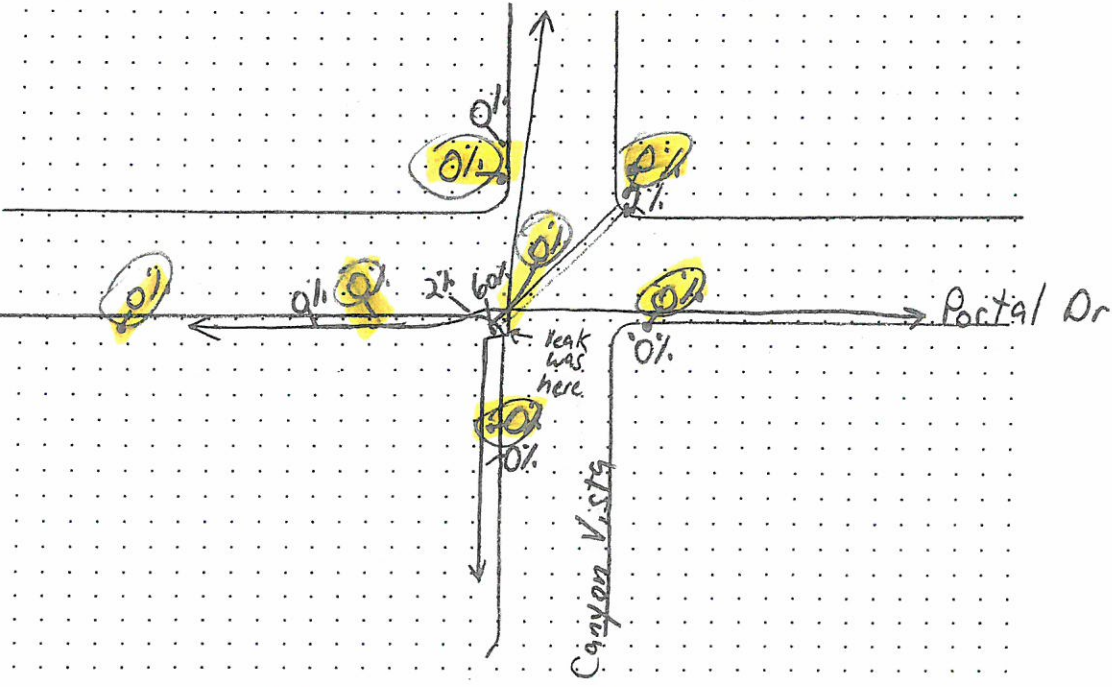
(REFER TO INSTRUCTIONS FOR COMPLETING)
DISTRIBUTION SYSTEM LOCATION SKETCH (include all measurements from fixed reference points)

REMARKS: I zeroed out leak repair on 10-30-15 I used CG-I #6485 cal 10-30-15 all holes checked were 0% LEL. Checked by Chris 10-30-15
Chris Beeler 10-21-15 DATE Humbert 11-25-15 SUPERVISOR'S SIGNATURE DATE

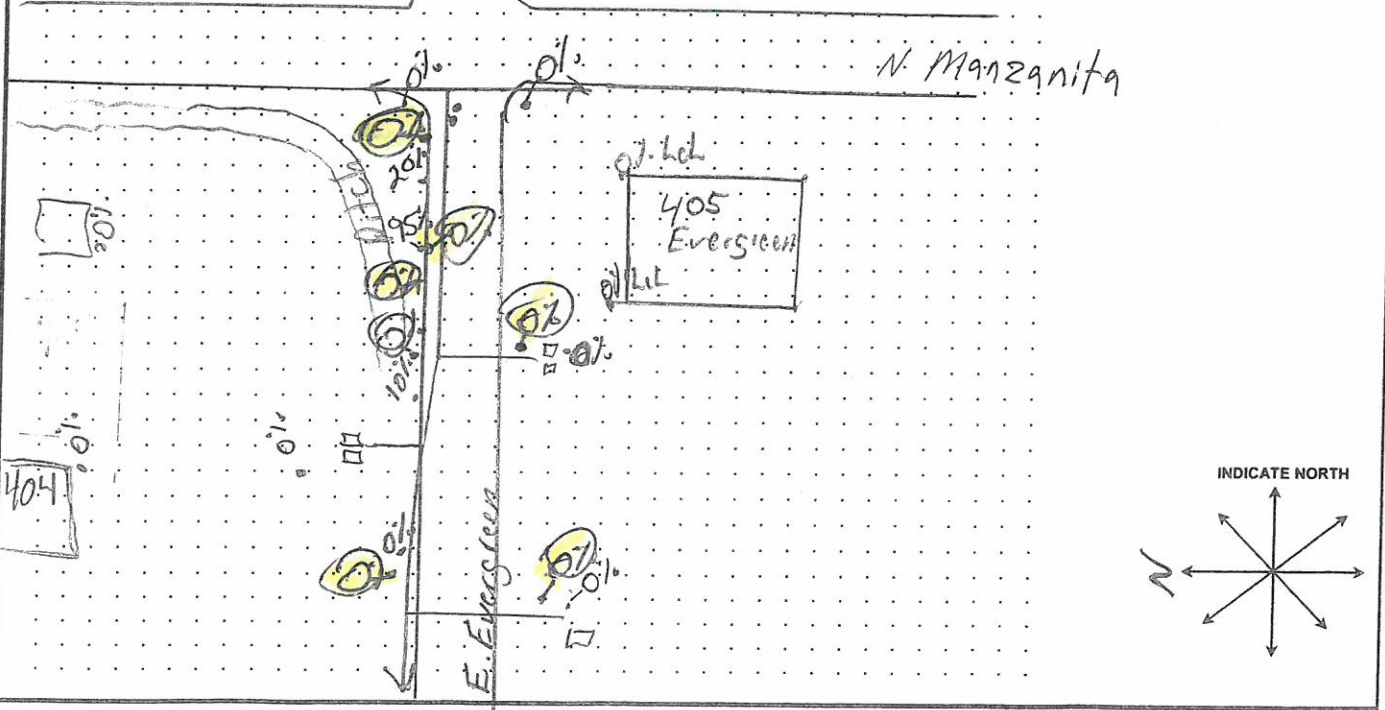
(REFER TO INSTRUCTIONS FOR COMPLETING)
DISTRIBUTION SYSTEM LOCATION SKETCH (include all measurements from fixed reference points)

REMARKS: I zeroed out leak repair on 10-7-15 I used CGI #6485 cal 10-7-15
All holes checked were 0% checked by Chris 10-7-15
Chris Bush 9-23-15 Completion 12-7-15
SIGNATURE (OF ONE WHO REPAIRED) DATE SUPERVISOR'S SIGNATURE DATE
