Department of  
Environmental  
Conservation

# LAKE GEORGE BEACH

## Pollution Source Investigation Update

June 2018

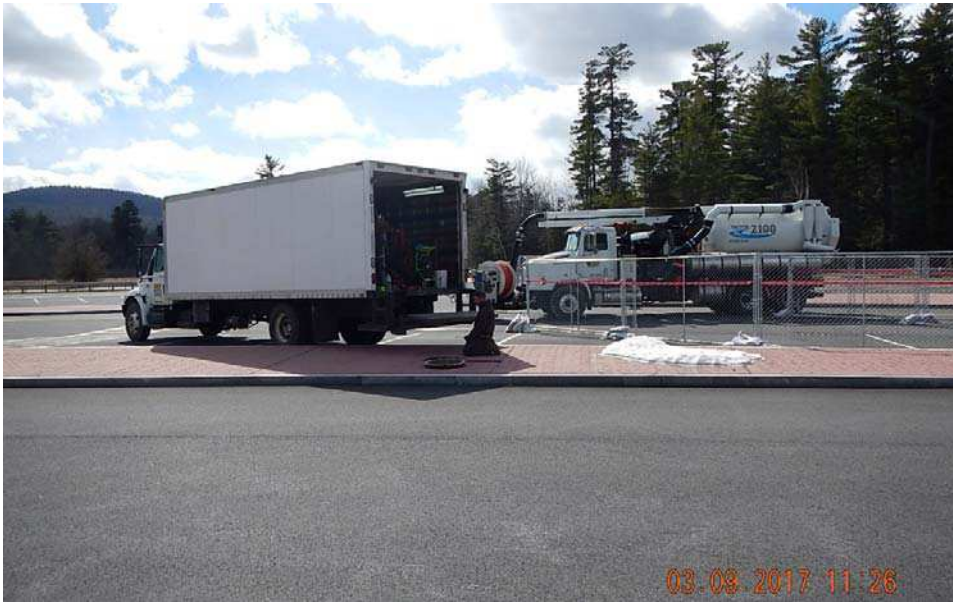
Video camera inspection truck

DEC staff and staff from the Village of Lake George, Town of Lake George, Lake George Association, Lake Champlain/Lake George Regional Planning Board, Warren County Soil and Water Conservation District, Lake George Waterkeeper, and Lake George Park Commission dye tested, smoke tested, and camera inspected the sanitary sewer infrastructure in the vicinity of the beach to verify the integrity of the system and identify any leaks or sections of pipe that needed replacement. The Town of Lake George performed additional testing and inspection of the Caldwell Sewer District sanitary collection system after the close of the swimming season, identifying infrastructure in need of repair or replacement.

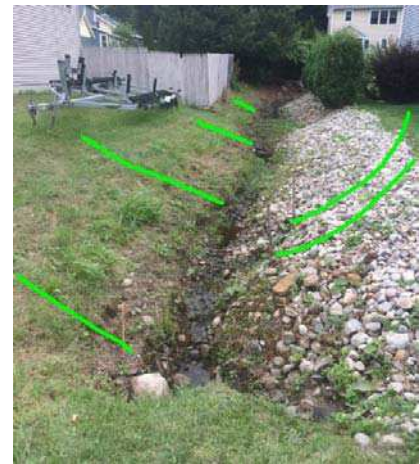
In August, local forces from the Town and Village of Lake George removed vegetation from the open swale between Cedar Lane and Beatty Road in order to locate any pipes or potential discharges into the swale. Several pipes were identified once the vegetation was removed. Outfall locations were marked and photographed. The pipes are believed to be footing drains or basement sumps from nearby residences. Ground Penetrating Radar (GPR) was brought in to locate the origin of the pipes. Two pipes appear to originate from residences adjacent to the channel. The GPR identified a total of six pipes that appear to discharge into the channel. Many residences in this neighborhood are occupied only seasonally or infrequently throughout the summer. Due to infrequent occupancy, obtaining permission from landowners to conduct follow up dye testing or inspections was difficult. DEC and its partners plan to follow up with dye testing of private residences in the vicinity of the swale in 2018.

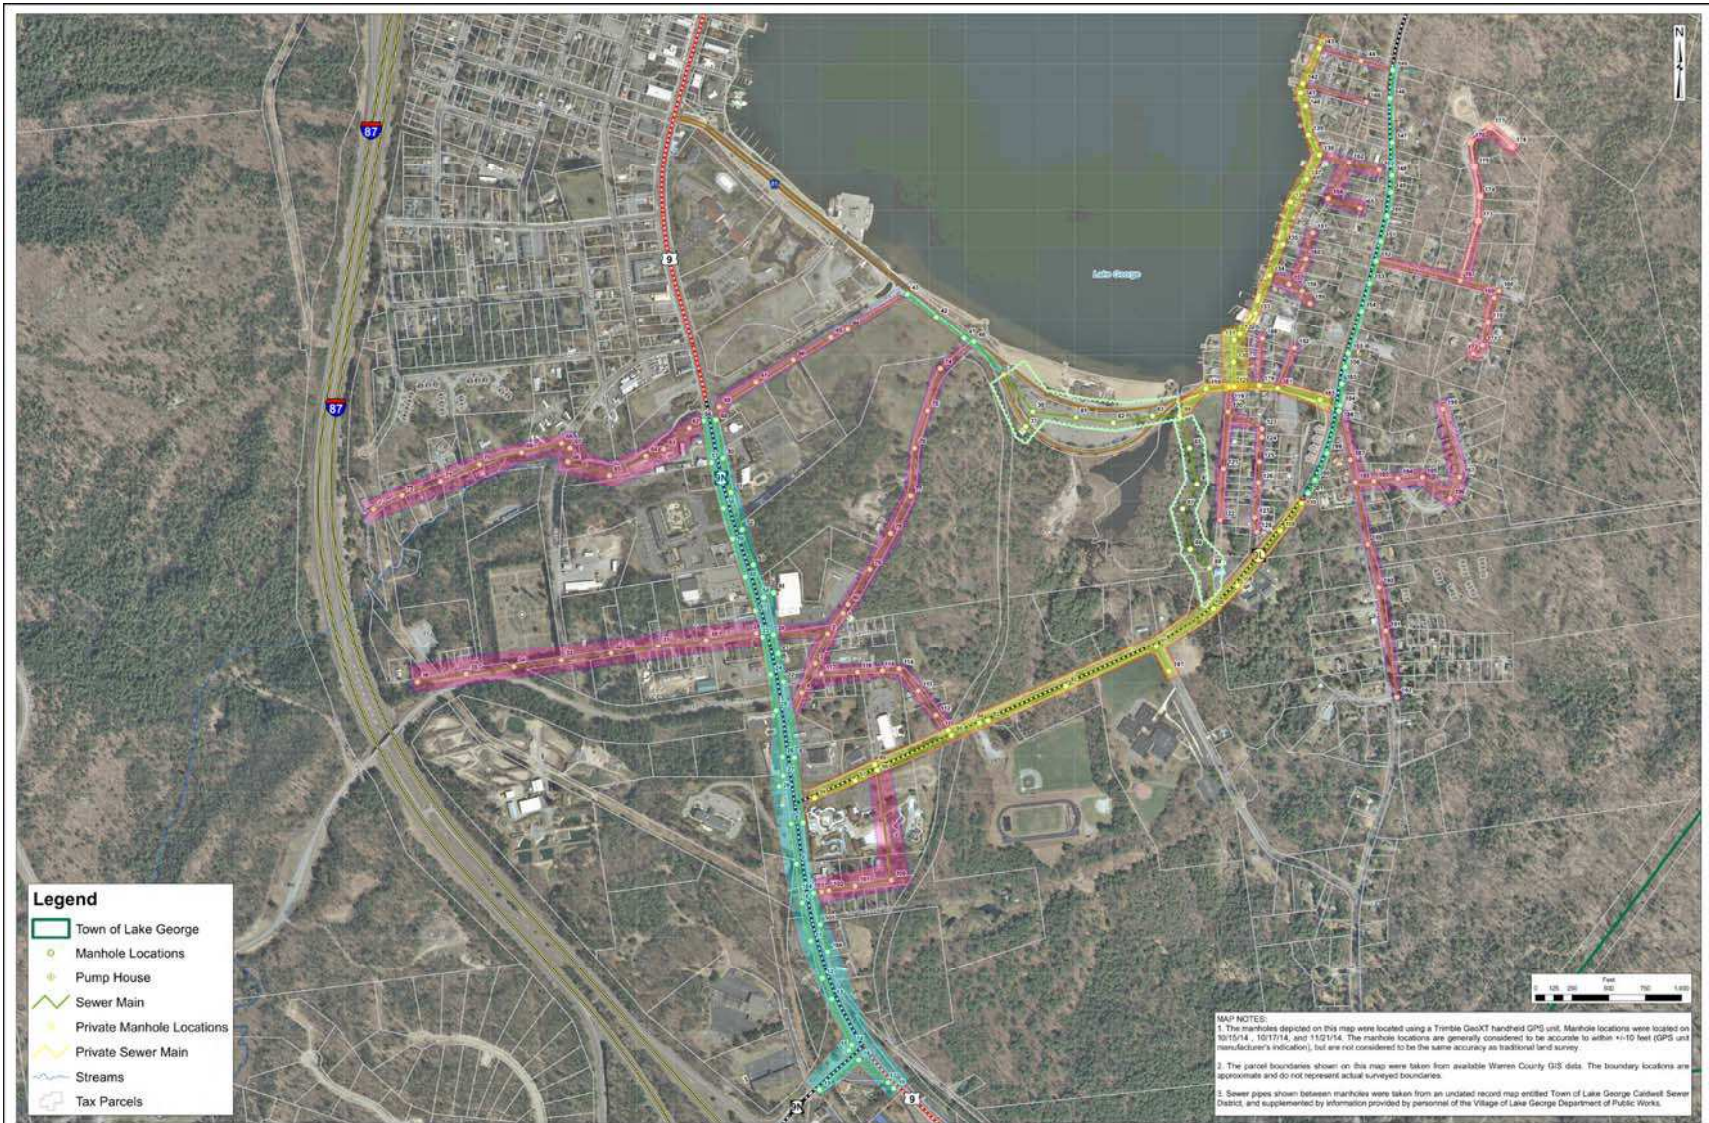
**Caldwell Sewer District CCTV Completed in 2017 & Preliminary Finding Regarding Recommended Repair**

<b>CCTV BY CONTRACTOR</b> Spring 2017	Sewer main from manholes 102 to 105 Sewer main from manholes 102 to 99 on Beach Road Sewer main from manholes 110 to 90 and 88 to 80 on Route 92																								
	<b>CCTV BY CONTRACTOR</b> Fall 2017	All sewer mains on Route 92 Sewer main from manholes 103 to 104 and 104 to 101 on Route 92 Sewer main from manholes 42 to 40 on Beach Road																								
	<b>CCTV BY THE VILLAGE</b> July 1, 2017 to March 30, 2018																									
	<b>RECENTLY REPLACED</b> NO CCTV PROPOSED																									
Created by	GMM																									
Date	8/10/2018																									
Scale	1 inch=250 feet																									
Project	91421.00																									
Page	1

The Town of Lake George will repair the defects in the sewage collection system for the Caldwell Sewer District. The estimated cost to repair the severe defects is \$463,000. The town was awarded a \$100,000 engineering planning grant and a \$120,000 Water Quality Improvement Project grant through DEC and the New York State Environmental Facilities Corporation to assist with the repairs.
