# Structural Assessment Report

August 2023

3313 Bay Avenue,  
Ocean City, NJ 08226  
TADCO ID: J-021171  
Block: 3306, Lot: 1

Seaspray Condo Association  
3313 Bay Avenue  
Ocean City, NJ 08226  
c/o I. Dominic Simeone, Esq.  
Harvard Law Building  
1522 Route 38  
Cherry Hill, NJ 08002

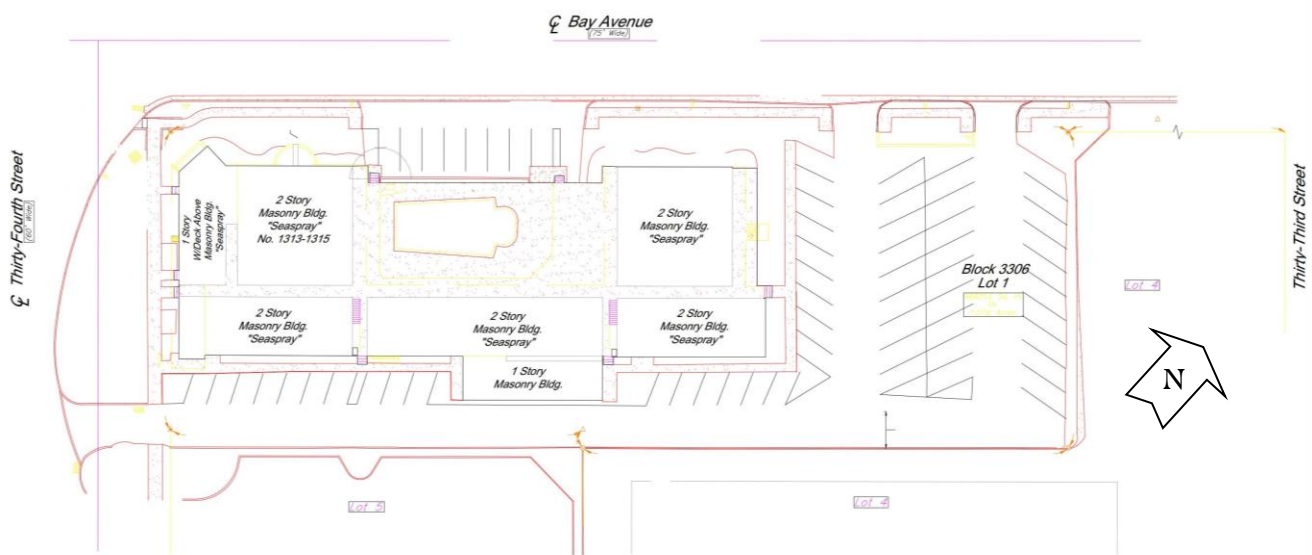
Figure 4 Site map.

The property consists of 2 story segmented buildings aligned to make a C shape facing the Bay Avenue with a pool in front of the property. A single-story structure at the rear of the residential buildings used as the laundry facility. Along the southwest of the building, there is a single-story framed building with timber floor framing. Refer to the site map in the Figure 4 for more details.
