# PHASE II ENVIRONMENTAL SITE ASSESSMENT

## BUILDING MATERIALS INSPECTION

# Phase II Environmental Site Assessment Report for Building Materials Inspection

El Centro Motel  
112 South Kendrick Avenue  
Glendive, Montana

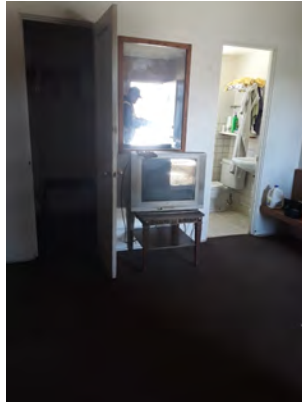
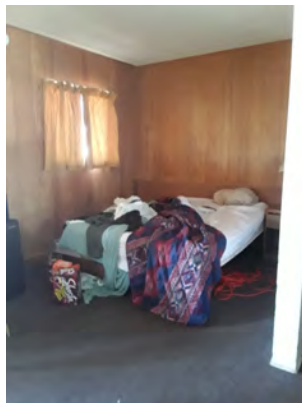
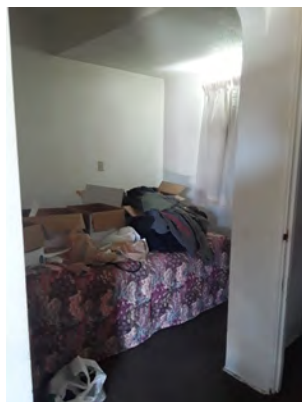
105

Samples collected from rooms 101/102, 103, 104, 105, 106, 107, 108, 121, 123, 124, and the Laundry room contained methamphetamine at a concentration above the MDEQ threshold of 1.5 µg/100cm<sup>2</sup> (see **Table 4**). To address the methamphetamine contamination, we recommend hiring a methamphetamine remediation contractor to remediate these areas. The waste materials should be disposed of at a Class II landfill. A contractor trained to complete methamphetamine clearance sampling, who is separate from the methamphetamine cleanup contractor, should collect methamphetamine clearance samples after all cleaning has been completed.

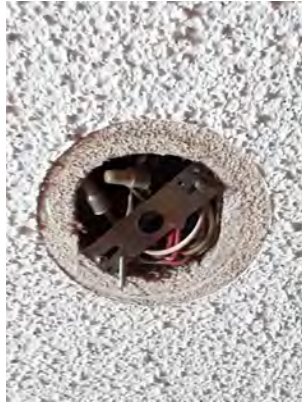
S4.3abc

| Client ID<br>Lab ID | Lab<br>Description | Lab<br>Attributes | NON-ASBESTOS COMPONENTS | | ASBESTOS<br>% |
|---|---|---|---|---|---|
| <b>S4.3a</b><br>B237408.113 | Ceiling Surfacing | Homogeneous<br>Tan<br>Fibrous<br>Loosely Bound | | 70% Binder<br>15% Perlite<br>10% Vermiculite | 5% Chrysotile |

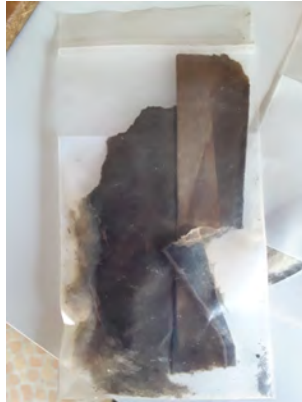
T14.1a

| Client ID<br>Lab ID | Lab<br>Description | Lab<br>Attributes | NON-ASBESTOS COMPONENTS | | | ASBESTOS<br>% |
|---|---|---|---|---|---|---|
| <b>T14.1a</b><br>Layer 1<br>B237408.137 | Insulation | Homogeneous<br>Gray<br>Fibrous<br>Loosely Bound | 50%<br>50% | Fiberglass<br>Mineral Wool | | None Detected |

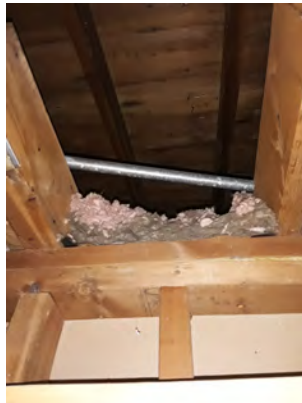
T14.1c

| Client ID<br>Lab ID | Lab<br>Description | Lab<br>Attributes | NON-ASBESTOS COMPONENTS | | | ASBESTOS<br>% |
|---|---|---|---|---|---|---|
| <b>T14.1c</b><br>Layer 1<br>B237408.139 | Insulation | Homogeneous<br>Gray<br>Fibrous<br>Loosely Bound | 50%<br>50% | Fiberglass<br>Mineral Wool | | None Detected |

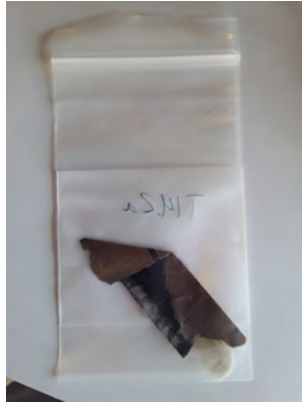
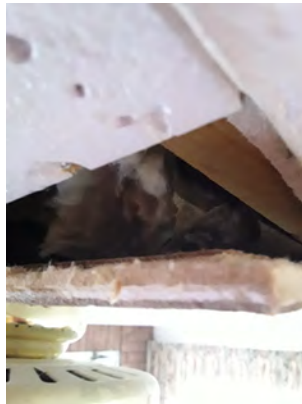
T14.2bc

| Client ID<br>Lab ID | Lab<br>Description | Lab<br>Attributes | NON-ASBESTOS COMPONENTS | | | | ASBESTOS<br>% |
|---|---|---|---|---|---|---|---|
| T14.2b<br>Layer 1<br>B237408.150 | Insulation | Homogeneous<br>Gray<br>Fibrous<br>Loosely Bound | 100% | Fiberglass | | | None Detected |
| T14.2c<br>Layer 1<br>B237408.151 | Insulation | Homogeneous<br>Gray<br>Fibrous<br>Loosely Bound | 100% | Fiberglass | | | None Detected |
