# Winter Island Barracks Building Re-Use Feasibility Study

SALEM, MASSACHUSETTS

### 3.0 CONDITIONS ASSESSMENT AND CHARACTER-DEFINING ELEMENTS

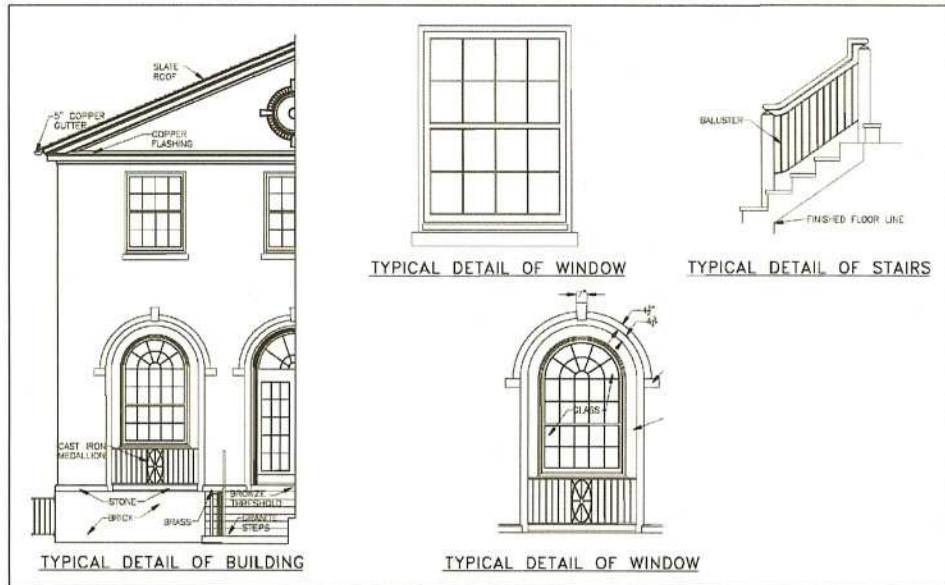
Barracks Building 2007 Roof and Trim

*Roof:* The building's roof design is a shallow hip (circa 7 1/2 in 12) covered with slates. Ornamental brick chimneys are positioned about 30 feet from the north and south ends.

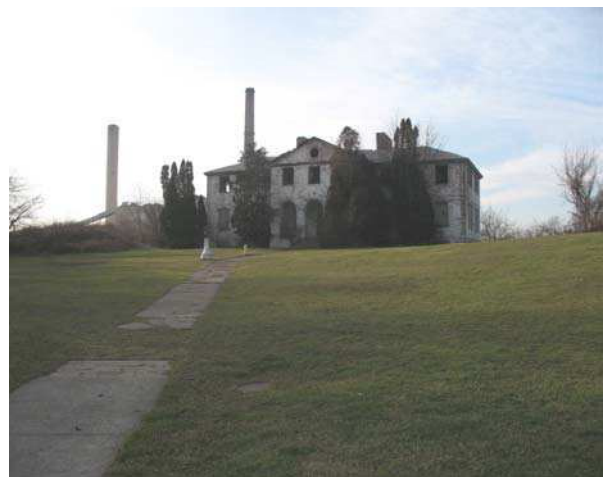
View of East Lawn

The site appears to be relatively free of encumbrances to further development. The sloping terrain lends itself to molding and the vegetation is unremarkable.
