MASSACHUSETTS DEPARTMENT OF ENVIRONMENTAL PROTECTION
FIELD ASSESSMENT AND SUPPORT TEAM (FAST)

**Evaluation of Investigations, Remedial Activities, and
the Potential for Vapor Intrusion at the
Varian Site, Beverly MA**

MassDEP RTN 3-00485

January 2021

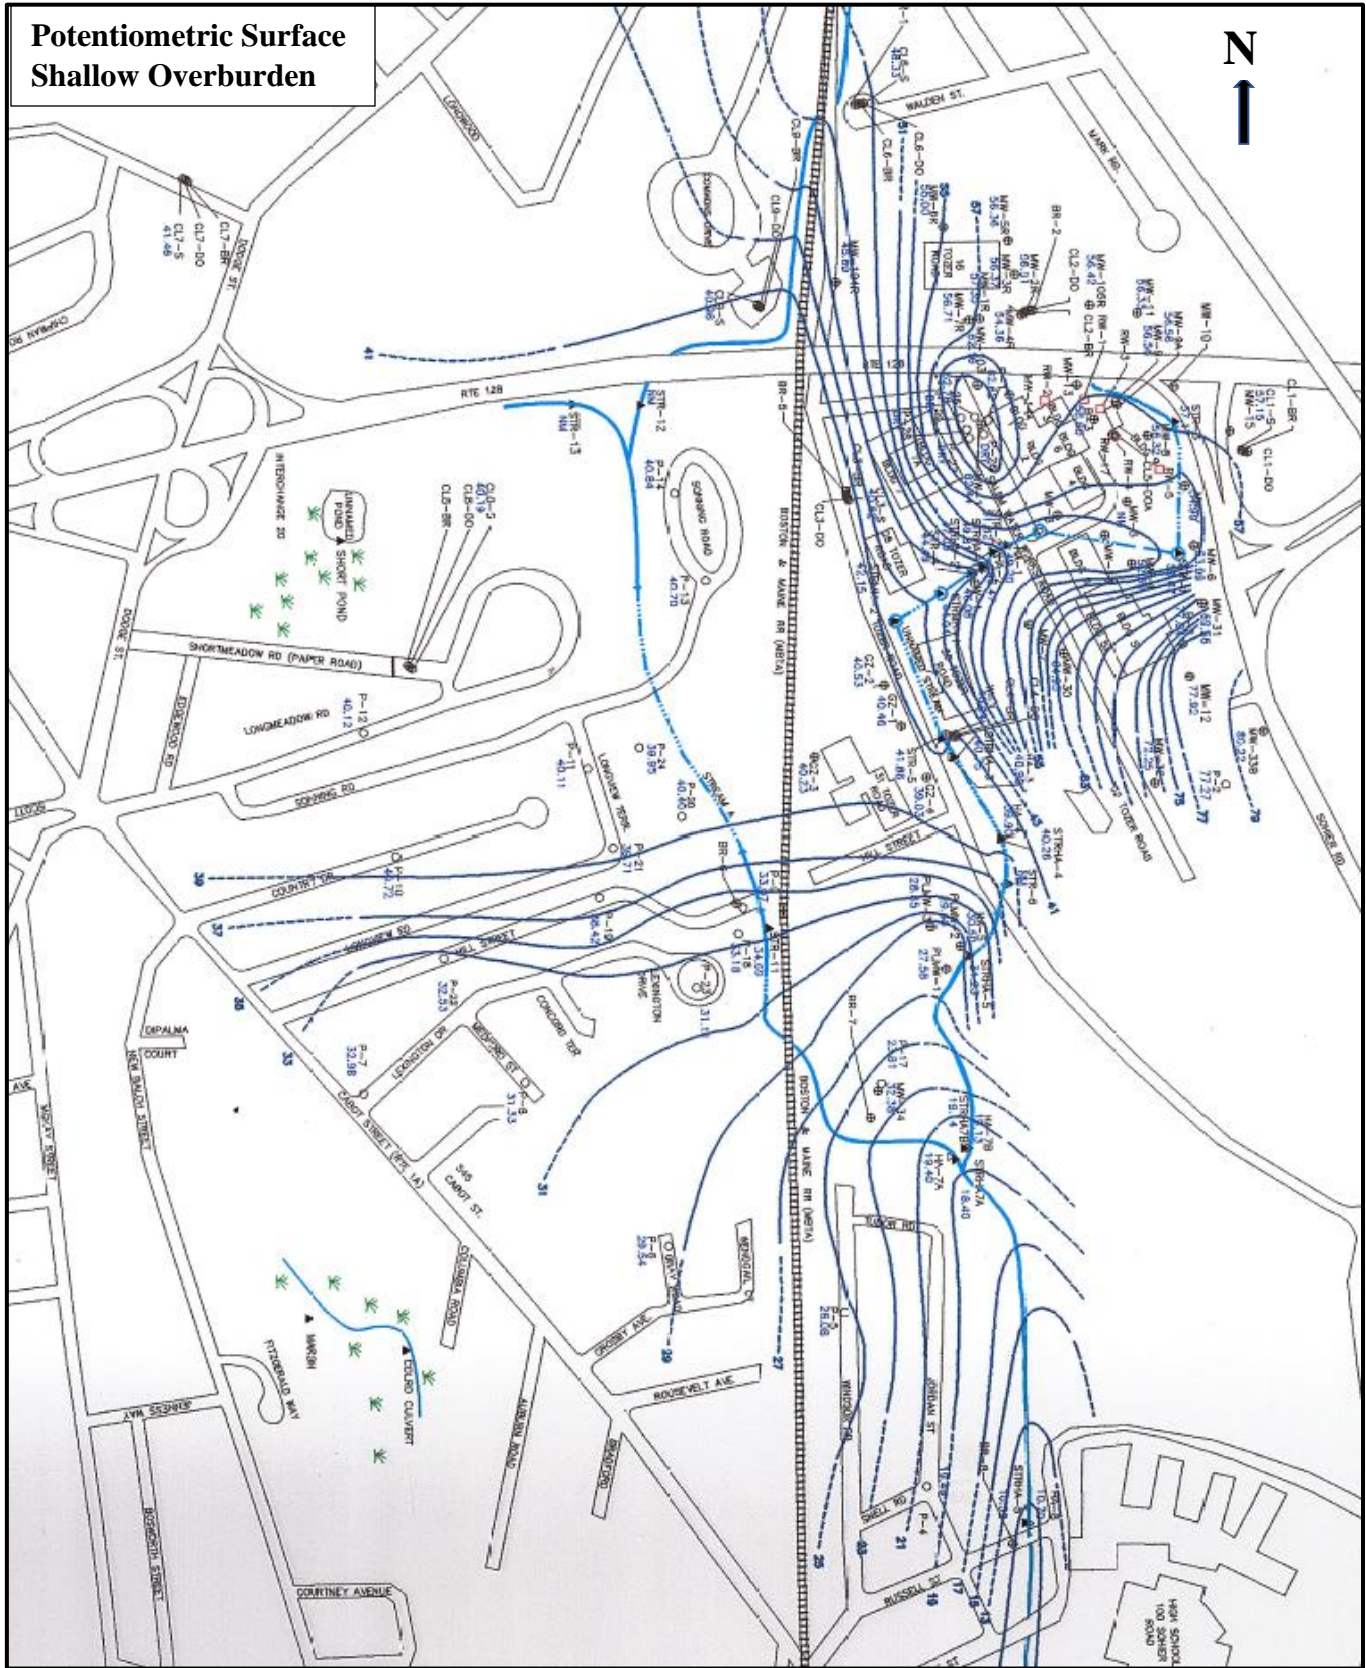
Of most interest is the movement of groundwater in the shallow overburden, as this defines the areas where contaminants at the water table interface could create a vapor intrusion pathway into overlying structures. As presented in Figure 2, groundwater flow in the shallow overburden is predominantly in a westerly direction from the former Varian property, slowly looping to the south in the Sonning/Longview Road neighborhood area, where the potentiometric surface is relatively flat. South of Lexington Drive, flow direction turns towards the southeast, then east, presumably induced by the localized discharge of overburden groundwater into Stream A.

Figure 2. October 1998 site-wide potentiometric surface map of the shallow overburden aquifer shows predominantly westerly/southwesterly flow from the former Varian facility towards Tozer Road, looping south and then easterly towards Stream A (IT 2000).

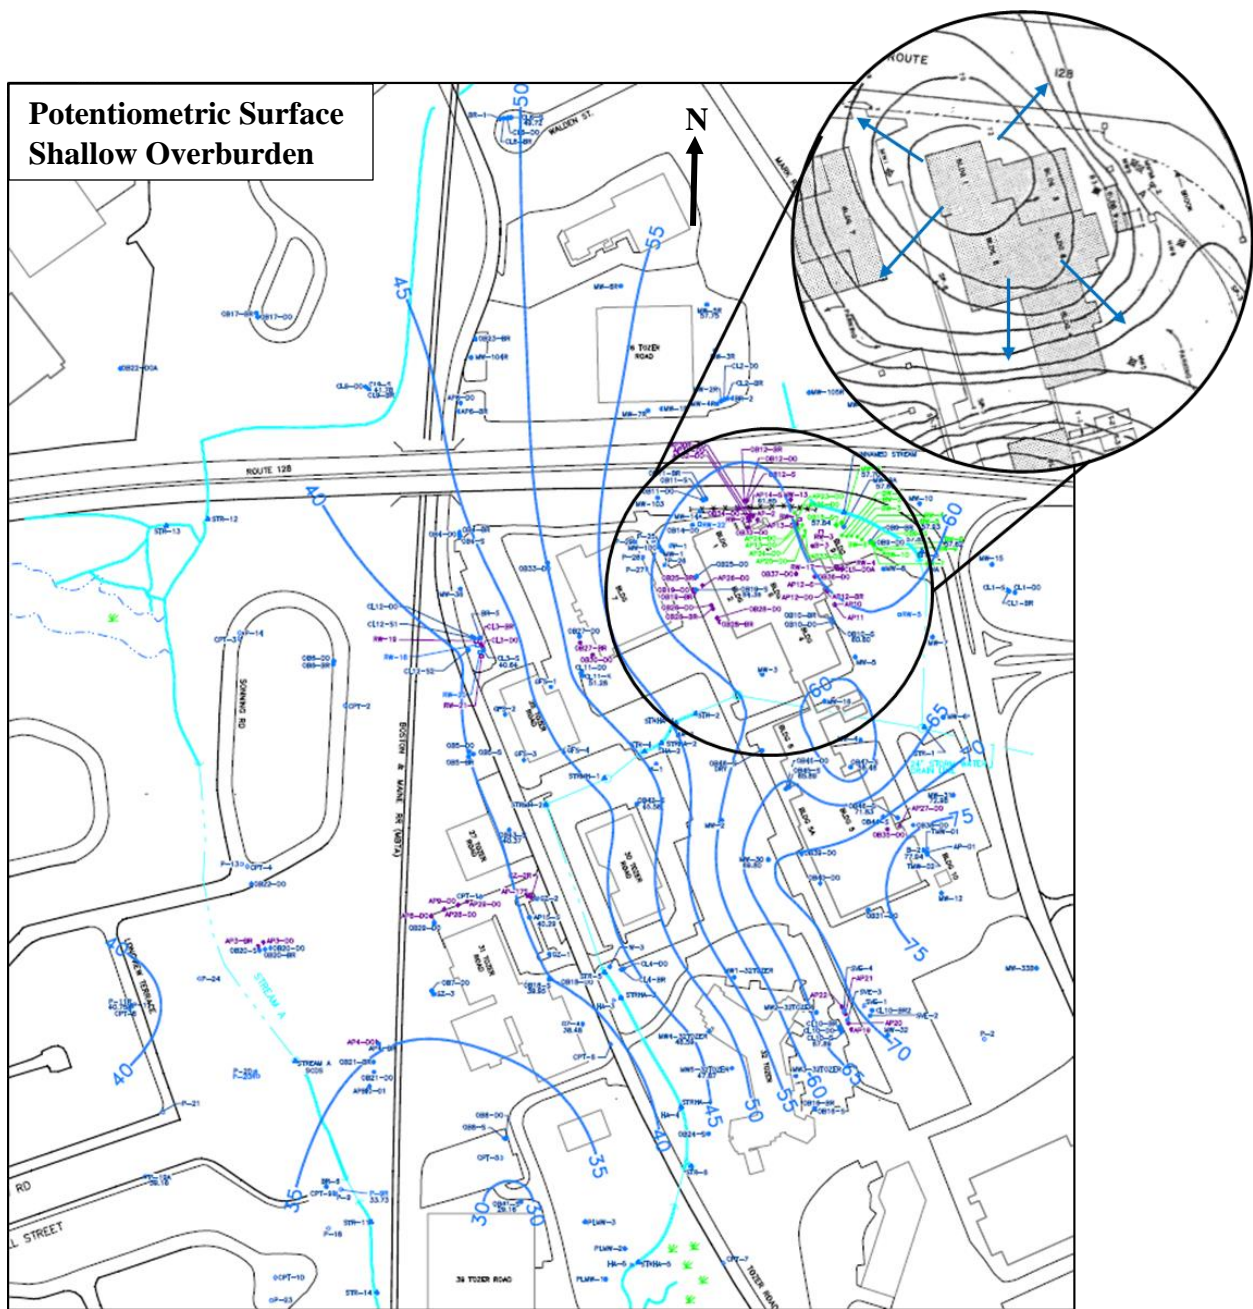
- In the northeast corner of the former Varian property, there is localized radial overburden flow (Figure 3). This is particularly evident in the Building 3 area, where shallow groundwater flows east and south towards the Unnamed Stream, north towards Rt. 128, and west towards Tozer Rd. Groundwater that flows east and south towards the Unnamed Stream then turns west, following the stream channel.
- Shallow groundwater discharges to the streams, and thus it is expected that contaminants present in shallow groundwater would also be found in the surface water (IT 2000).
- North of the former Varian facility, the bedrock aquifer has a clear northwesterly flow (Figure 5). In contrast, the overburden aquifer has a westerly flow in this area.

Figure 3. Potentiometric surface map of the shallow overburden aquifer shows predominantly westerly flow from the former Varian facility towards Tozer Road (CBI 2016b). A more detailed look shows radial flow in the overburden aquifer beneath the Building 3 area, with an easterly and southerly component toward the Unnamed Stream (CHIEE 1987).

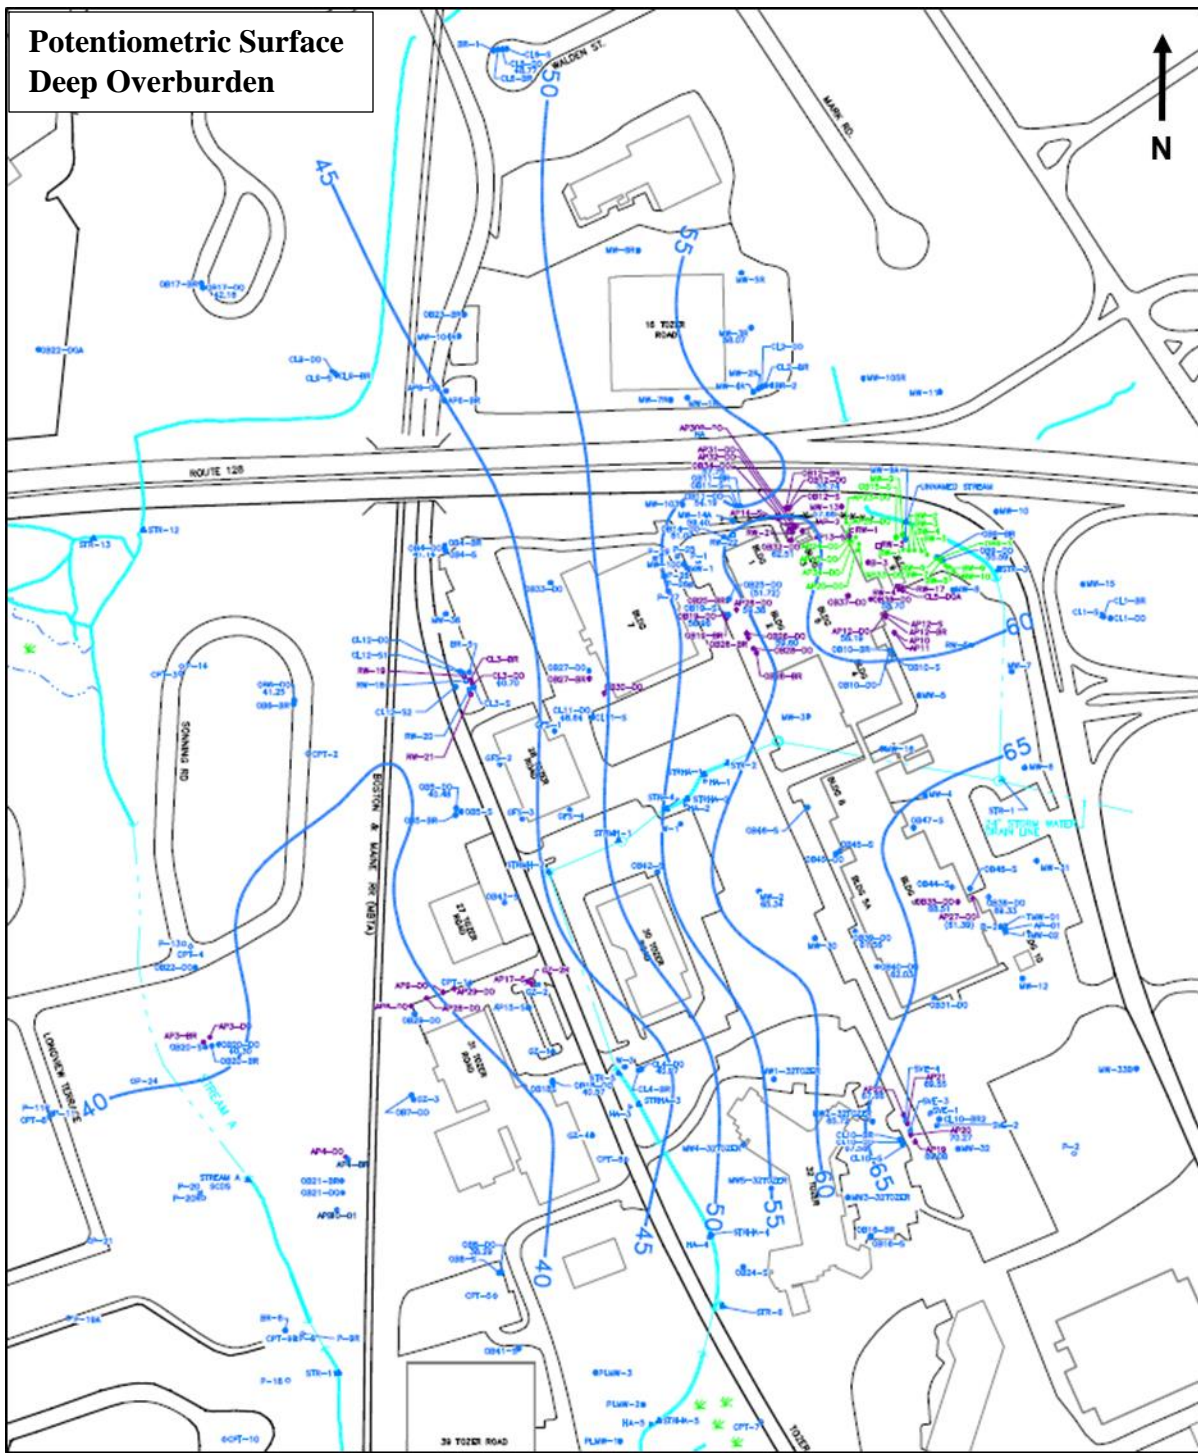
Figure 4. Potentiometric surface map of the deep overburden aquifer shows groundwater migrating west from the former Varian facility (CBI 2016b).

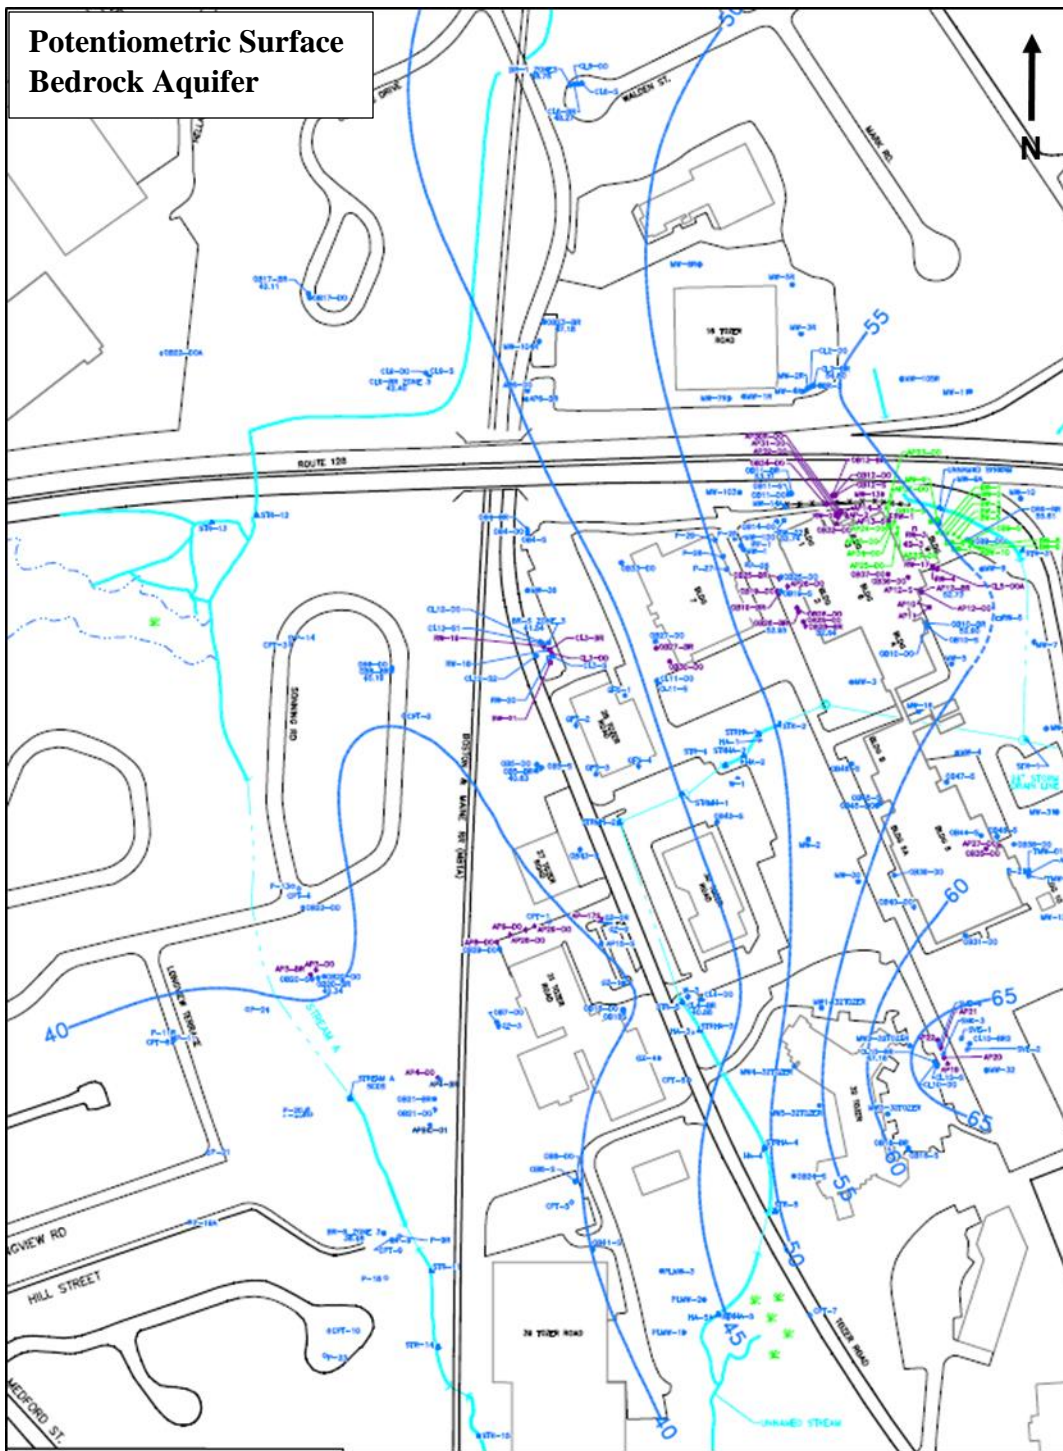
Figure 5. Potentiometric surface map of the bedrock aquifer shows groundwater flowing west from the former Varian facility.

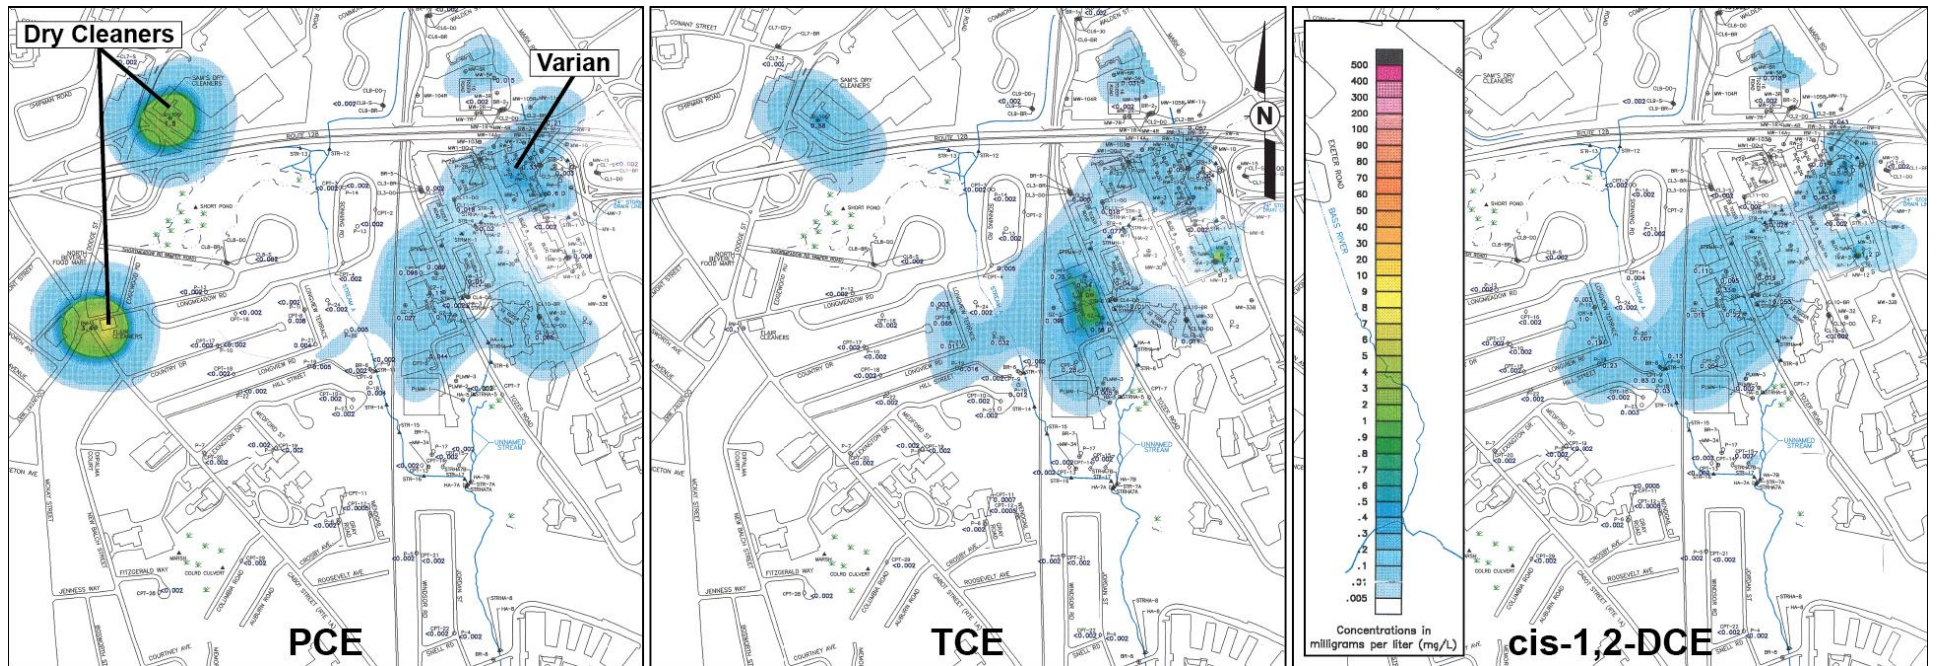
In 1998–1999, the VOC plume originating at the Varian facility stretched west past Longview Terrace, south to 39 Tozer Rd., and north of Rt 128 (Figure 6).¹⁰ Two other areas of elevated PCE are located west of the site and appear to be associated with dry cleaners (though neither of these sites appear to be impacting the neighborhood downgradient of the Varian site, nor comingling with the Varian plume).

¹⁰ The apparently detached TCE plume is the result of incomplete sampling. In 1999, more wells were sampled, which resulted in a continuous plume as seen with PCE and cis-1,2-DCE.

Figure 6. Shallow overburden plumes of PCE, TCE, and cis-1,2-DCE presented in the Phase II report (IT 2000).

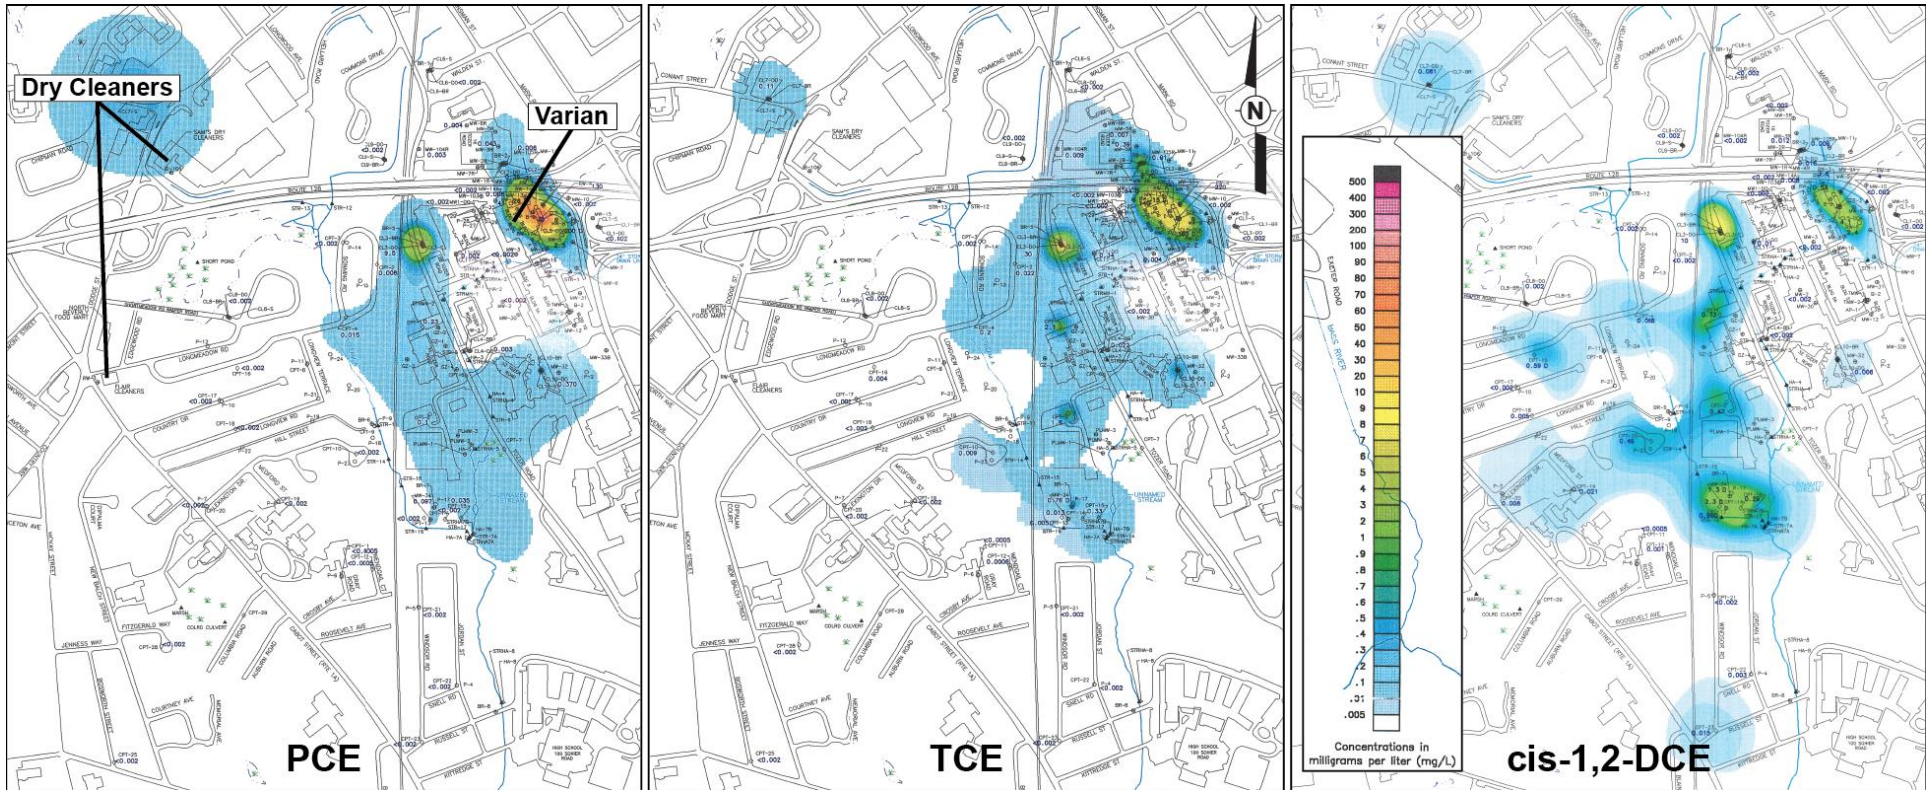
In 1999, the extent of VOC contamination in the deep overburden was more extensive than the shallow overburden, with DCE present as far west as Cabot St. and as far south as Tudor Rd. (Figure 8). Two purported detached DCE plumes are presented: one east of 32 Tozer Rd. and one near the intersection of Cabot St. and Russel St (south). While a possible occurrence, detached plumes are an unusual phenomenon, generally occurring only in highly transmissive aquifer systems following the rapid depletion of source area residual NAPL (API 2007). More typically, reports of such detachments are due to a lack of a sufficient network of data points between the source area/plume and purported discrete downgradient plume. That appears to be the case here, given the limited well network in this area, and absence of other likely source areas.

Figure 8. Deep overburden plumes of PCE, TCE, and cis-1,2-DCE presented in the Phase II report (IT 2000).

The 2020 results also do not adequately represent the deep overburden VOC plume in the residential neighborhood west of the railroad tracks. In 1999, cis-1,2-DCE was detected beneath Lexington Dr. and Medford St, as well as along Sonning Rd and Country Dr. Since 2002, the deep overburden wells in this area have not been sampled (with the exception of CL08-DO on Longmeadow Rd., which contained no detectable VOCs in 2020). Therefore, the current status of VOCs in the deep overburden in this area is mostly unknown, and additional sampling is needed to delineate the western edge of the deep overburden VOC plume.

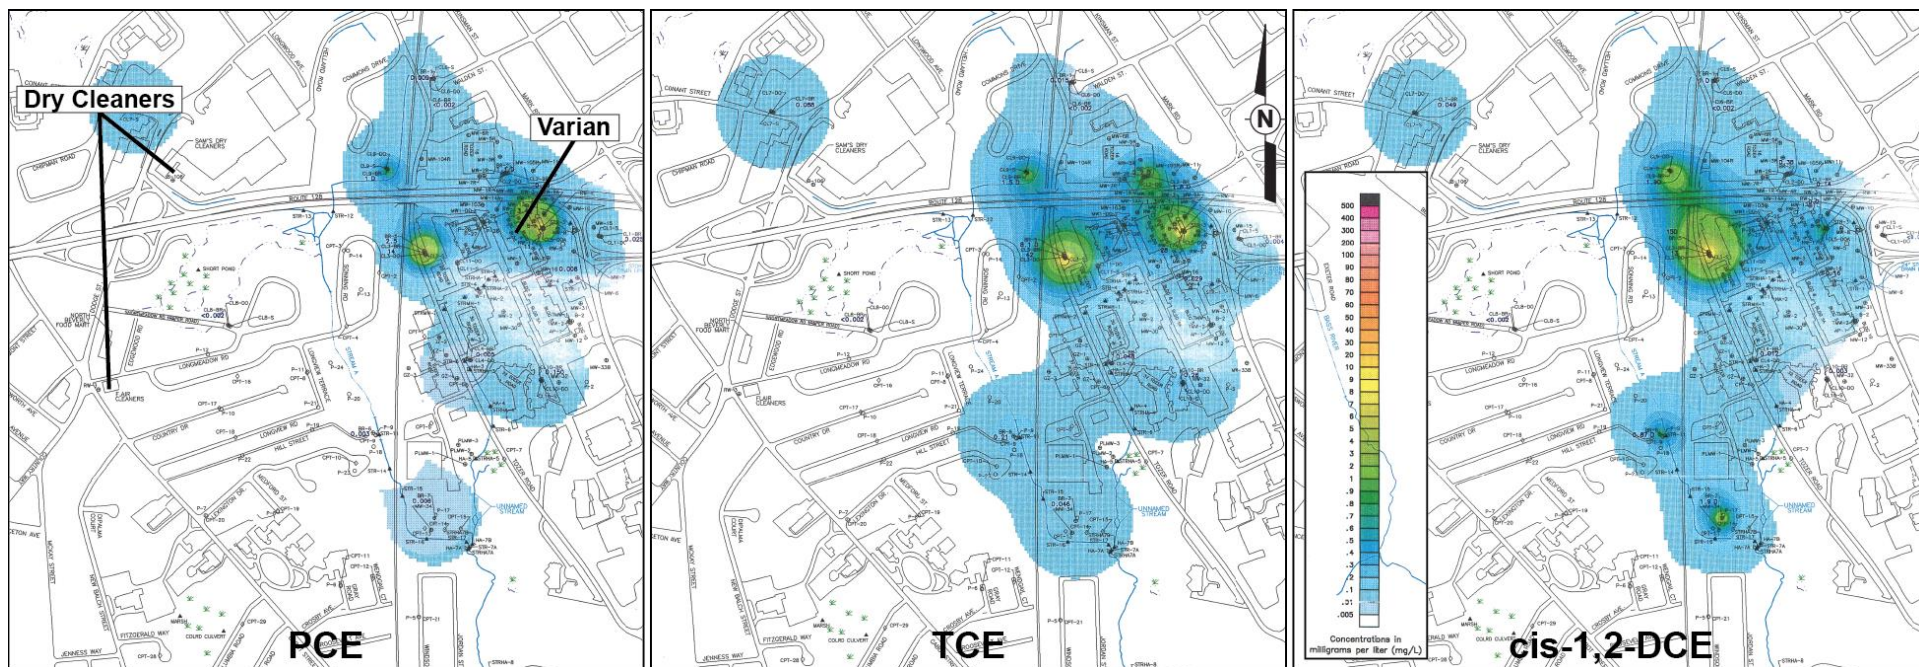
In 1999, the VOC plume in the bedrock aquifer extended south of the confluence of Stream A and the Unnamed Stream, west beneath the residential neighborhood (Hill Street area), and north to Commons Dr. and Walden St. (Figure 10). Fewer bedrock wells resulted in more uncertainty regarding the extent of the plume. For example, no bedrock wells were placed along Lexington Dr., where the deep overburden plume extended to Cabot St., so it's unknown if the bedrock plume had a similar extent. Data gaps such as this existed west, south, and north of the plume.

Figure 10. Bedrock plumes of PCE, TCE, and cis-1,2-DCE presented in the Phase II Report (IT 2000).

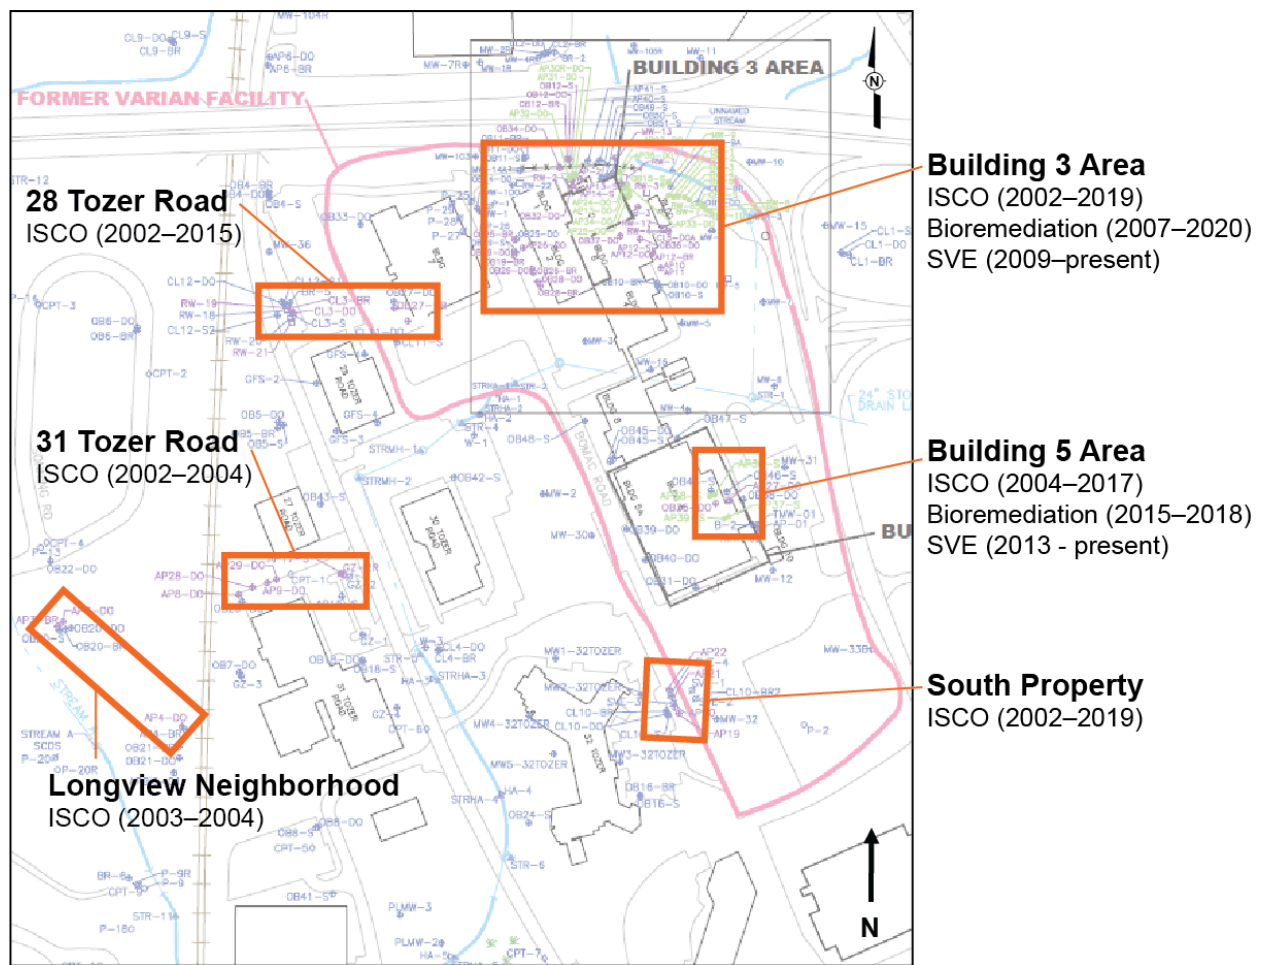
In 2002, Comprehensive Response Actions began at the site. In the subsequent 18 years, there have been 81 wells in 6 separate areas that received Remedial Additives (e.g., sodium permanganate, sodium lactate). Three remedial technologies have been applied across the site: *in situ* chemical oxidation (ISCO), bioremediation, and soil vapor extraction (SVE). The remedial areas are shown on Figure 15.

Figure 15. Remedial areas, technologies, and application dates at the Varian site.

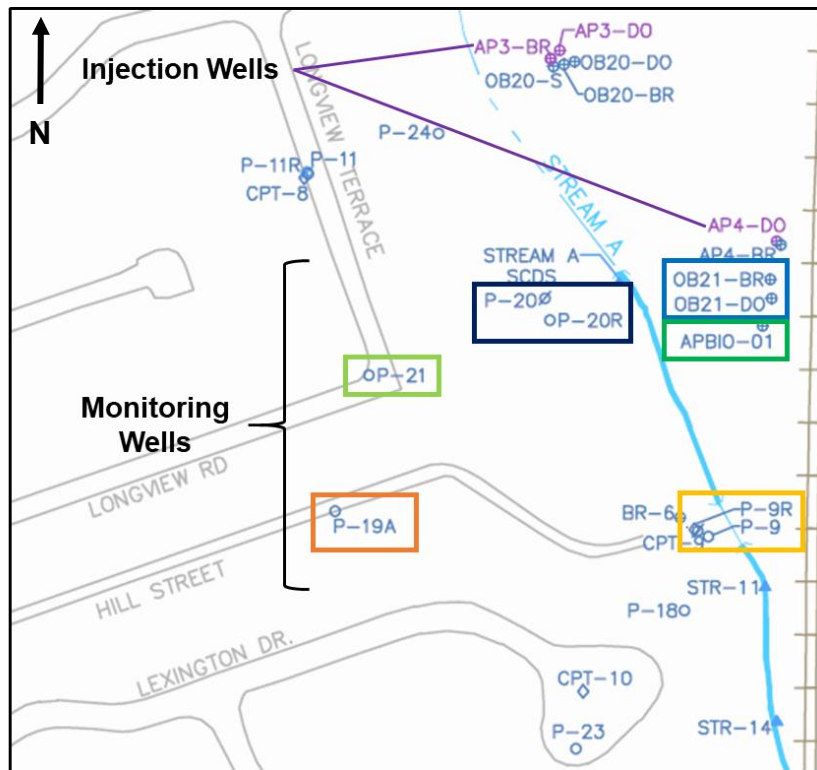
In 2004 and 2005, ISCO was applied to deep overburden and bedrock wells located west of the railroad tracks: AP3-DO, AP-4-DO, and AP-3-BR (Shaw 2009) (Figure 19). Downgradient monitoring wells include shallow wells in the residential neighborhood (P-9, P-11, P-18, P-19A, P-20, P-21, P-24)¹⁵ and observation wells (APBIO-01 (DO), OB-20-DO [too close to injection wells], and OB-21-DO).

Figure 19. Longview neighborhood injection and monitoring wells (basemap from APTIM 2020b).
