Assessment of Public Housing

Alexander County Housing Authority
AMP IL007000001 – McBride Place

November 5, 2015

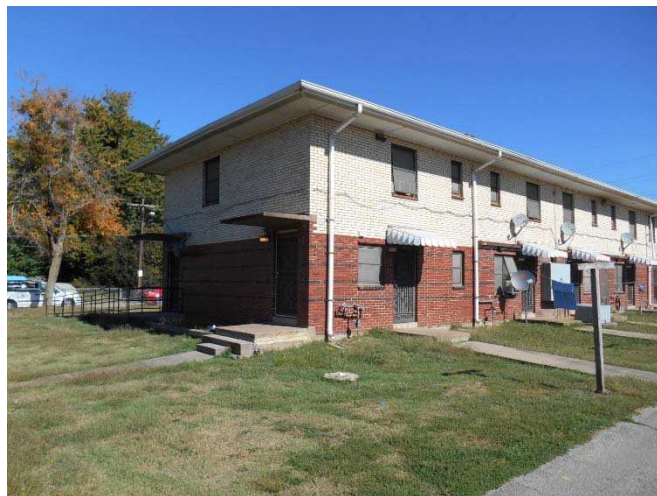
Image 13

The buildings are constructed of slab-on-grade first floor, structural concrete second floor, load-bearing exterior/interior masonry (cmu) walls. The original construction had low-slope roofs on wood framing. The roofs were overframed with steep-slope wood trusses and shingle roofing in the 1998. The original brick veneer is still visible at the Elmwood Place apartments (Image 13), but have been covered with stucco and siding at the McBride Place apartments. (Image 12)

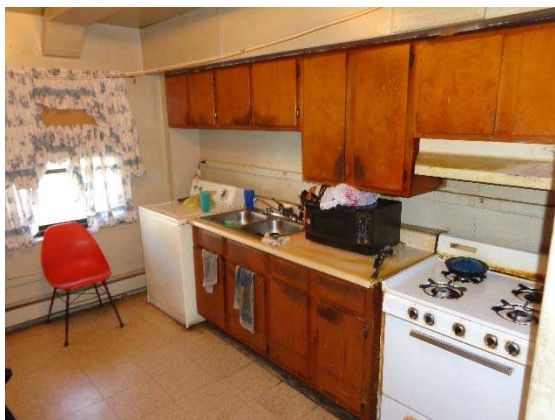
Image 22

The kitchen deterioration varies within the apartments, but all are in need of new cabinets and countertops within the next 5 to 10 years. Many have damaged or missing doors, leaking sinks and old appliances. All apartments have had vented range hoods installed since original construction, but the hoods need replaced. Washer/dryer connections are not present in all apartments, only a small percentage have connection boxes installed. Most tenants connect clothes washers to hose connections found under the kitchen sink. (Image 23) No drain has been provided, so the tenant either drains the washer into the kitchen sink (which is not designed/sized for this use) or drains the waste out the window into the yard (which causes lawn damage and soil/suds build-up). (Image 24) Dryer vents are not present in all units. Many tenants vent the dryer out a window or allow the dryer to vent into the apartment adding uncontrolled humidity into the apartment, which leads to failing paint and mold development. (Image 25)

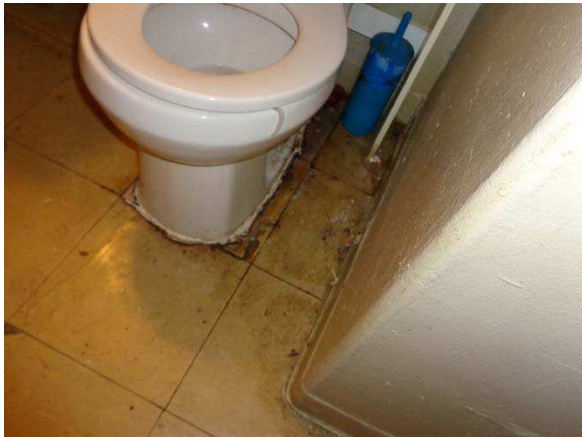
Image 26

Bathroom fixtures have signs of wear in the porcelain finishes. Bathtub drains are aging and leak into the floor below. Toilets are not all low-flow and also have issues with leaking drains and tanks. (Image 26) No ventilation is provided in the bathrooms. A window is located in the exterior wall of the bathtub, but most tenants do not open the window to ventilate humidity. Mold growth on the wall finishes around the bathtubs was found in many apartments. (Image 27) The interior plumbing systems are aged and in need of replacement (see *Building Systems*).

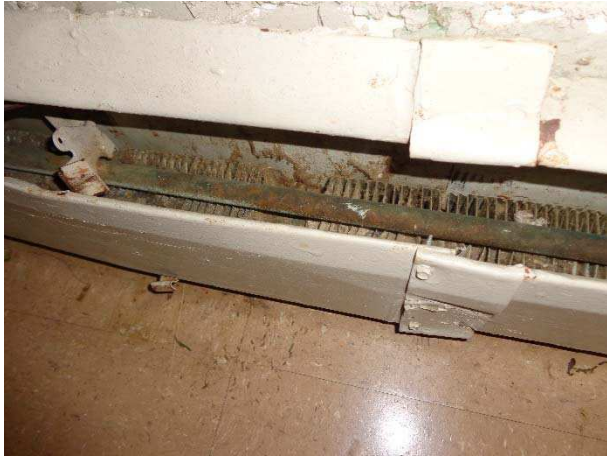
Image 28

The apartments are heated with hot-water heating (boiler) and baseboard finned tube piping. Controls for the system are a single thermostat in the apartment. Zone valves are either not present or not working, thereby not allowing proper control of the heat in the apartment. The bypass and recirculating piping in the baseboard covers are not insulated, allowing a small amount of heat release into the apartment whether required or not. (Image 28) The lack of an air-moving system adds to the growth potential of mold in the apartments. The baseboard covers are damaged and need replaced. (Image 29) Repairs to heat piping have resulted in exposed piping installed as access to the walls is not feasible.
