Evaluation of Historic Property for the City of Tucson

1409 East Broadway

May 22, 2016

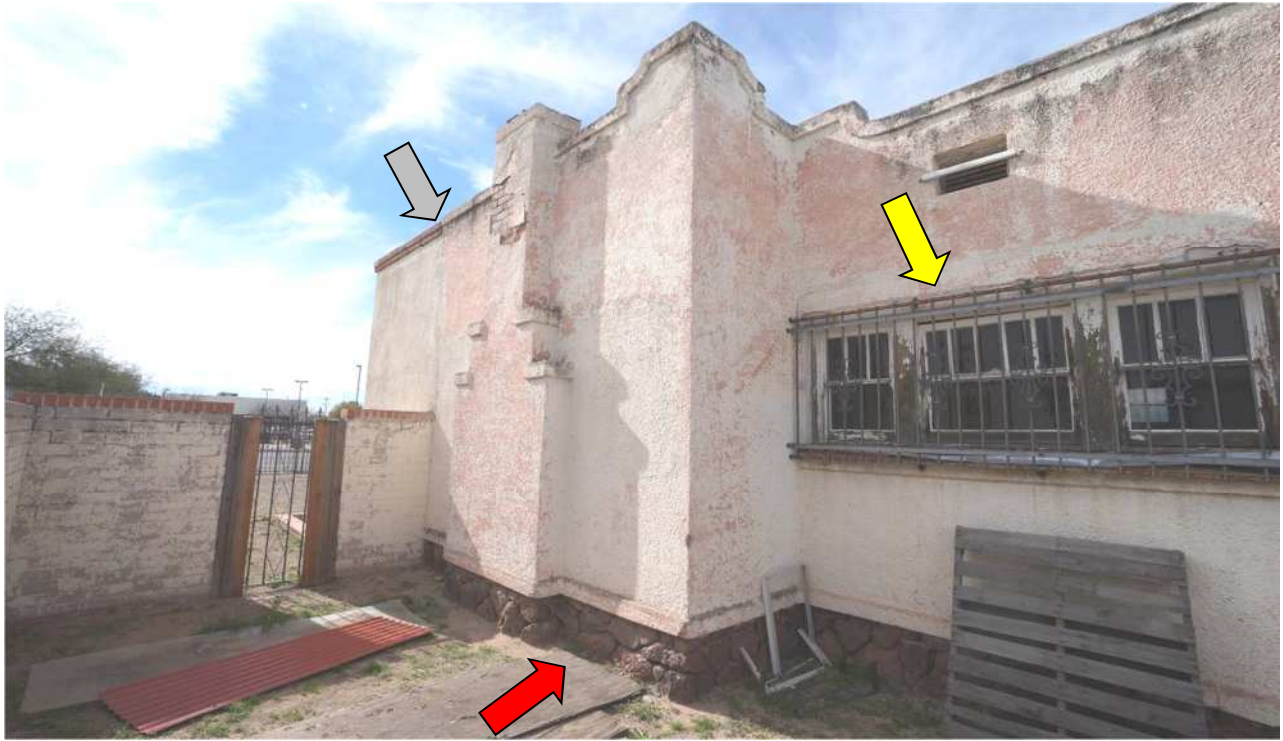
The core of the building and the garage in the north center of the lot were built in 1924 as a Mission Revival structure. In 1967, according to the permit set above, the original façade was torn off and a new contemporary façade with a different brick parapet cap (grey arrow below) was built, extending the façade toward Broadway. The original foundation is apparent because of the A-Mountain basalt stone (red arrow below) that faces the stemwall. The south façade addition does not have this detail. The parapet details are consistent between the older part of the mainhouse and the original garage. The old core building has original wood windows (yellow arrow below). Additions to the south and to the garage were also added later with different windows, construction materials and design. The building is in very poor condition with major structural failures and the almost complete destruction of the original character-defining interior elements. In our view, the building has lost substantial integrity and is no longer eligible as a contributing structure to the Rincon Heights Historic District. Despite numerous errors in the original Historic Inventory Form, we are in agreement with its ultimate conclusion that the building is not eligible as a Contributing Structure to the National Register District Nomination.

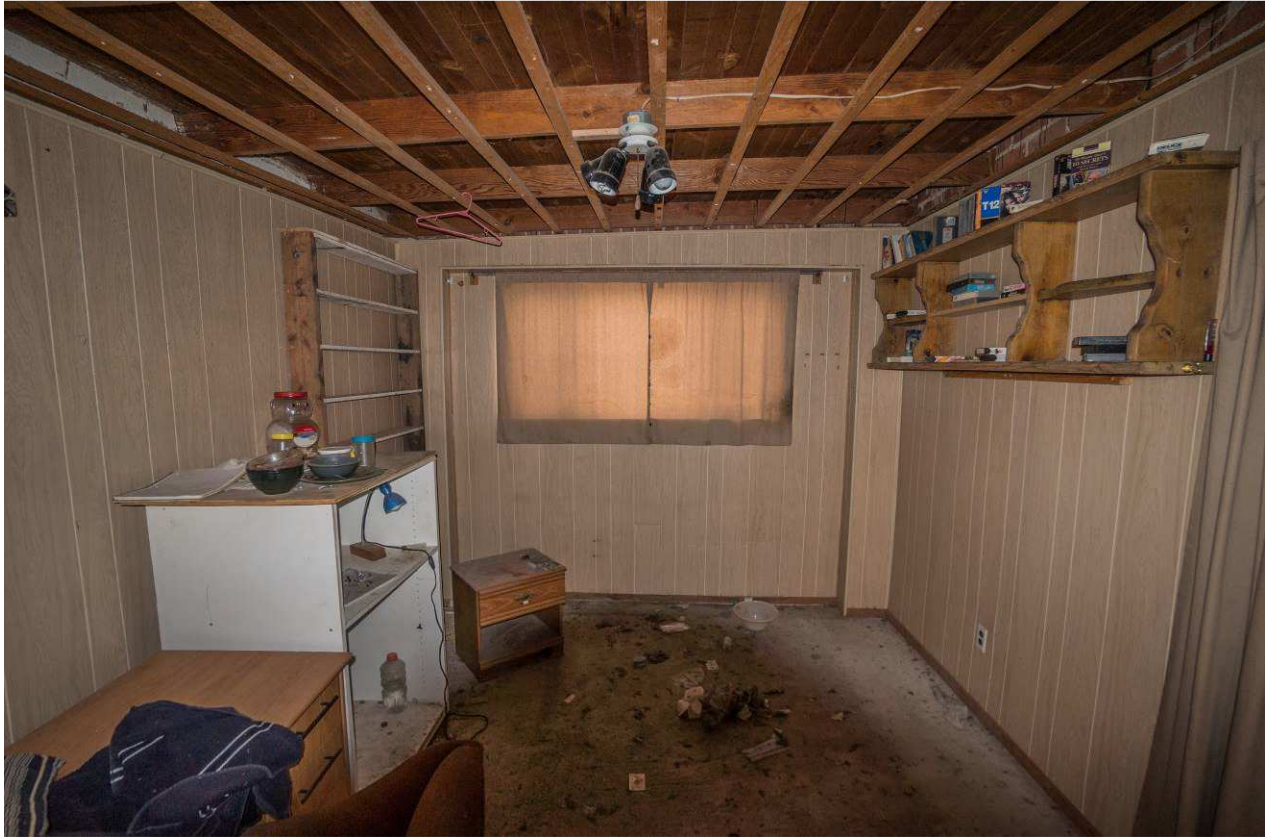
The condition of the outbuilding is poor. The building has seen very little maintenance over the years. Large sections of stucco are missing from the exterior. The exterior wood siding is in need of replacement. Exposed wood framing is weather-beaten and in some cases rotted.

Original Garage Area Interior

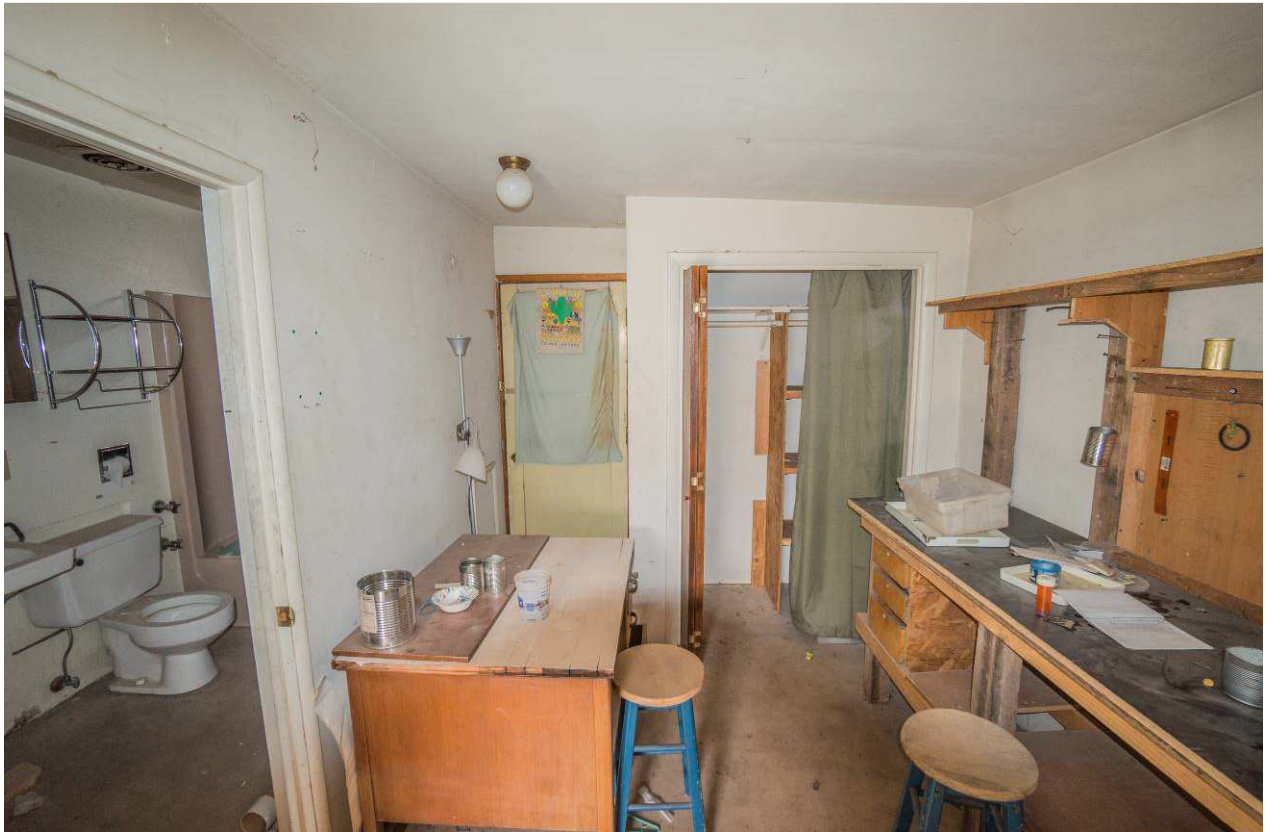
Other outbuilding interior
