## FIRE INVESTIGATION REPORT

Case # 18-591-06	Priority 1	Investigator Paul Ayres	Status Closed
Day of Fire Tuesday	Date of Fire 06/26/2018	Time of Fire 2:20 pm	Cause of Fire Undetermined
Date of Request 06/26/2018	Date Case Assigned 06/26/2018	Date of Investigation 06/26/2018	
City of Fire Gatesville	County of Fire Coryell		
Location of Fire 1507 West Main Street			
Type of Fire Investigation Origin and Cause	Injuries 13	Deaths 3

1. Undetermined
2. 1507 West Main Street, Gatesville, TX
3. Coryell Memorial Hospital
4. Tuesday, June 26, 2018

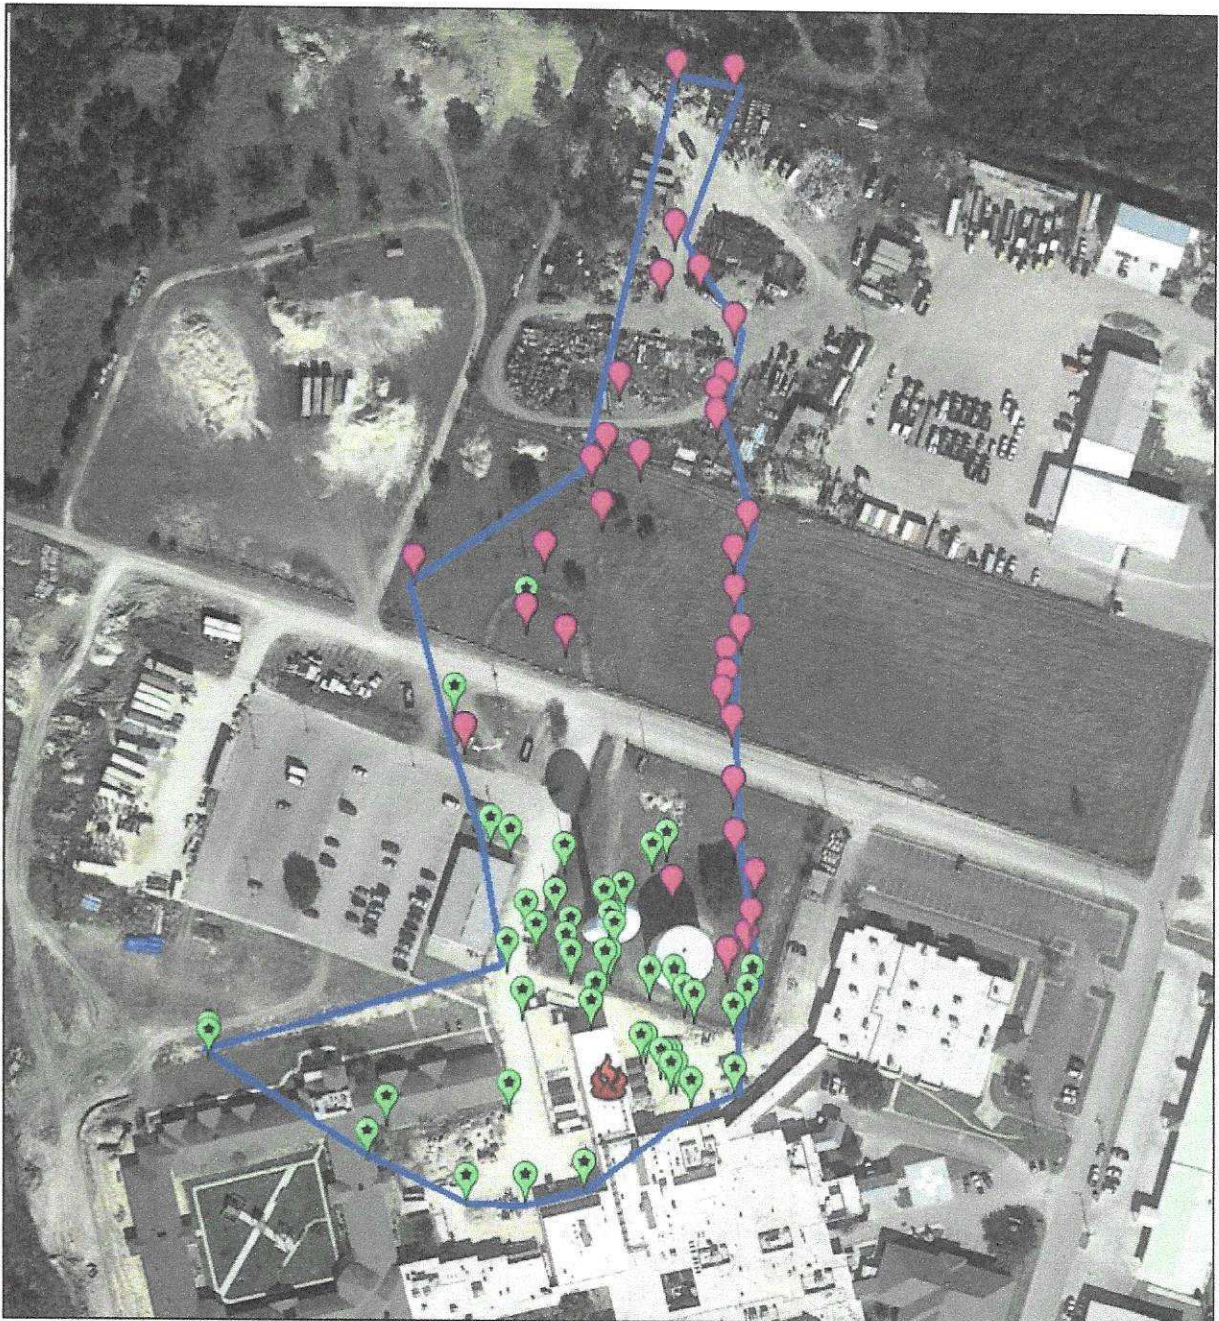
Figure 3: Diagram of Debris Field

- 1.20 On Wednesday, June 27, 2018 investigative teams began examining the debris field which extended approximately 1,100 feet north and 440 feet west of the epicenter, encompassing approximately 6.7 acres. A line search was conducted to search for any evidentiary items. No items of significant evidentiary value were found and there was no evidence of any explosive devices. Debris located in the debris field consisted of tools and structural components of the hospital. Once the debris field had been searched and documented, Brandy Lane was re-opened to authorized emergency personnel. The diagram below illustrates the size of the debris field, with pink markers indicating lightweight debris and green markers indicating heavyweight debris. An analysis of the debris field indicated that lightweight debris was likely carried to the north by prevailing wind.

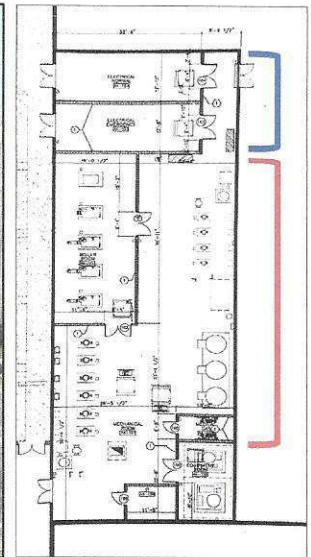
Figure 7: Damage to Roof Assembly

- 1.25 The entire roof over the mechanical room, boiler room, and electrical rooms had been destroyed by the explosion. Lightweight insulating material was launched into the air and was carried by prevailing winds. This explains the large debris field to the north of the explosion which is mostly lightweight materials. Metal roofing panels were scattered around the perimeter of the structure and some were still lying on the roof. Portions of the membrane covering were observed in the debris field. No portion of the roof over the mechanical room, boiler room, or electrical rooms was intact (Figure 7).

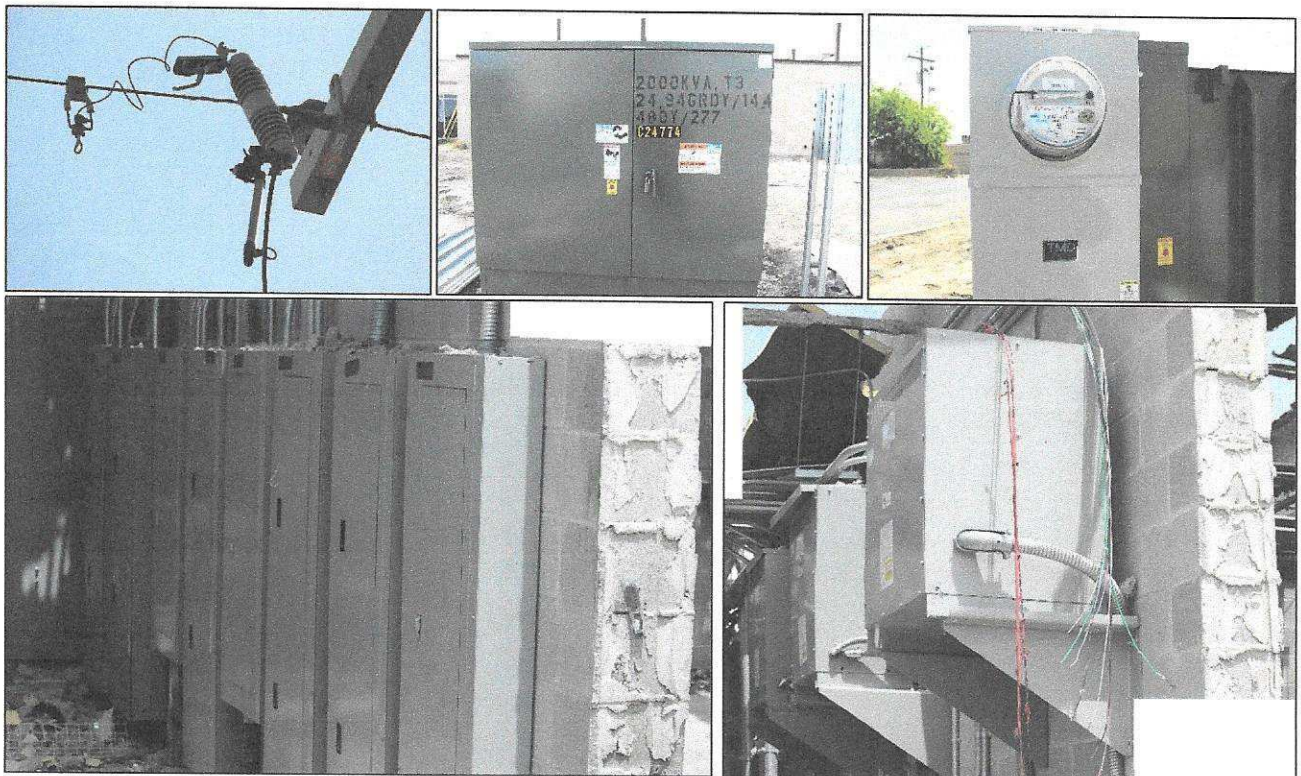
Figure 10: Electrical Utilities

transformers and breaker panels inside each electrical room. Three Generac generators were located on the east side of the structure and provided emergency power to the secondary electrical room.

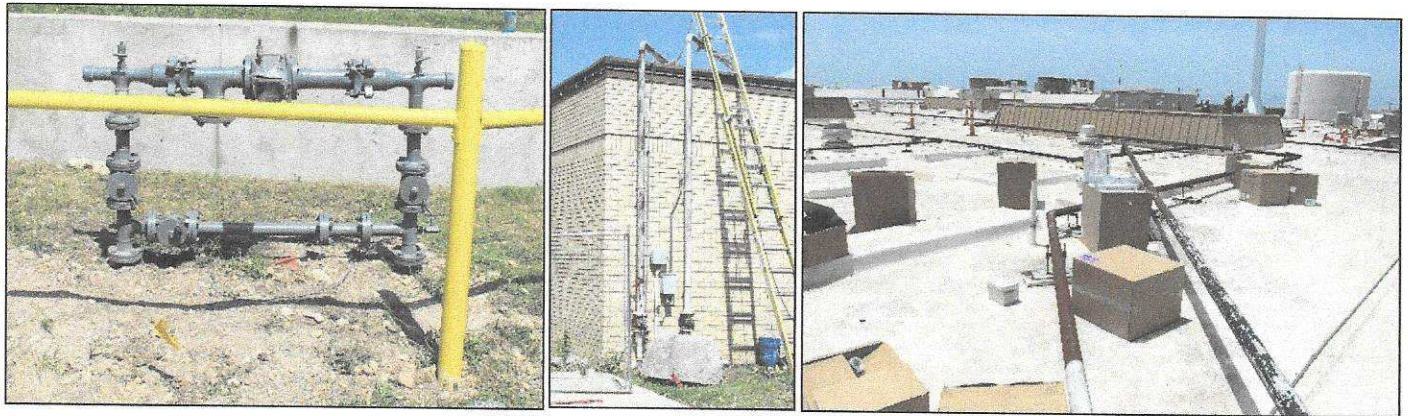
Figure 11: Natural gas meter, riser, and gas line on the roof.

in the courtyard and loading dock area. Each section of the natural gas system was accounted for and documented. After assessing the natural gas system, investigators determined the most probable location of a natural gas leak was the open valves and disconnected couplings serving the water heaters. Detailed documentation of the natural gas system is provided below:

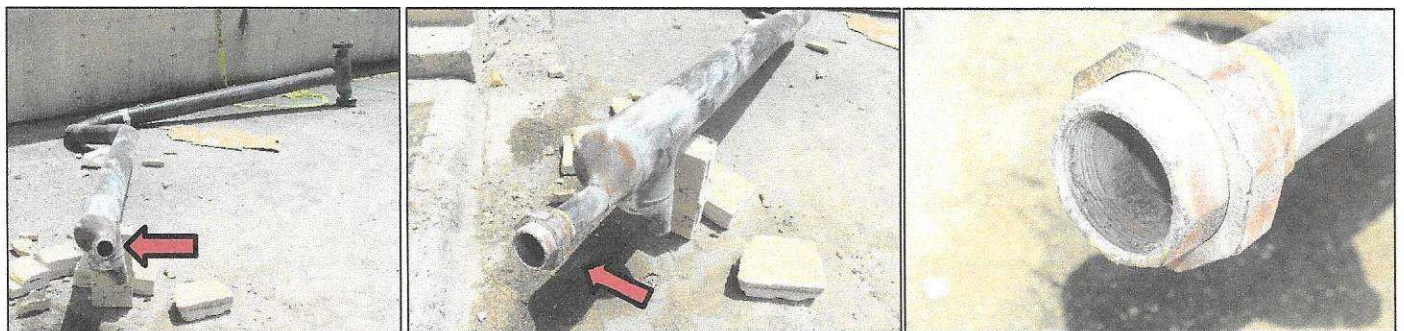
Figure 24: At the other side of the "tee" on the roof provided natural gas to the water heaters.

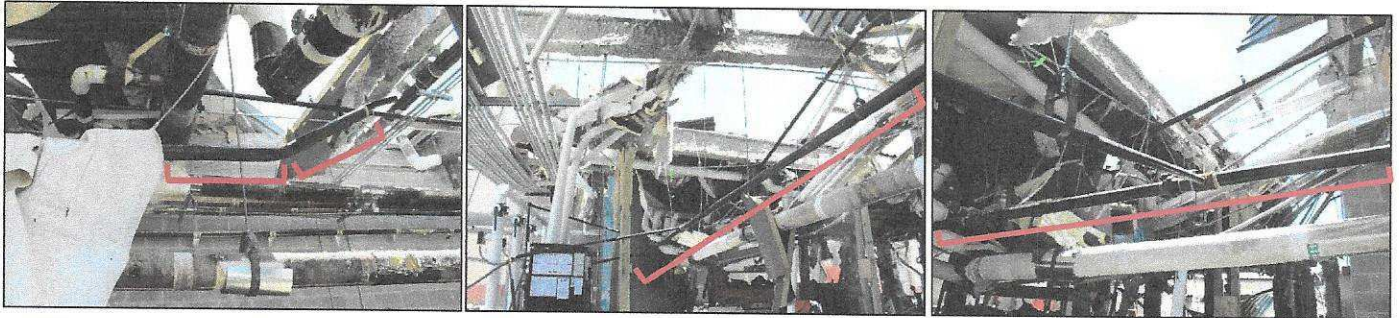
- 1.34 Further examination of the water heater units in the mechanical room revealed that the natural gas pipe supplying them had been disconnected at the coupling to the north and south units. These couplings were not sheared and did not exhibit any evidence of forceful separation. It was determined that the couplings were disconnected prior the explosion. The valves on both pipes were open, allowing natural gas to flow freely into the mechanical room. It is important to note that the most significant damage to the I-beams, electrical conduit, and glycol system was aligned with the location of the water heaters.

Figure 25: A riser extended from the "tee" on the roof to the mechanical room. A horizontal pipe then supplied natural gas to each water heater.

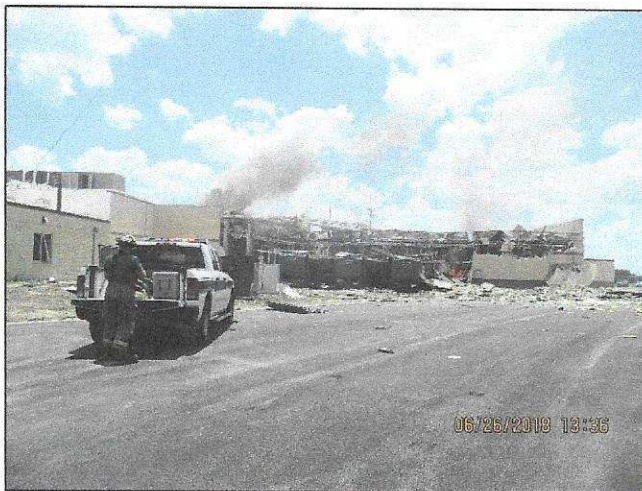
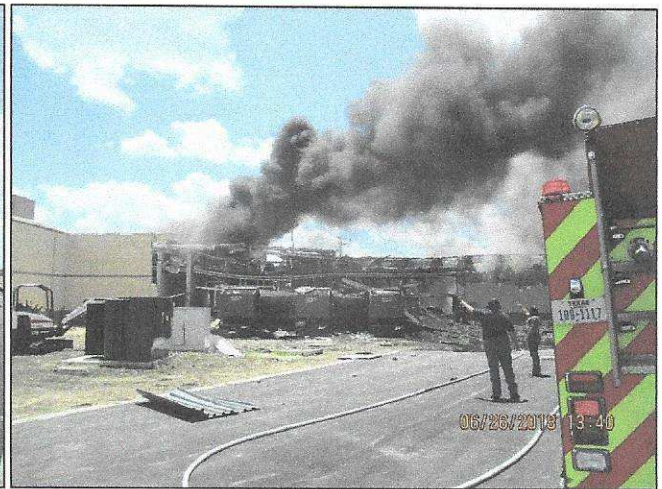
- 1.47 Gatesville Fire Department responded to the explosion incident and provided fire, rescue, and emergency medical services. A copy of their report is attached to the case file. Multiple firefighters were interviewed about their actions and observations. Firefighters were initially focused on getting all victims out of the structure and searching for any trapped victims. During the search, small fires involving insulation materials were spreading. Firefighters then focused their attention on extinguishing the fires and stabilizing the incident. Photos of the scene were made available by first responders which show the progress of the incident.

Figure 27: First responder photographs at 13:36 and 13:40 respectively
