**TO:** Mayor and Common Council  
**FROM:** Chief Steven G. Roux and Chief Michael L. Hover, Consulting Engineer Dan Penzkover and Consulting Architect Trevor Frank  
**FOR:** Council Meeting of January 9, 2024  
**SUBJECT:** Public Safety Building Feasibility Study DRAFT Report Review

# Public Safety Building

# Rice Lake Public Safety Building Report

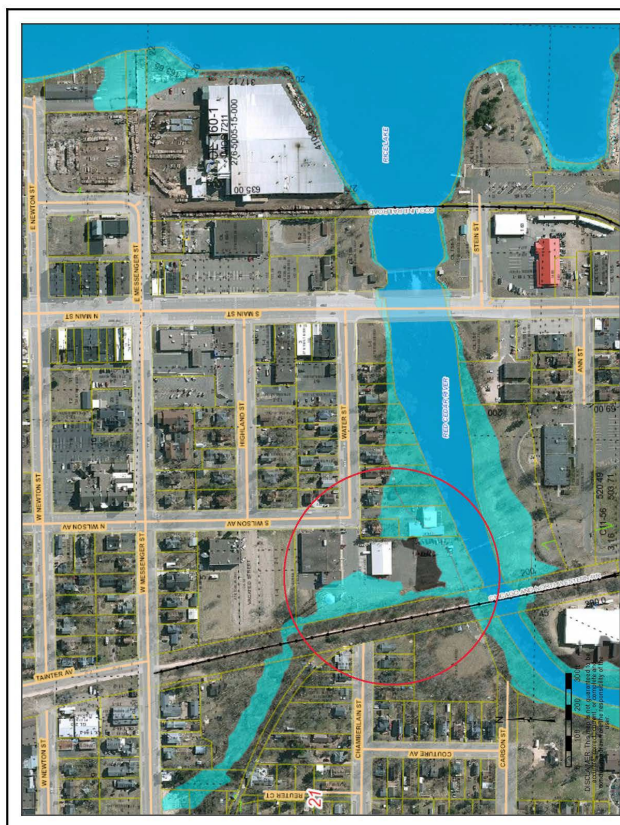
The GIS map indicates the extents of the flood plain on the existing Wilson Avenue public safety building site. These extents severely limit expansion of the existing facility on the current site.

A site test fit of the Wilson Avenue Site is part of the site analysis section of this report and illustrates the challenges of the site to adequately accommodate a public safety building over time.

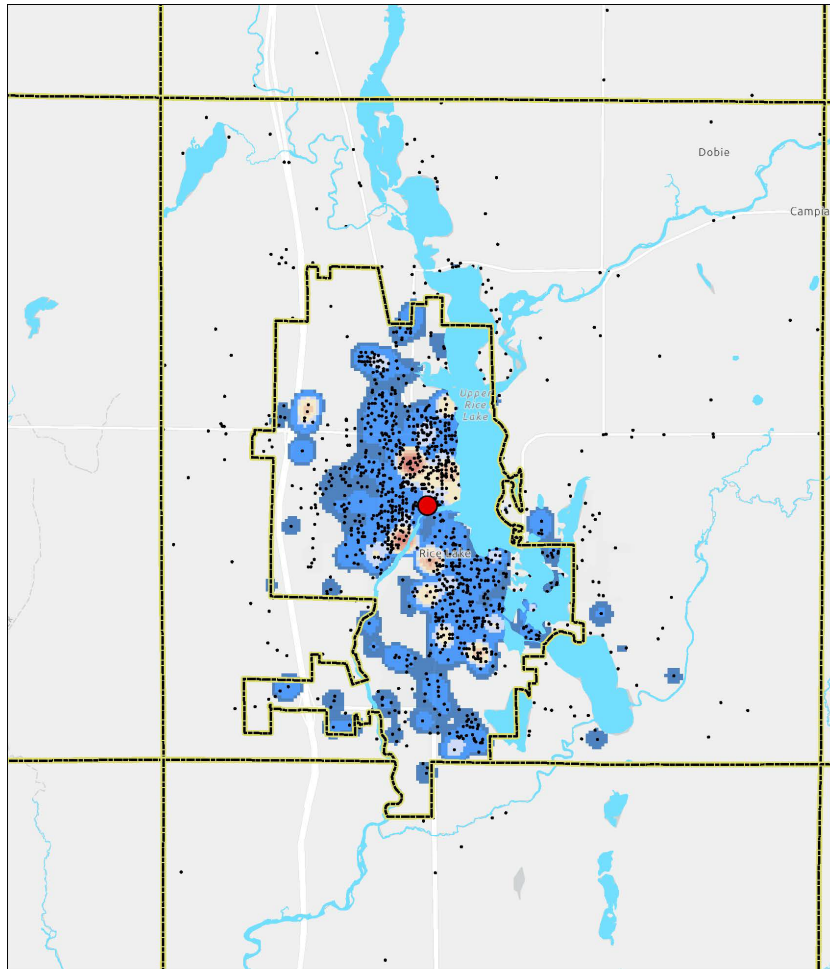
# Wilson Avenue Avene Site

**INCIDENTS AND HEAT MAP**

Lower Incidents Higher Incidents

EXISTING LOCATION

Using emergency call data for the Rice Lake Fire and EMS department from 2015-2022, GIS Analysts on the consulting team developed drive time and heat mapping analysis to determine the best site location for the replacement of the Fire/EMS Station. As part of this analysis the GIS specialists were asked to review the City's emergency response data to determine if there was an advantage to locating the facility on one of the six proposed site locations. The maps show the incident locations within the response area for the RLFD/EMS and also provide drive time analysis from the current and proposed station locations. The maps are included on the pages that follow this introduction. There was some minor difference in response time between the 6 sites analyzed but some of the immediate response area (1-2 minutes response time) was expanded through the downtown commercial zone by siting the public safety building more central to the downtown area. An analysis of the sites based on response time in relationship to the concentration of calls for service is part of the site analysis for each of the six individual sites.

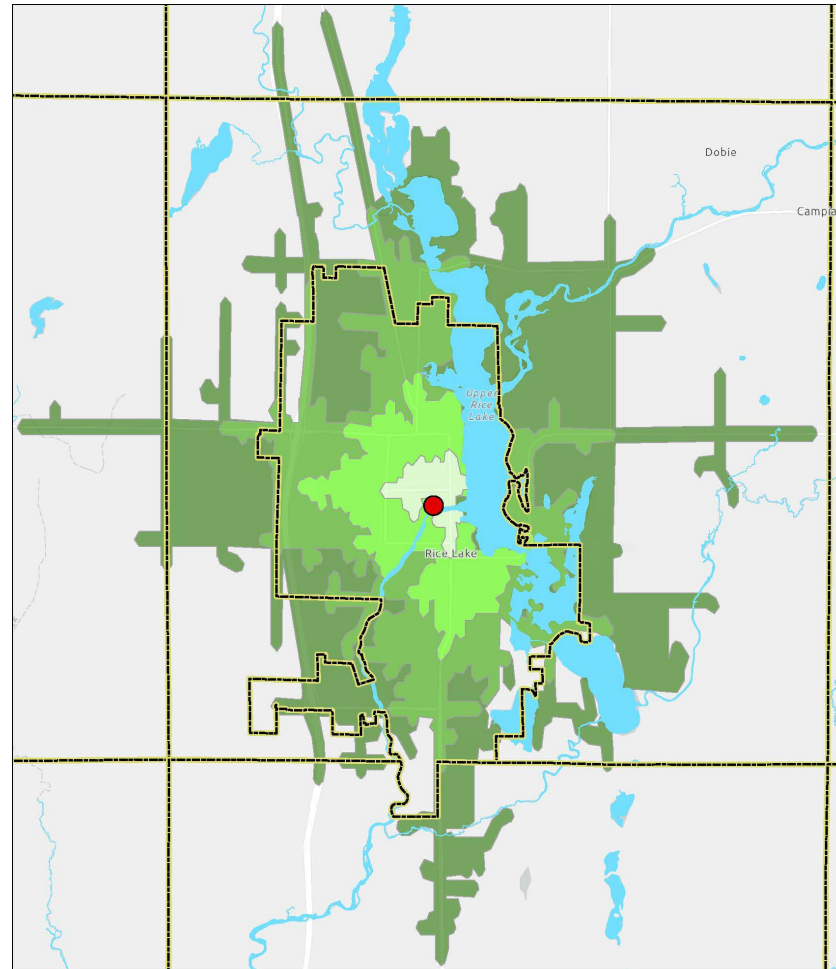
**DRIVE TIMES**

EXISTING LOCATION

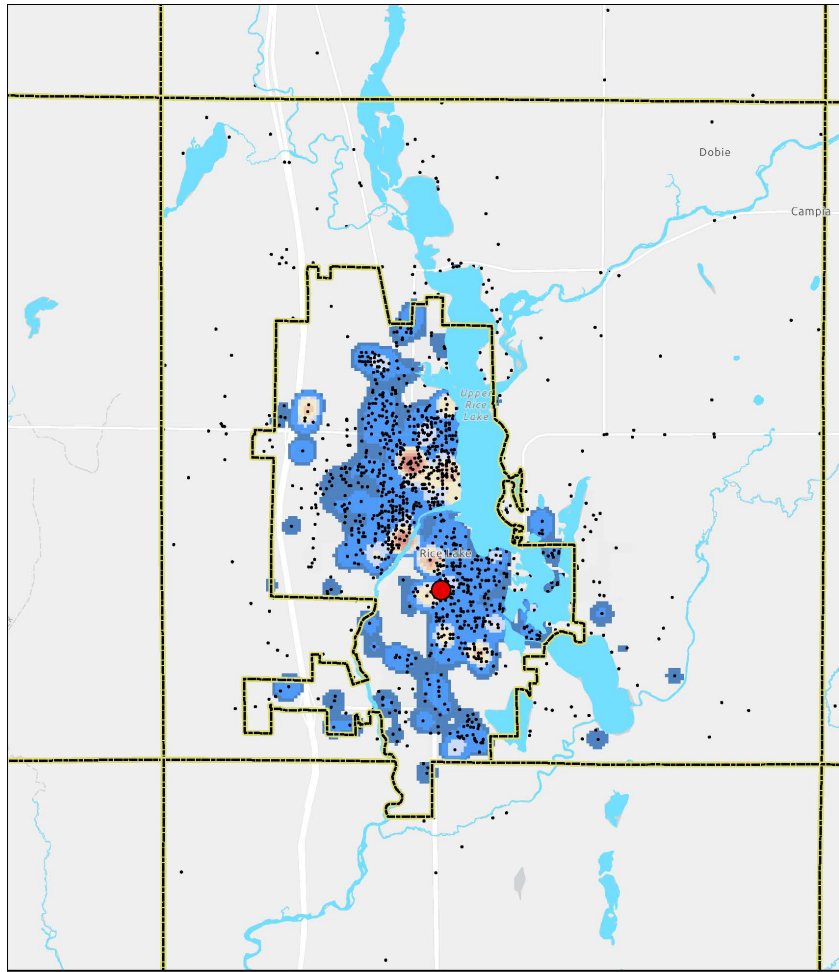
# Burger King Site

**INCIDENTS AND HEAT MAP**

Incident Occurrences  
 Lower Incidents Higher Incidents

BURGER KING SITE

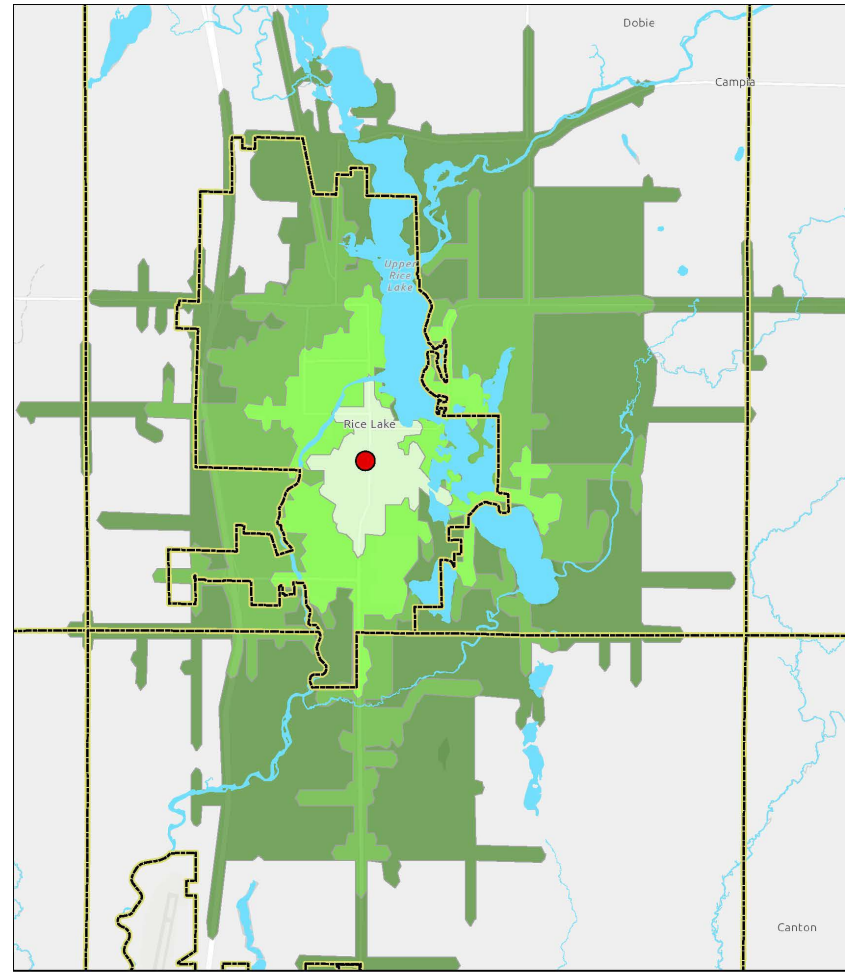
**DRIVE TIMES**

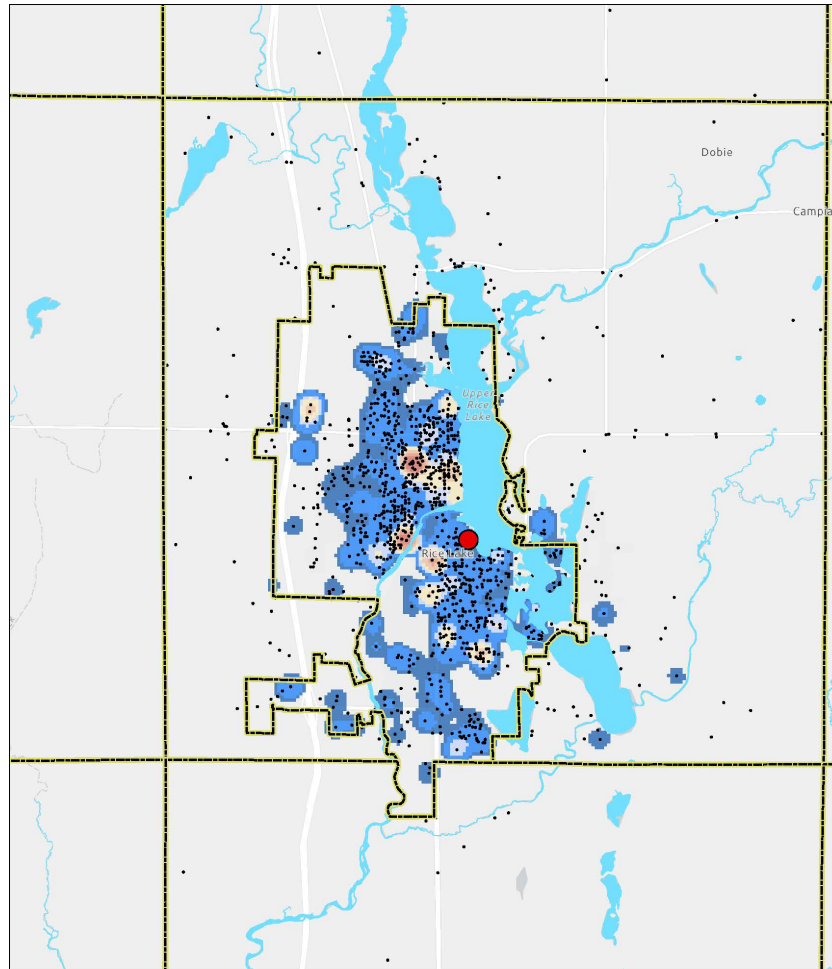
JOHNSON TRUCK BODY SITE

**INCIDENTS AND HEAT MAP**

Lower Incidents Higher Incidents

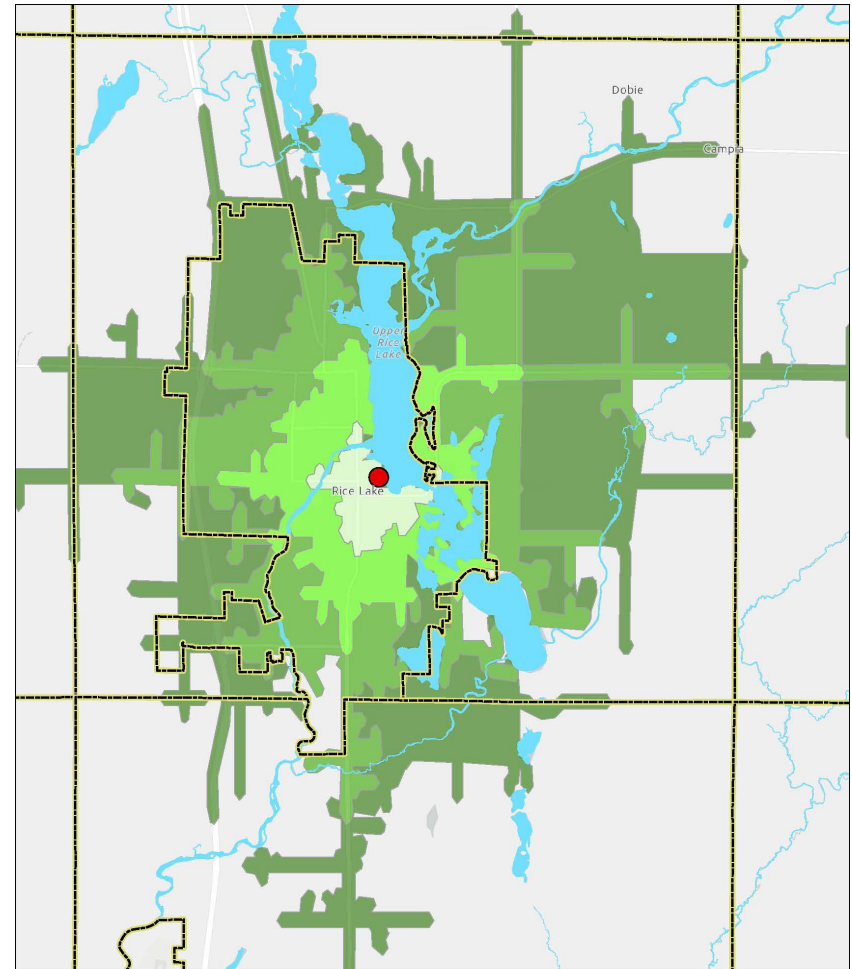
JOHNSON TRUCK BODY SITE

**DRIVE TIMES**

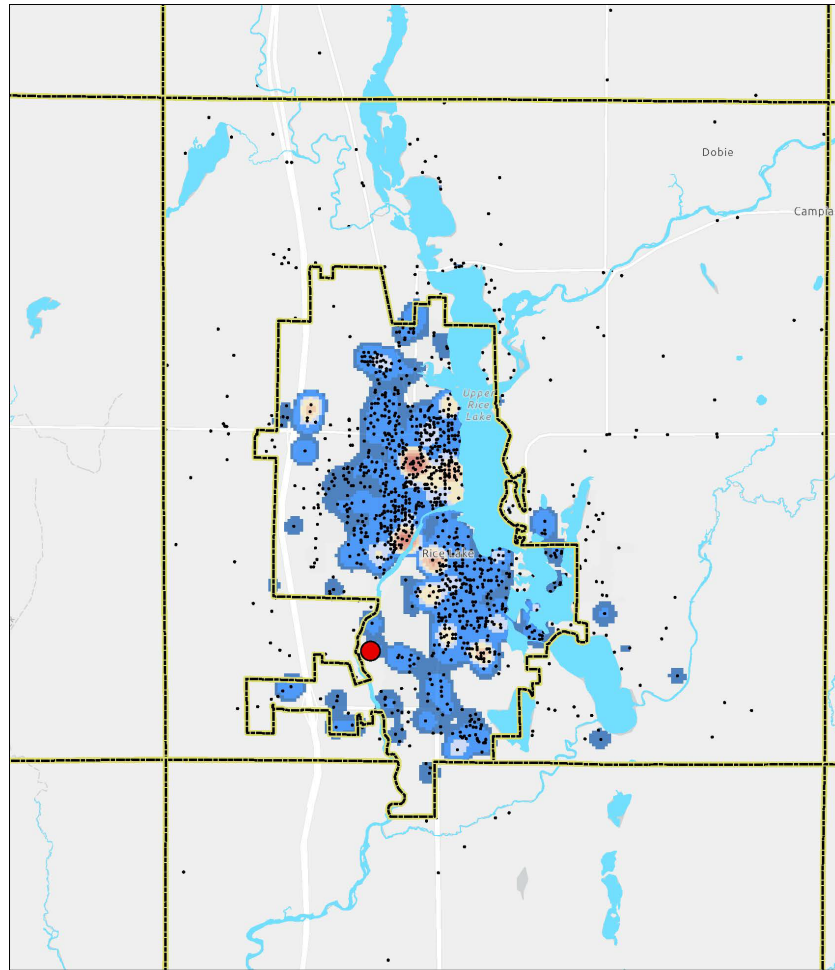
NORTHWOOD TECH SITE

**INCIDENTS AND HEAT MAP**

Lower Incidents Higher Incidents

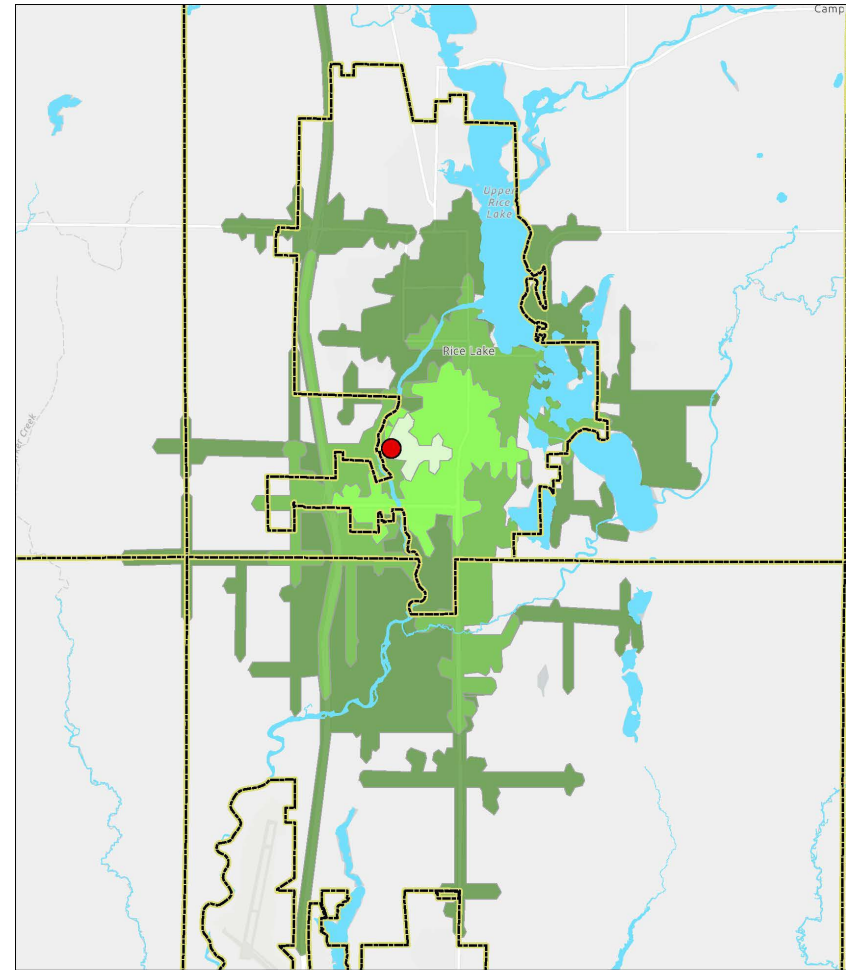
NORTHWOOD TECH SITE

**DRIVE TIMES**

GIS Analysis: the existing site at West South Street and College Drive was used to develop drive time analysis to the emergency service area within the city of Rice Lake. GIS response time mapping revealed that from the Northwood Tech site location the majority of the calls for service now fall outside the 0-2 or 2-4 minute response time zones. These areas are illustrated by the light yellow and light green areas on the map (see page 48). Moving the facility northwest would push the Public Safety facility west against the western-most boundary of the service area. This has an impact on the zero to two-minute response time zones and takes away much of that zone's north and westerly capacity. There are some higher incident areas located to the north and these incident locations that now fall in the 4-6 and 6-8 minute response zones. The Northwood Tech location does impact the response times within the service area but the impacts, while not ideal, do not dramatically impact the overall response time. There is a large portion of the northern 1/3 of the city outside the 8 minutes response area from this site. Based on the size of the site and its proximity to major traffic arteries, this site is considered a desirable location. The newly annexed properties west of the Walmart were also analyzed as part of this response analysis. The drive analysis map omits a small parcel NW of Walmart site within the City limits. Drive time to these newly annexed parcels are identical to the adjacent parcels shown on the response map.

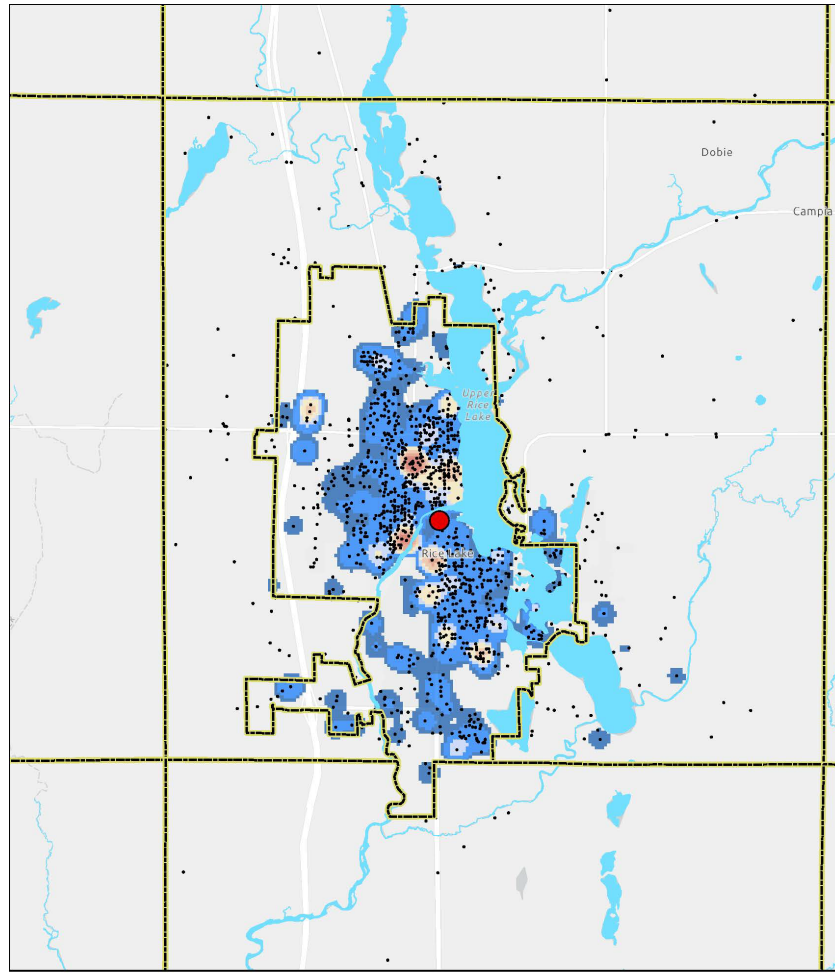
FRED TATE SITE

**INCIDENTS AND HEAT MAP**

Lower Incidents Higher Incidents

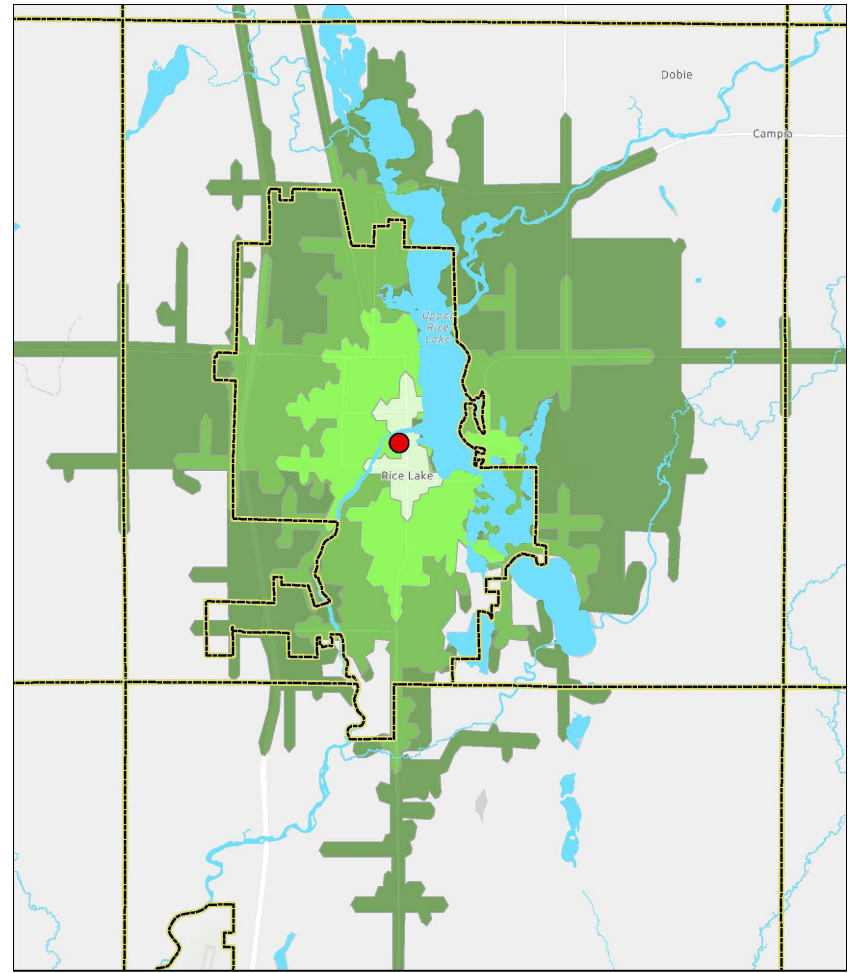
**DRIVE TIMES**

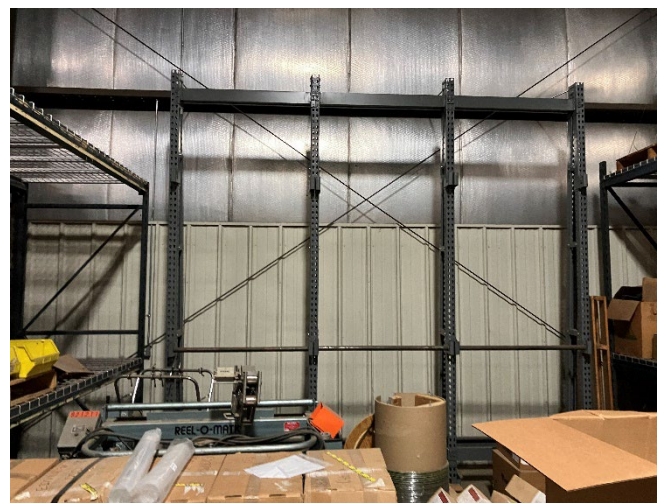
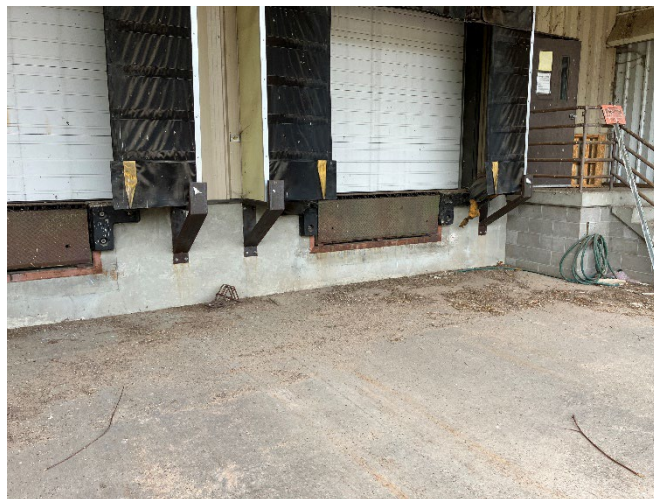
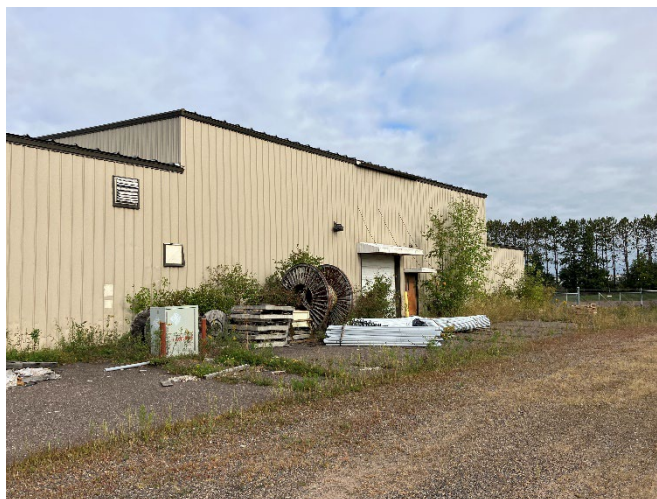
Structurally, the current building was constructed as a proprietary metal building system (PEMB). The larger garage and storage spaces have rigid gable frames spanning approximately 105 feet side to side. The frames consist of open web steel joist girders at the roof supported on wide flange columns at the sidewalls and at a single interior support column offset from the ridge. Spacing of the frames is approximately 25 feet. The roof structure is comprised of purlins with metal roofing spanning between the frames. The end walls are bearing frames. The exterior walls of the garage and storage have steel girts and metal siding. There is intermediate "X" bracing between several of the column bays which provides lateral support for the walls. This bracing cannot be removed without replacing it with moment frames or additional cross bracing in some of the other column bays.

The office roof is also metal roofing on purlins but supported on solid web steel girders rather than open web members. The roof pitch of the garage is continued another 50 feet over the office. The office space has suspended ceiling hung from the roof framing. The exterior walls of the office have cold formed steel framing in-fill with finished drywall interior and veneer masonry exterior.

Overall, the building is in good structural condition, with no significant deficiencies or areas of concern noted.

If this building were to house "essential services" additional structural considerations are in order. ASCE 7 commentary states "Buildings and structures typically grouped in Risk Category IV include hospitals, police stations, fire stations, emergency communication centers, and similar uses." I suspect this building originally fell under Risk Category II. Risk Category IV buildings are required to be structurally capable of withstanding larger snow (20%) and wind (~9%) loads than Risk Category II structures. In that case, strengthening of the building would be required to meet code. It is assumed that the existing building was designed to Risk Category II. Given the proprietary

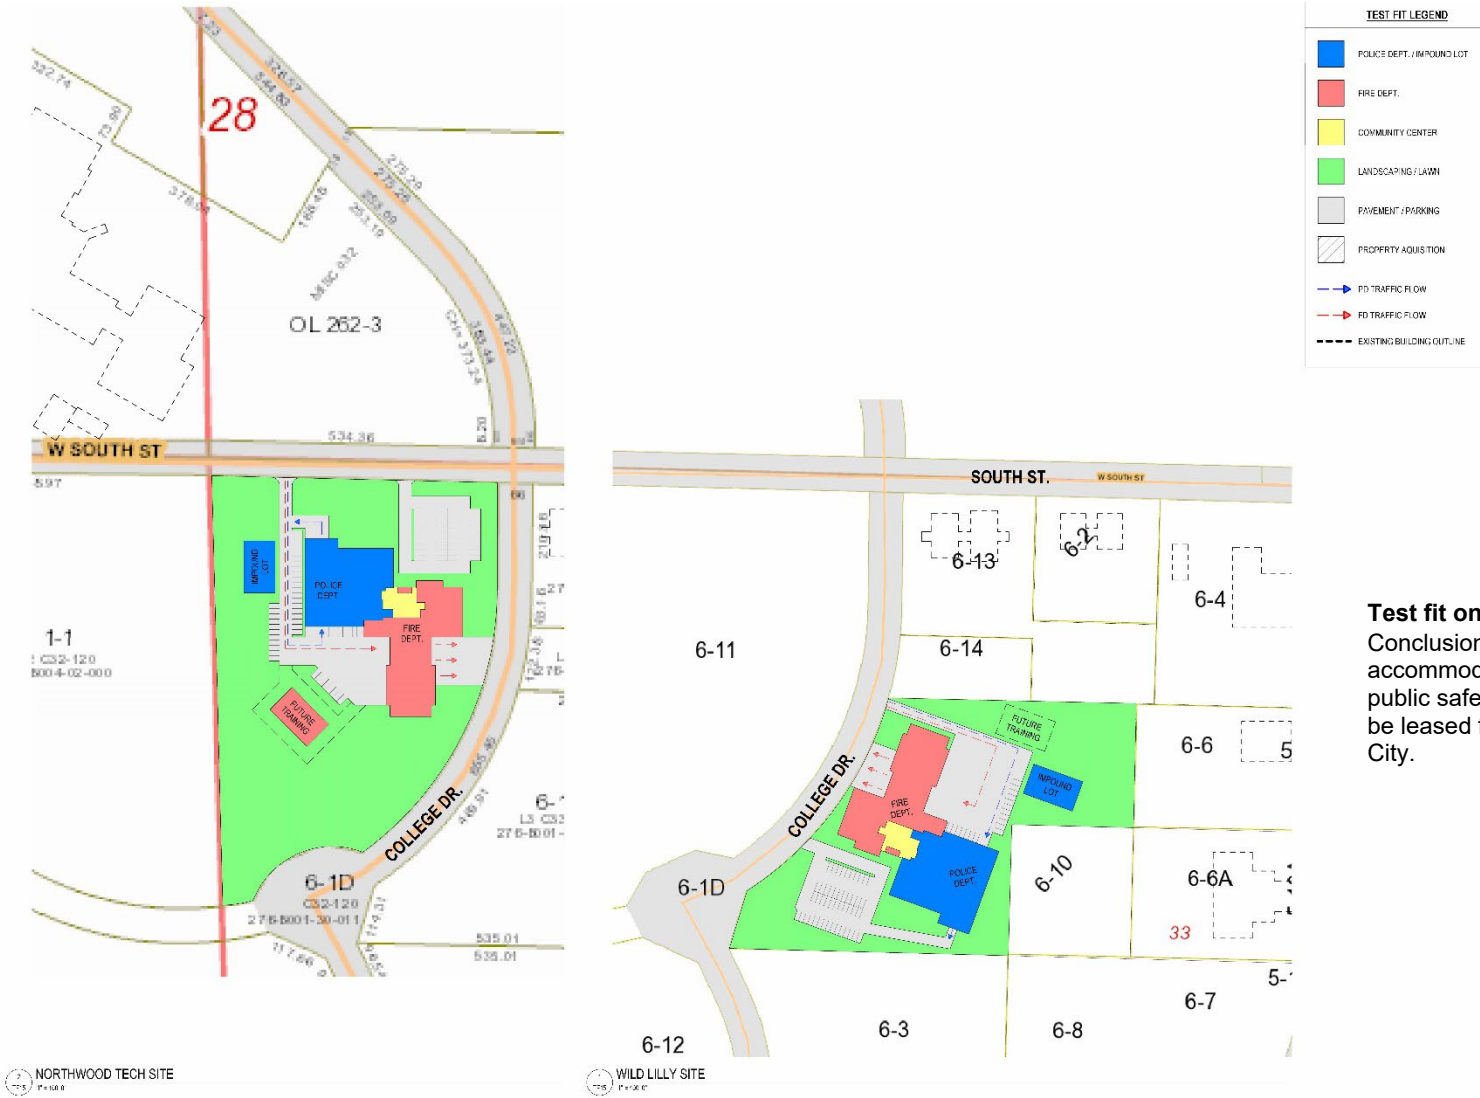
**Test fit on the existing Northwood Tech Site**  
 Conclusion: The site is adequately sized to accommodate the long term needs of the public safety facility. The property would likely be leased from the Technical College by the City.

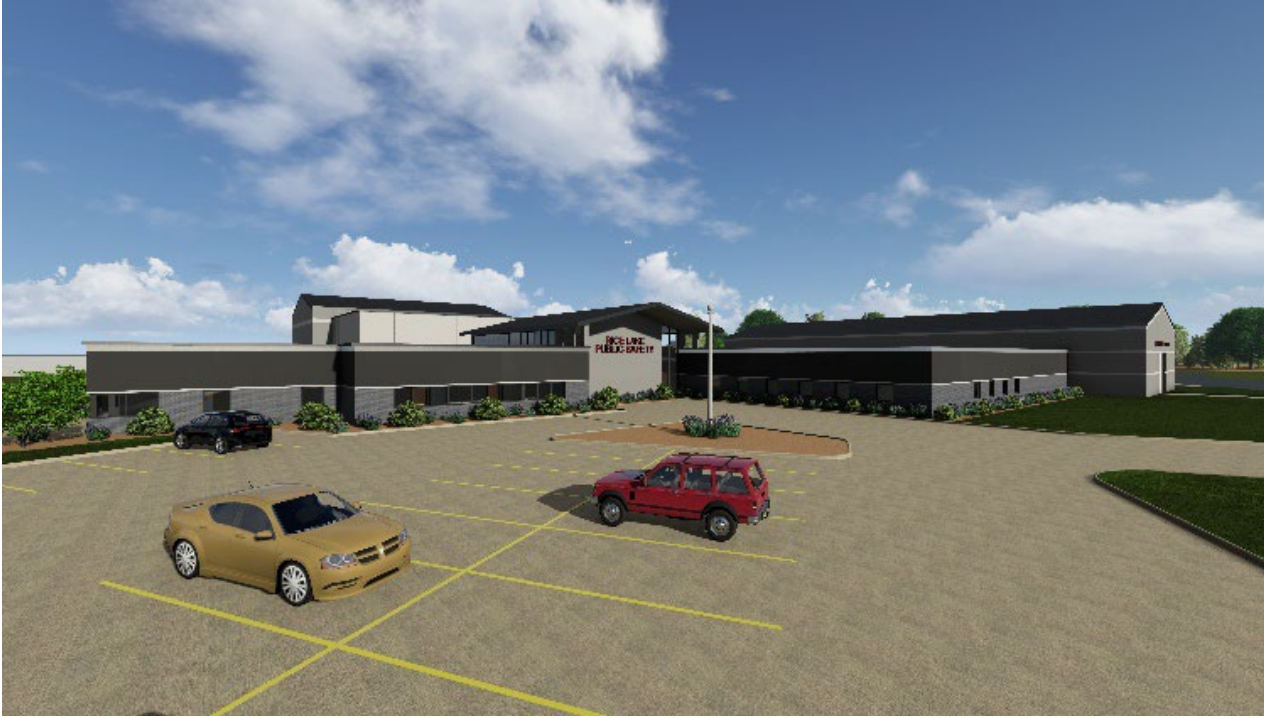
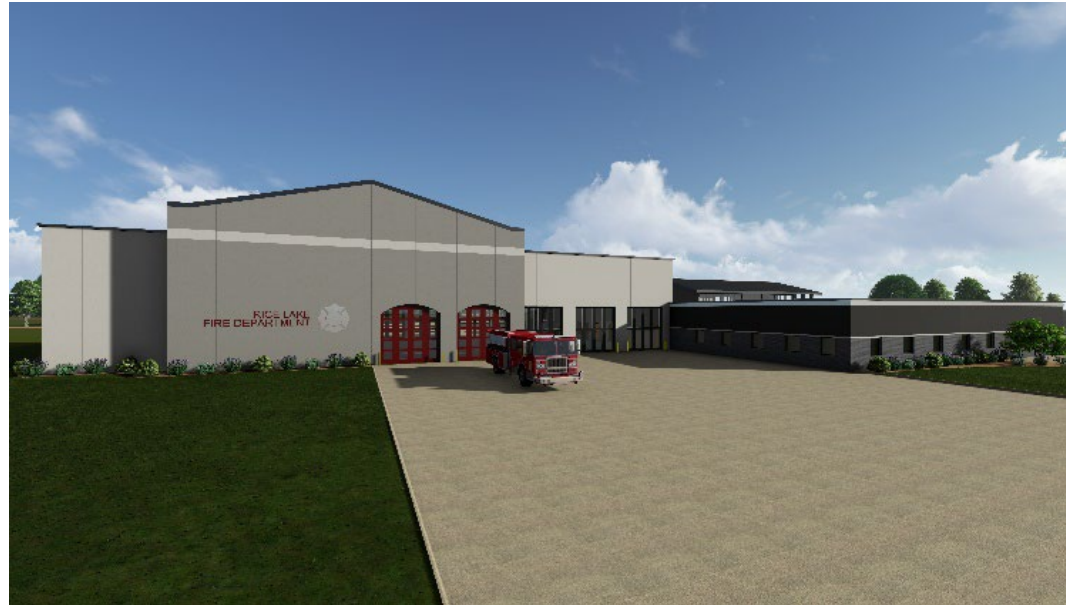
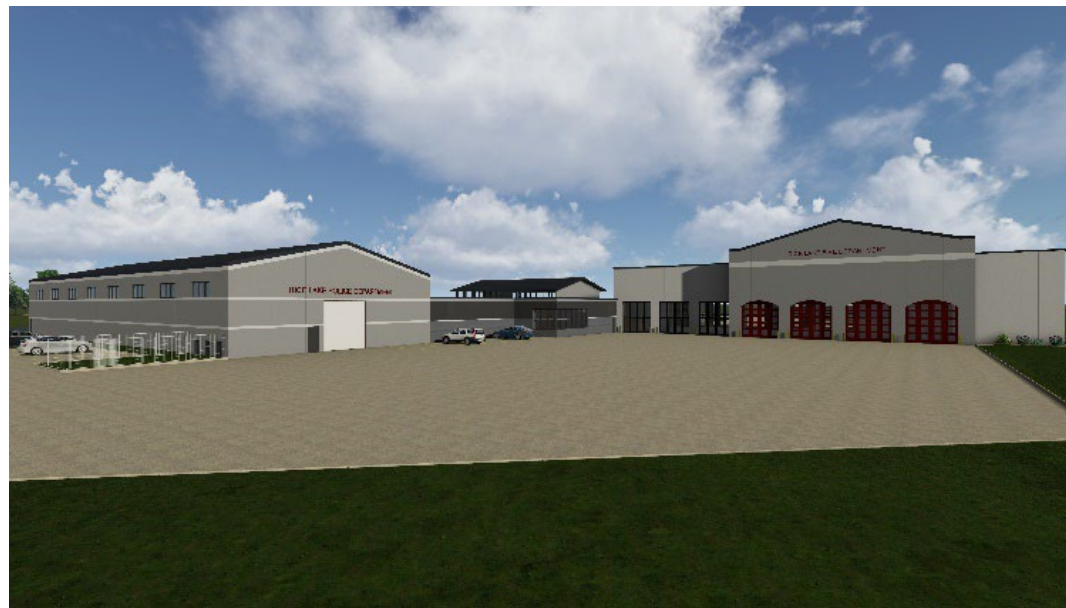
The illustrations that follow this discussion are used as a guide to graphically express the intent of the aesthetic of the new public safety facility. Traditional materials such as brick and stone are used on the majority of the facility due to its highly visible location within the central business district.

Material selections are also driven by local code requirements for specific zoning classifications within the community. The material palette for a building in a downtown commercial district is usually different from the requirements in an industrial setting. With the public safety building being a main feature in the commercial core, consideration was made as to the aesthetics and the quality of the material selected.

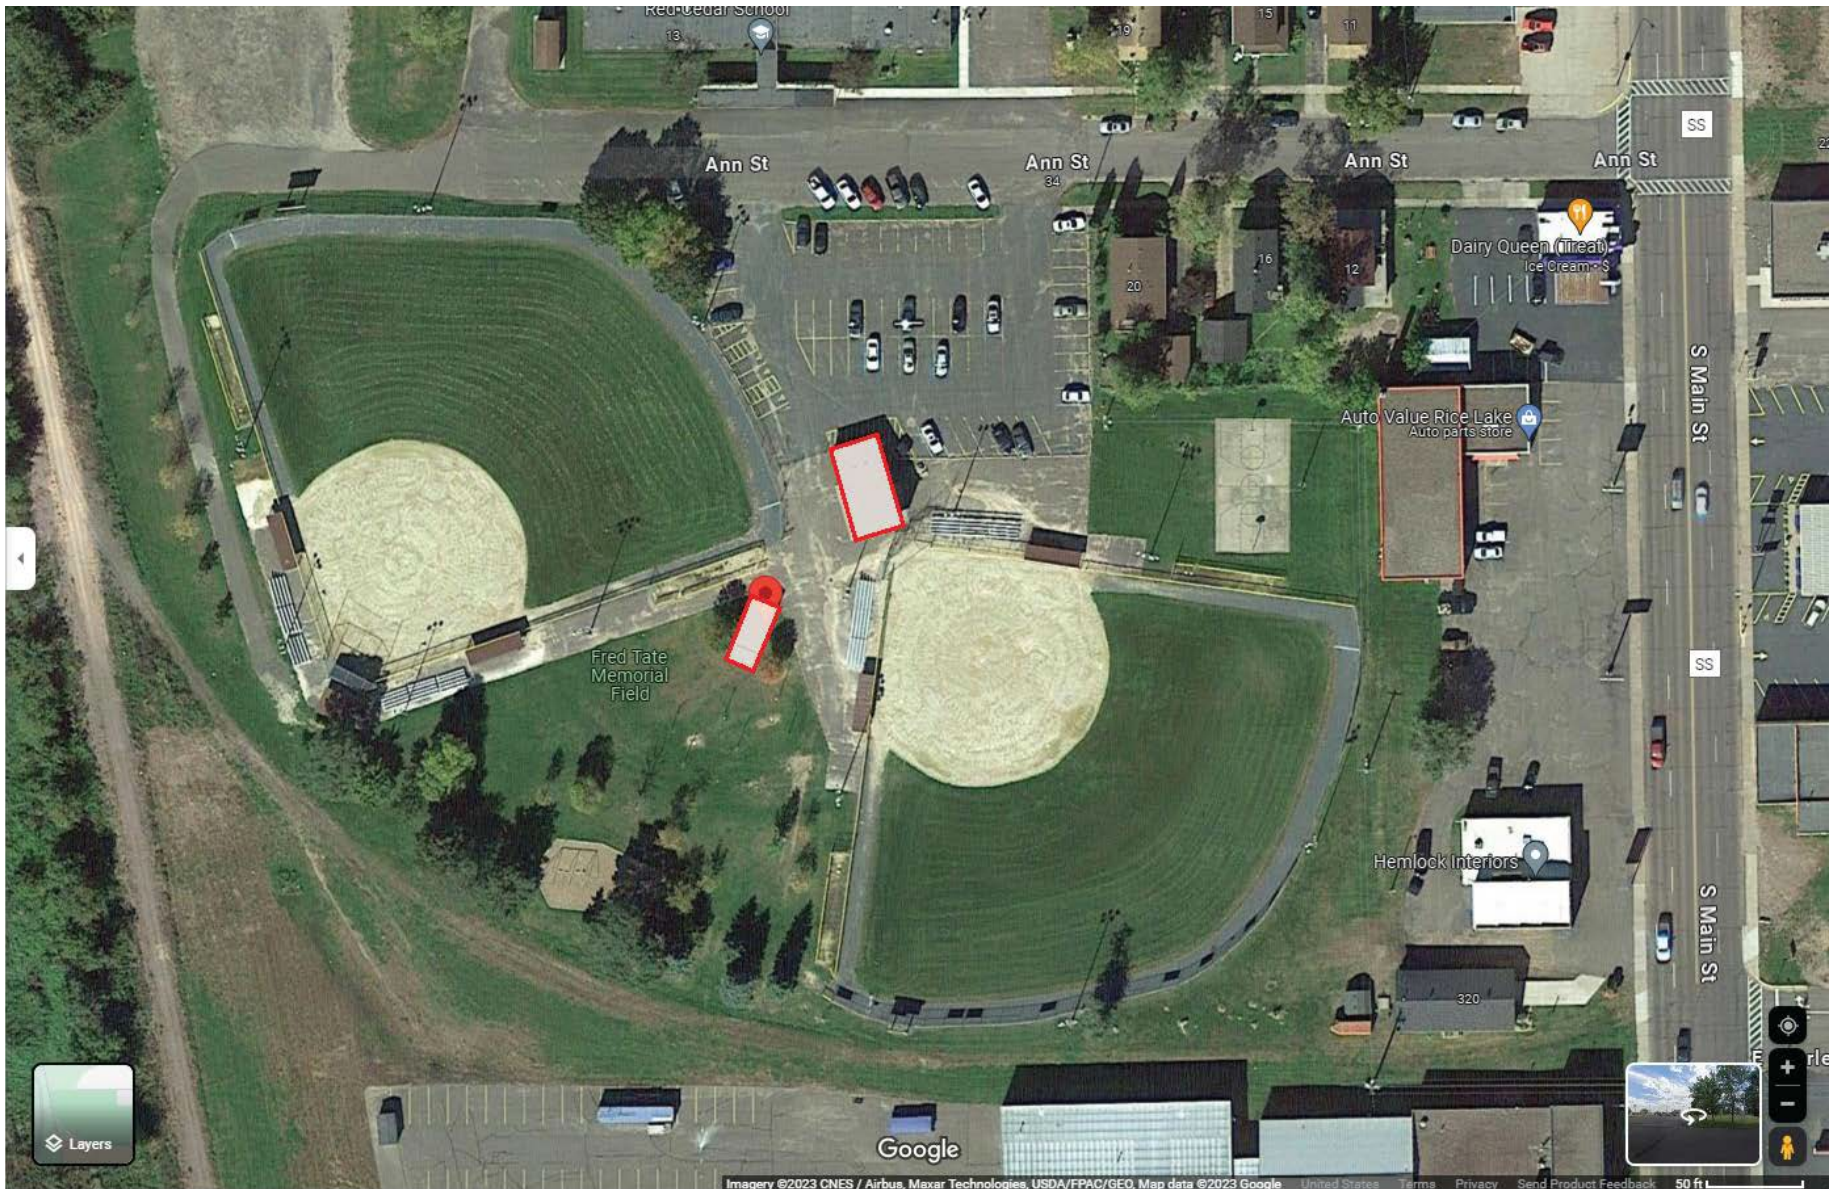
### Tate Park Site Demolition

Each of the sites were analyzed to determine the amount of demolition necessary to prepare the site for development. The following exhibits demonstrate the level of demolition necessary on each of the individual sites. Wilson Avenue and Northwood tech site development assumes no building demolition is necessary
