## CITY OF SANTA MARIA PARKS & RECREATION

### 2024 City Wide Parks Assessment

*Rotary Centennial Park & Robin Ventura Field*  
2625 College Drive

#### PROJECT DESCRIPTION

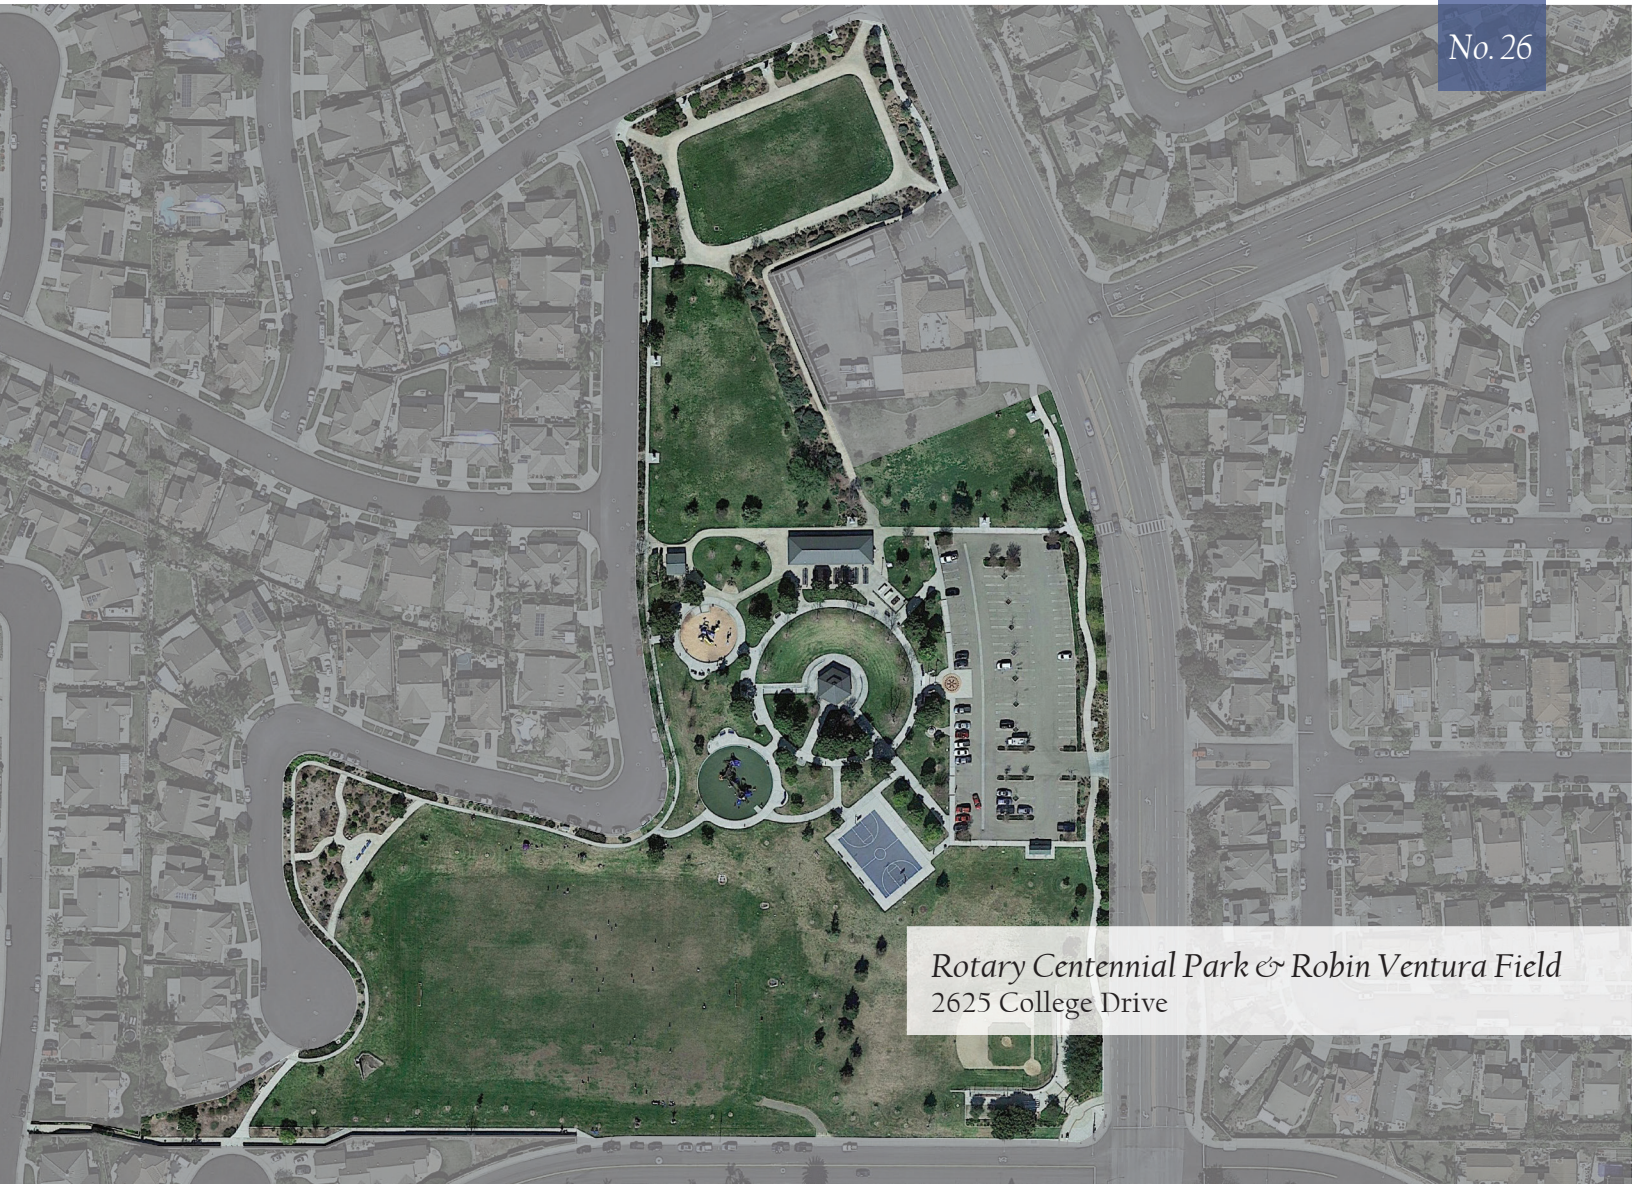
No. 26

A 14.5-acre community park established in 2005 includes a large metal roof picnic area with Santa Maria barbecue and built-in counters, entrance with rotary logo, art installation, flags and clock, two playgrounds, one basketball court, gazebo, exercise trail with fitness stations, Peace Pole, small grass basin surrounded by native plantings, large grass basin for soccer, restroom, and parking lot.

Robin Ventura T-ball Field includes a steel entrance archway and sign, decorative wrought iron fencing, and bleachers.

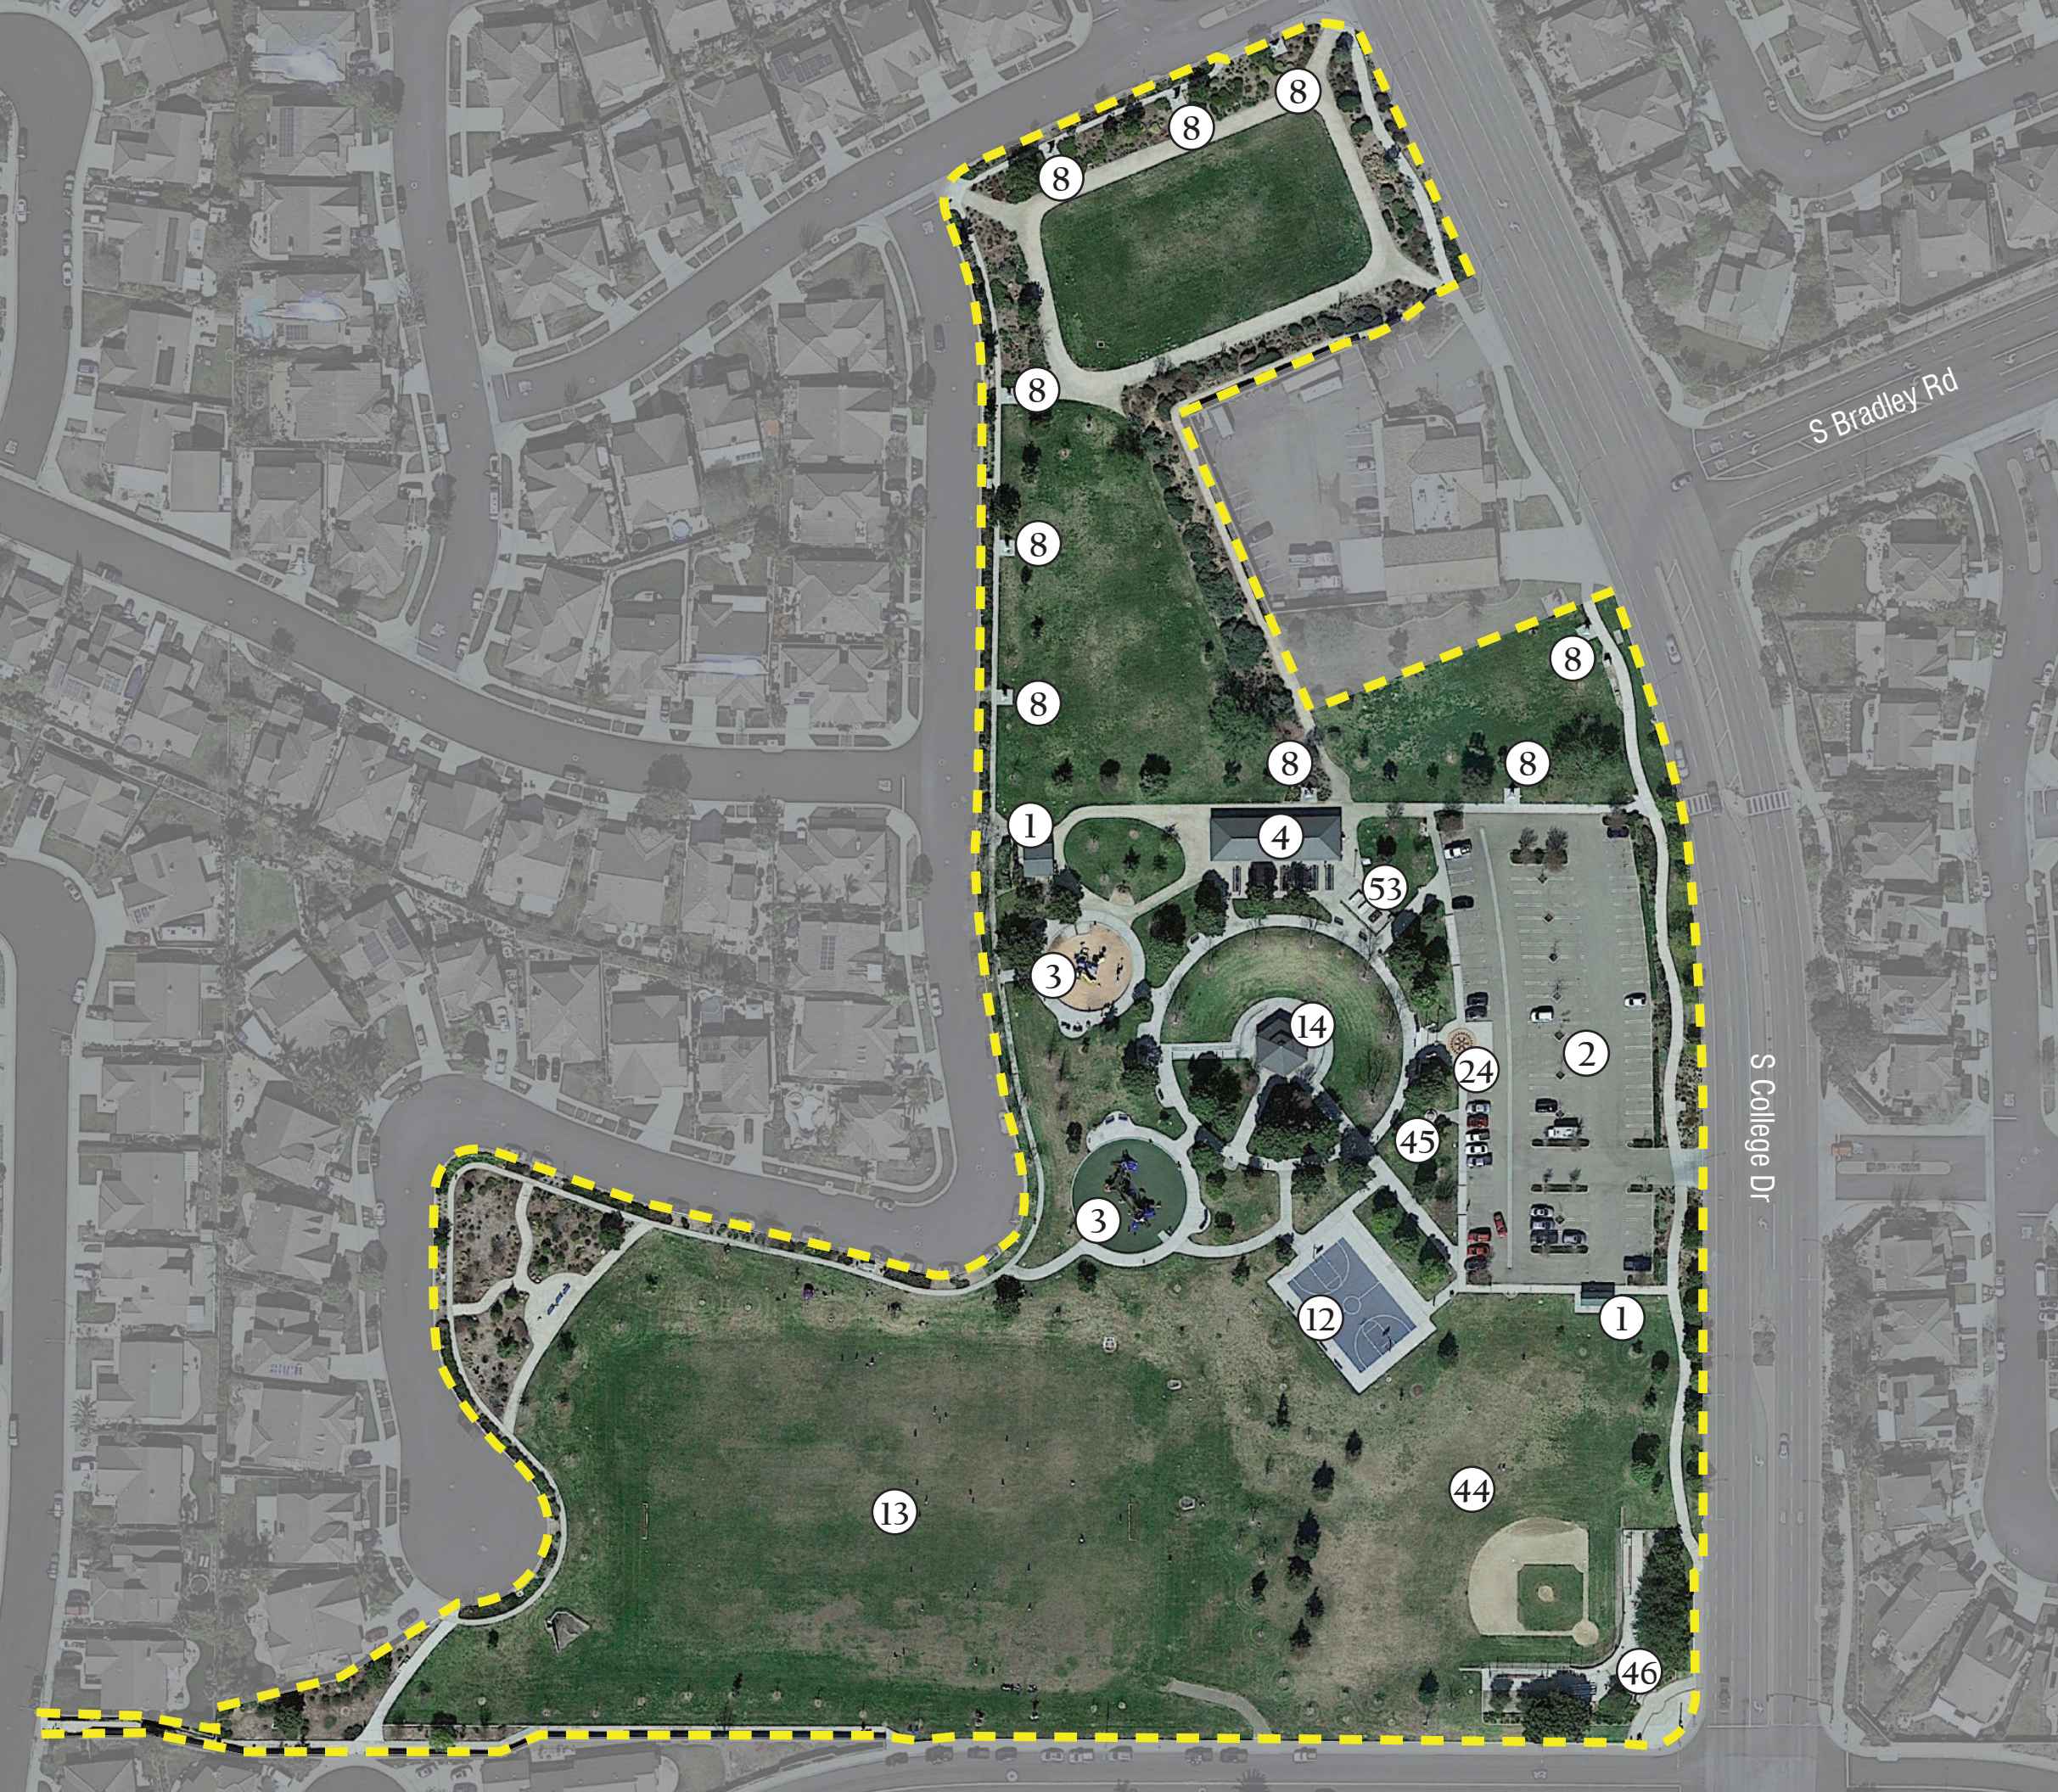
# Rotary Centennial Park & Robin Ventura Field

2625 College Drive

- — SITE BOUNDARY
- ① RESTROOM
- ② PARKING
- ③ PLAYGROUND
- ④ PICNIC AREA & SHADE STRUCTURE
- ⑧ FITNESS STATION
- ⑫ BASKETBALL COURT
- ⑬ SOCCER FIELD
- ⑭ GAZEBO
- ②④ ART INSTALLATION
- ④④ T-BALL FIELD
- ④⑤ CLOCK
- ④⑥ MONUMENT SIGN/ARBOR
- ⑤③ SANTA MARIA BBQ
