# National Transportation Safety Board

## CONTROL ROOM AND SUPERVISORY CONTROL AND DATA ACQUISITION (SCADA) GROUP CHAIRMAN FACTUAL REPORT.

Accident Number: DCA-10-MP-007  
Type of System: Liquid Transmission Pipeline  
Accident Type: Pipeline Rupture  
Location: Marshall, Michigan  
Date: July 25, 2010  
Time: about 5:57pm  
Owner/Operator: Enbridge Energy, Limited Partnership  
Material Released: Crude Oil  
Pipeline Pressure: 520 Psig  
Component Affected: 30-inch diameter pipeline.

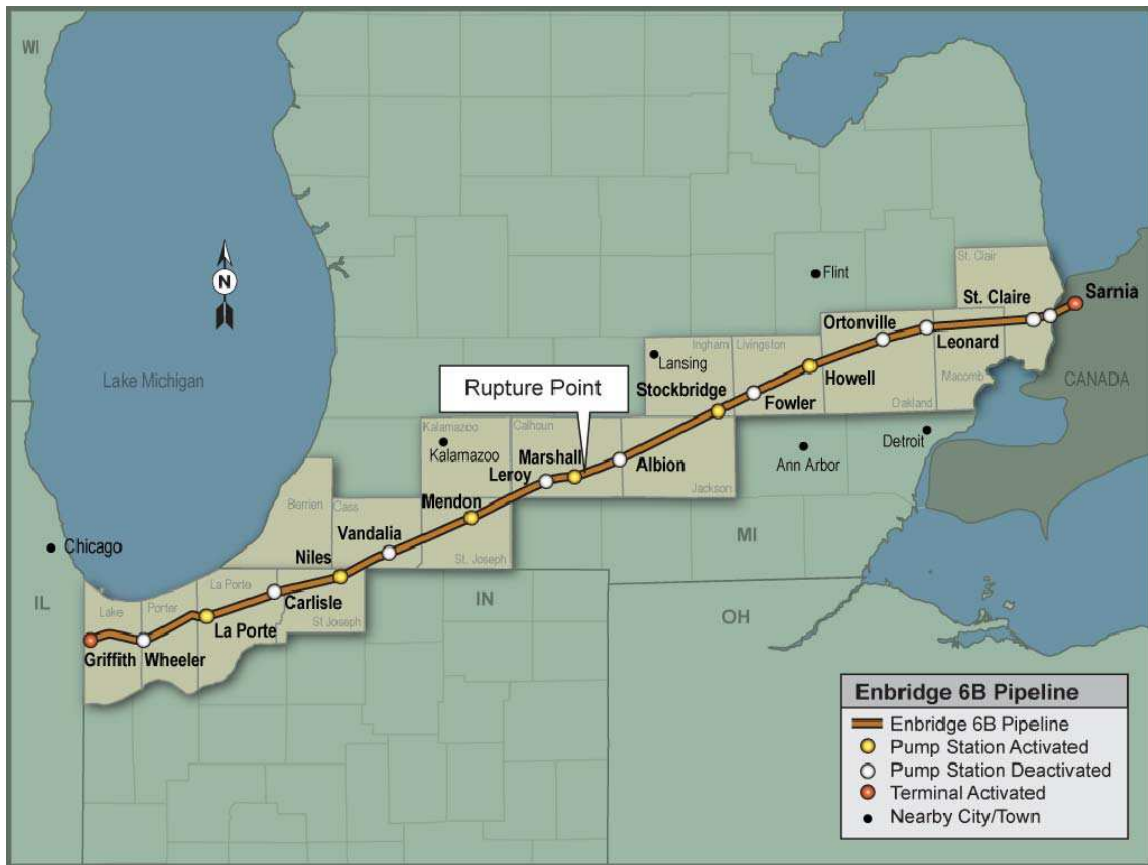
Figure: 1c Enbridge Energy Line 6B System Map from Griffith to Sarnia, Source: Enbridge Energy.

Line 6B consists of seven active pumping stations<sup>5</sup> (figures 1a, 1b, & 1c) with tankage at various locations between Griffith, Indiana and Sarnia, Ontario, Enbridge uses a computation pipeline model (CPM) for detecting leaks on Line 6B. The type of CPM used is a Real Time Transient Model. At Enbridge, this model is referred to internally as the Material Balance System or MBS. The MBS utilizes three volume balance calculation time periods for detecting leaks. The two volume balance sections at the time of this

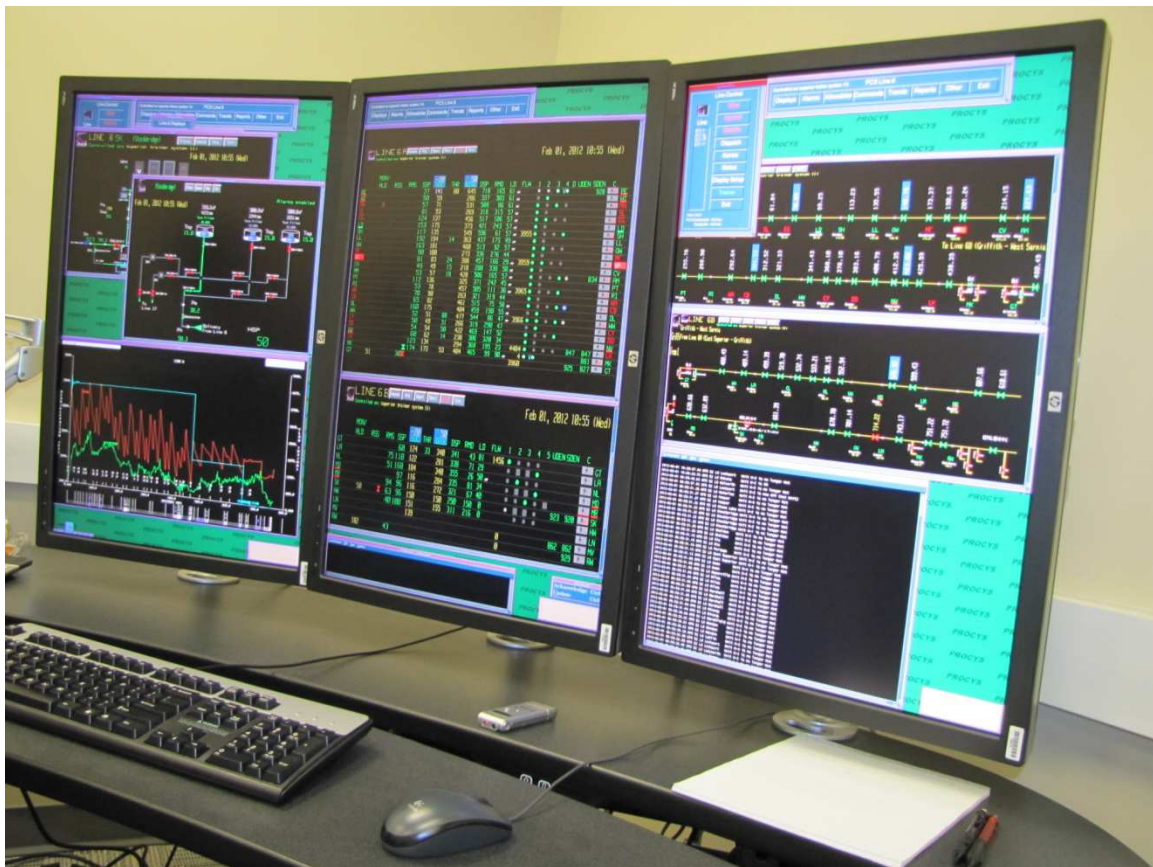
Figure 2: Simulated Training Console; operations SCADA screens displaying simulated Line 6A & 6B on February 1, 2012, Source: NTSB.  
See Appendix 2

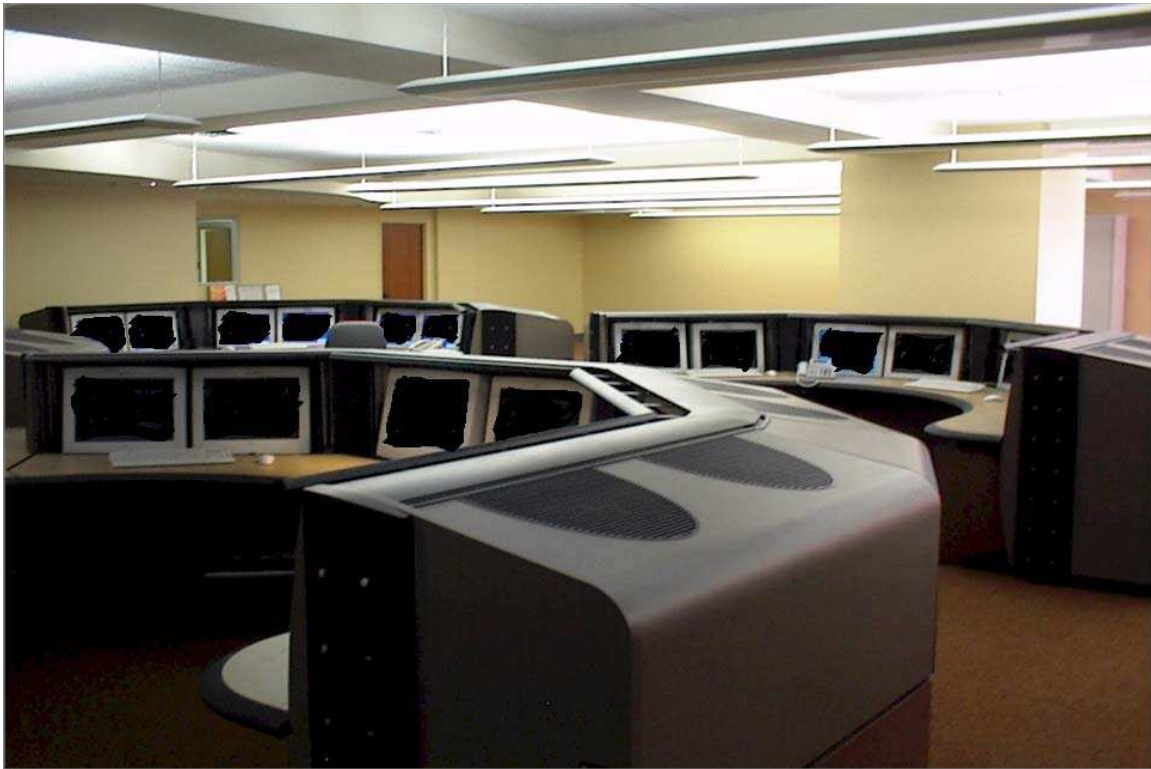
*Figure 2a: Typical Similar Operators Console on July 25 & 26, 2010 at the control center, Source: Enbridge.*

At start up and shut down operations, the operators through the means of computer with SCADA control capabilities send commands to the respective pumps and valves in the field. In addition to a separate computer database that houses the operation procedures and for administrative communications not shown in the figure below, the simulator console comprises three different monitor screens showing several computer window displays for various pipelines. These screens display information such as the pumps, MBS, pipelines, unacknowledged alarm panel, historical SCADA data and valves displays (see figure 2). But a typical console at the time of Line 6B pipeline rupture incident had up to eight smaller sized monitors per console (see figure 2a).

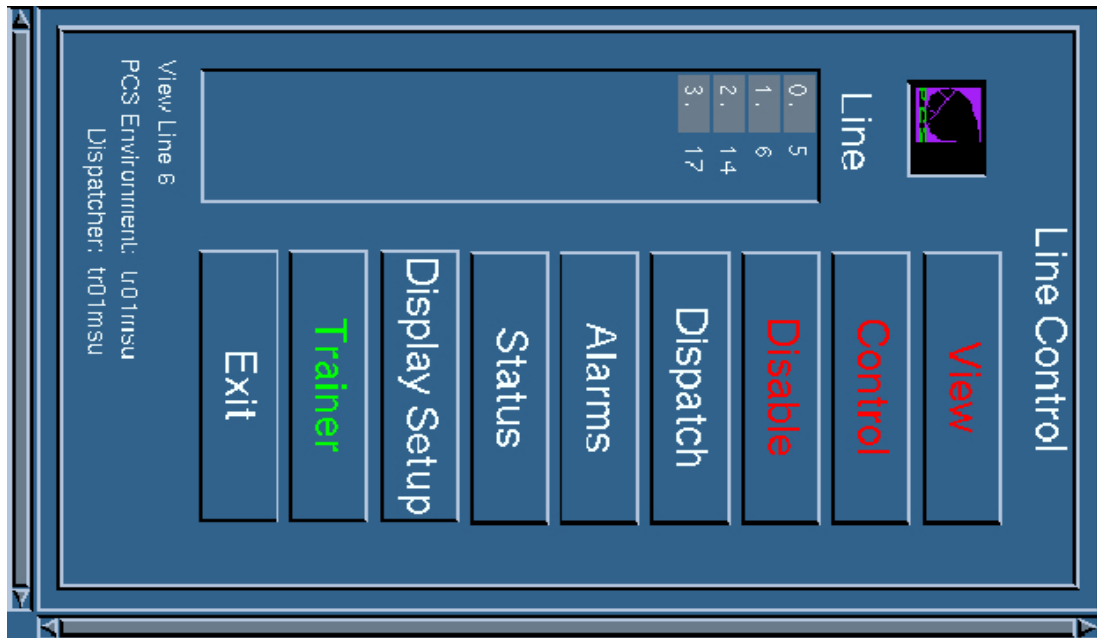
*Figure 3b: Line Control Panel on February 1, 2012, Source: Enbridge Energy (NTSB: IR 351)*

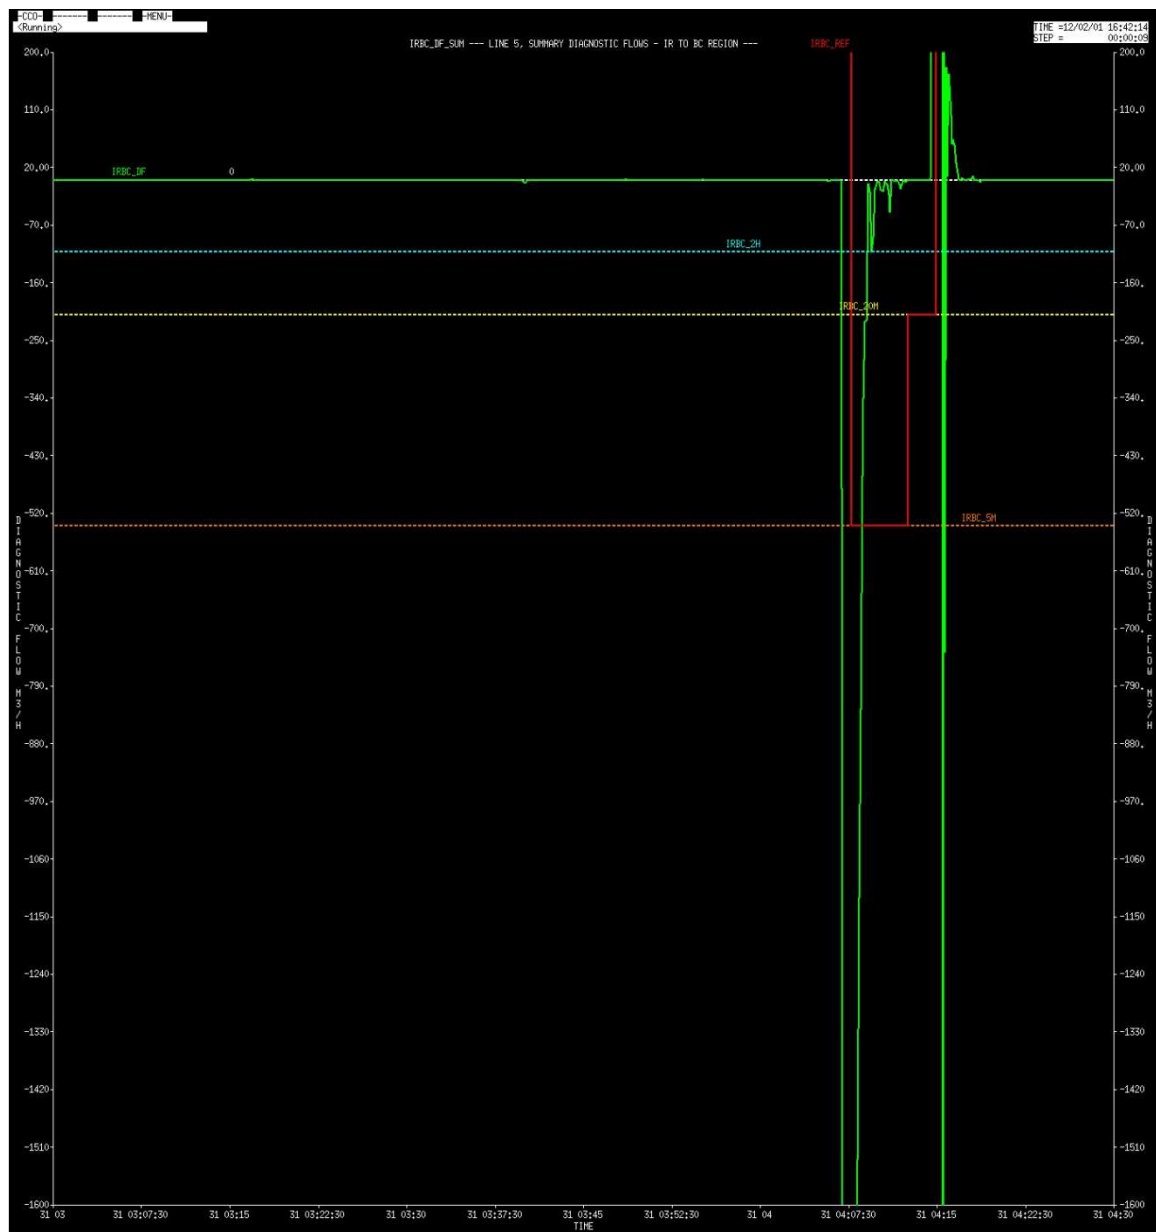
Figure 19: MBS Diagnostic Flow Summary – - NTSB/PHMSA IR 358, Source: Enbridge N0.172945
