National Transportation Safety Board

CONTROL ROOM AND SUPERVISORY CONTROL AND DATA ACQUISITION (SCADA) GROUP CHAIRMAN FACTUAL REPORT.

A. Accident

Accident Number: DCA-10-MP-007
Type of System: Liquid Transmission Pipeline
Accident Type: Pipeline Rupture
Location: Marshall, Michigan
Date: July 25, 2010
Time: about 5:57pm
Owner/Operator: Enbridge Energy, Limited Partnership
Material Released: Crude Oil
Pipeline Pressure: 520 Psig
Component Affected: 30-inch diameter pipeline.

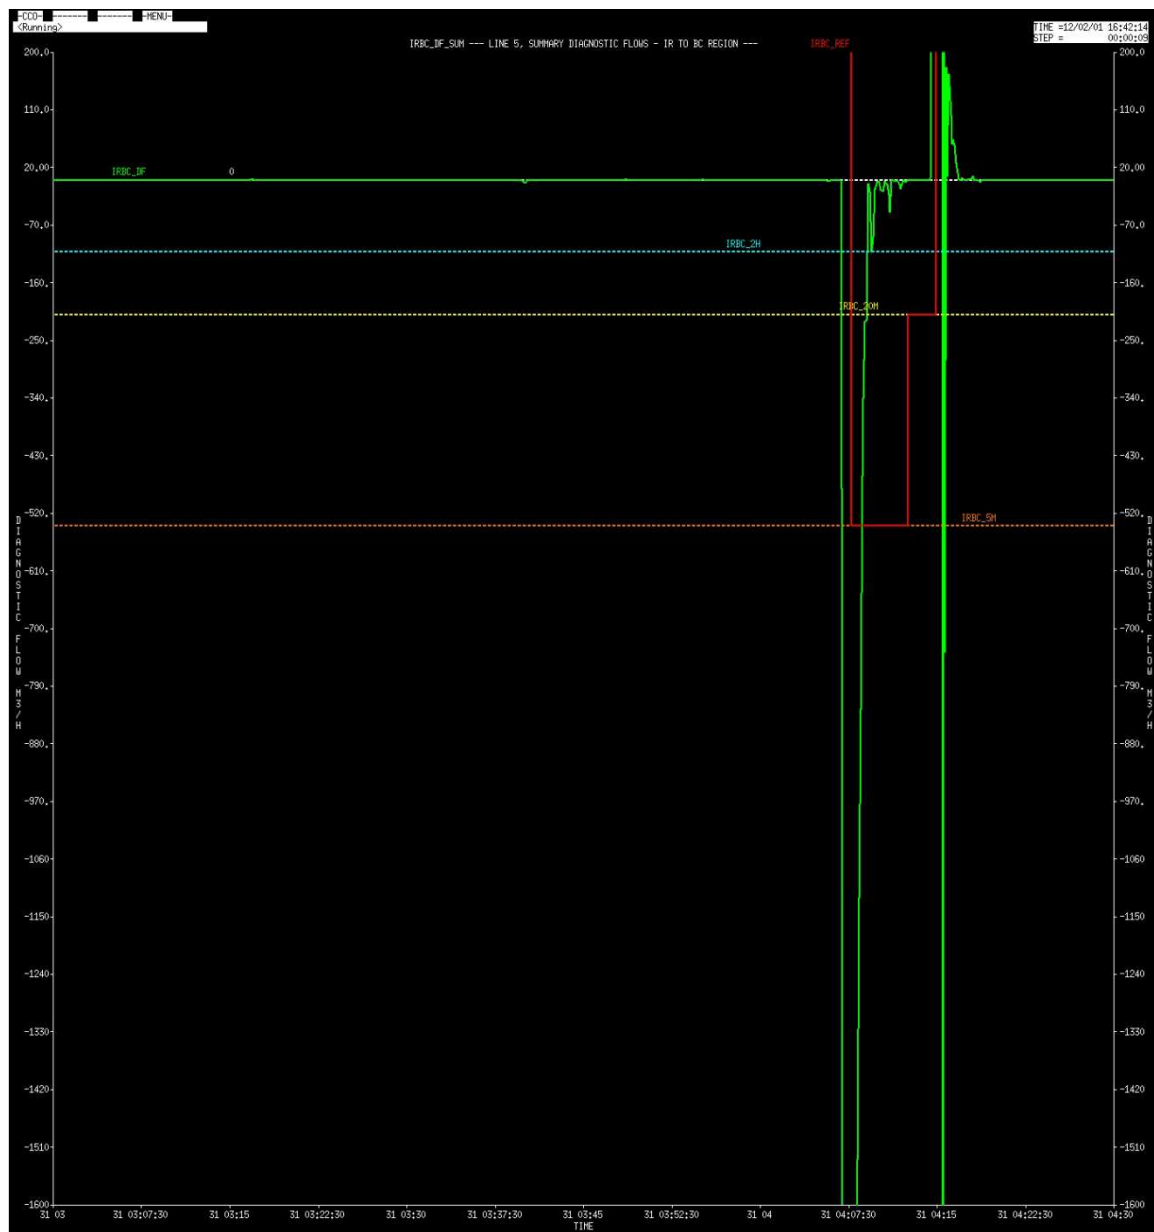
Figure 19: MBS Diagnostic Flow Summary – - NTSB/PHMSA IR 358, Source: Enbridge N0.172945
