IN THE UNITED STATES DISTRICT COURT
FOR THE DISTRICT OF ARIZONA

Case No. 4:15-cv-00250-TUC-DCB

**DECLARATION OF ELDON VAIL
IN SUPPORT OF PLAINTIFFS'
MOTION FOR PRELIMINARY
INJUNCTION**

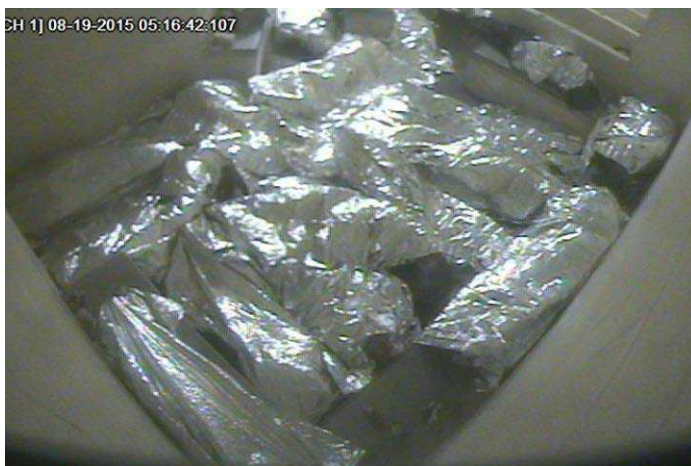
9 (Ex. 188).

16 32. Surveillance video from Tucson Station reveals that Defendants routinely
17 pack so many individuals into holding cells that detainees are commonly forced to lie
18 down on the concrete floors beneath the toilet stalls. Others are crammed so tightly, they
19 look like sardines in a can, with no room to move in any direction without rolling over
20 someone else:

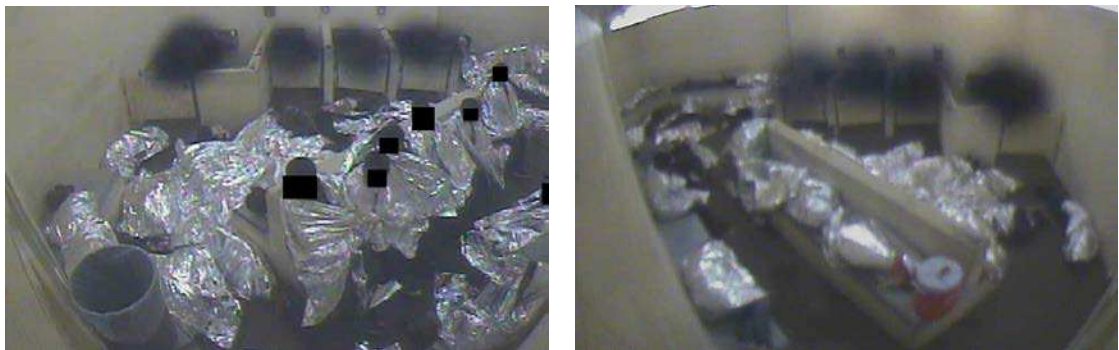
3 52. Although CBP apparently has no policies with respect to how often the Hold
 4 Rooms must be cleaned, surveillance footage from Casa Grande station shows hold rooms
 5 being cleaned once per 48 hours, if that. (Coles Decl. ¶ 41.) There are no cleaning
 6 supplies in the hold rooms and, according to detainees, the rooms often lacked a trash can.
 7 (ECF No. 2-1, Ex. 8 ¶ 11; *id.*, Ex. 16 ¶ 25; *id.*, Ex. 43 ¶ 15.) This means, effectively, that
 8 the Hold Rooms are hardly ever clean and that the areas around the toilets are generally
 9 dirty. (ECF No. 2-1, Ex. 8 ¶ 11 (diapers, toilet paper and other trash was strewn around
 10 the bathroom area); ECF No. 2-3, Ex. 35 ¶ 24 (1 toilet backed up and smelled terrible).)
 11 Unfortunately, this fact does not stop the overcrowding of the cells which makes it
 12 necessary for some detainees to lie down very close to those toilets in order to find a place

13 to sleep:

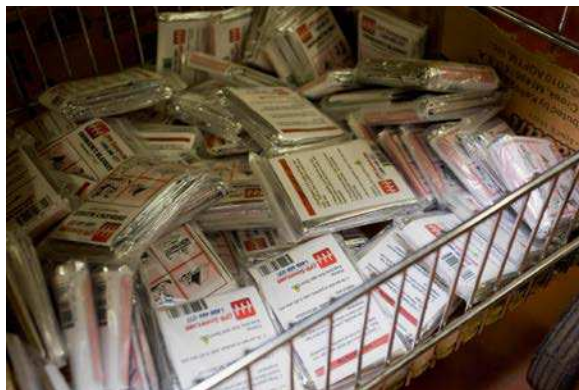
21 (Ex. 4.)

11 55. The only coverings I found were thin sheets made of Mylar, a material
12 similar in appearance to, but more durable than, aluminum. These sheets are almost paper
13 thin, but are referred to by CBP agents as “Mylar blankets”:

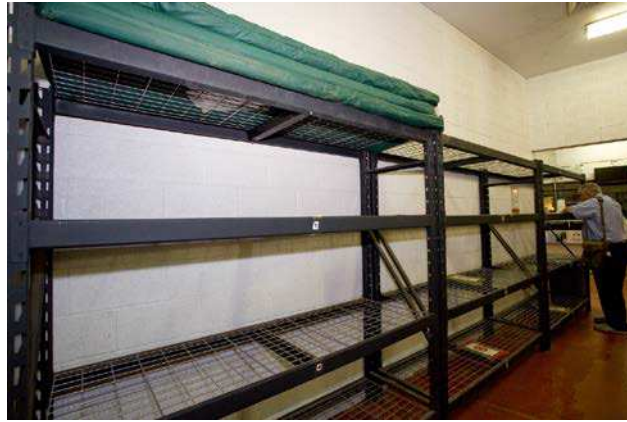
(Ex. 3.)

25 57. During my inspection of Casa Grande station, there were only three mats in
26 the entire facility:

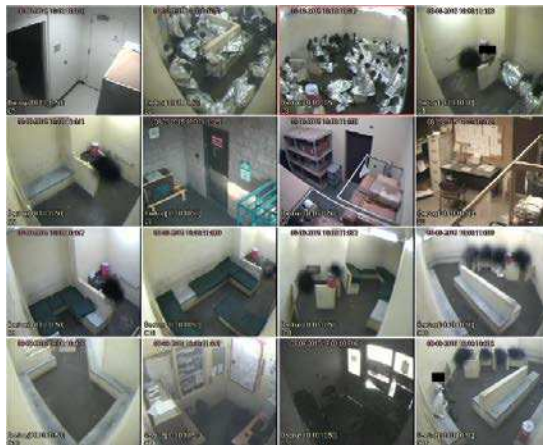
(Ex. 170; *see also* Ex. 147.)

59. Surveillance video from some of these stations often shows detainees lying on the concrete floors while, at the exact same moment in time in the same station, mats go unused in other unoccupied or less occupied cells:

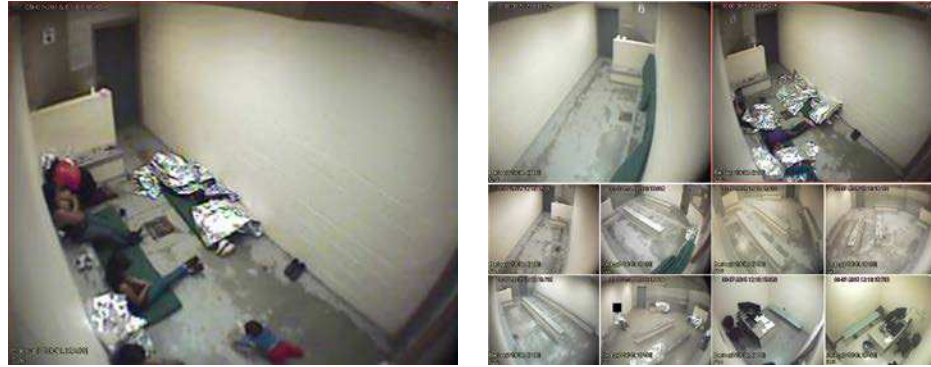
(Ex. 146, 147; *see also* Ex. 155.)

60. Surveillance video also shows families and children confined in cells with too few or no mats:

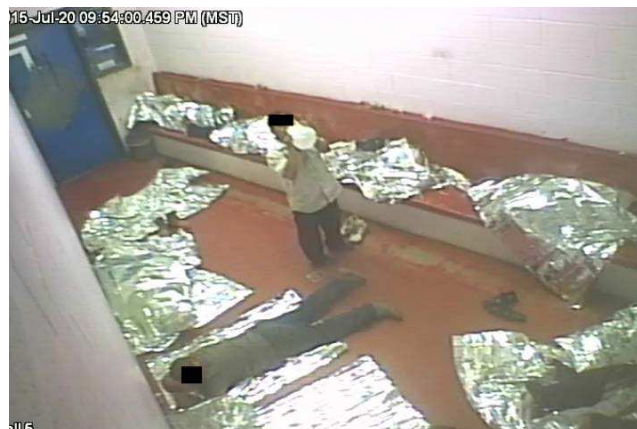
1 (Ex. 130; *see also* Exs. 125, 129, 130, 133, 141.)

18 81. This testimony is confirmed by surveillance video of the Casa Grande which
19 shows at least a dozen different detainees drinking from the same 1-gallon water jug over
20 the course of 5 days:

2 82. The jug was never replaced or cleaned, despite the cell being swept by
3 maintenances crews on several occasions over the course of the 5 days it was used.

1 regularly and repaired quickly when they are broken. If they wish to continue using water
2 jugs as part of their water delivery system, the regular cleaning and refilling of those jugs
3 should be scheduled and logged. In no case should detainees be expected to share the
4 same cups or drink from the same gallon jug as they present an obvious risk of the spread
5 of contagious disease.

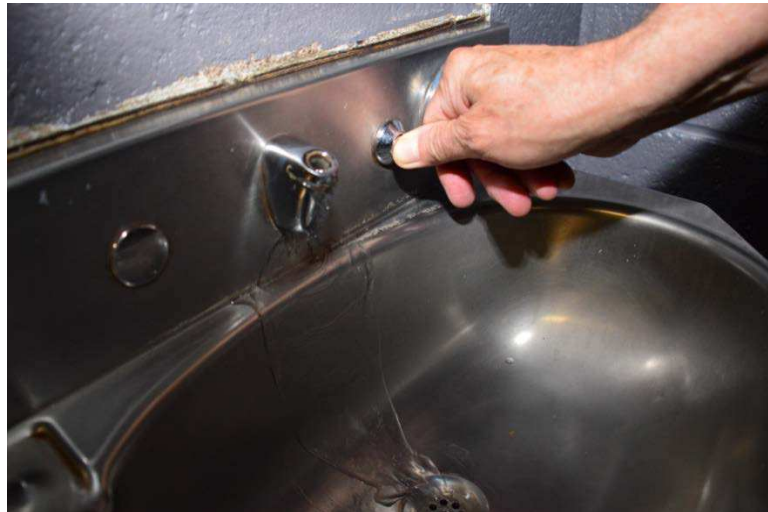
19 (Ex. 31.)

5 83. In hold rooms with “bubblers” to dispense drinking water, these were
6 usually located just above or adjacent to the toilets, often as part of the same metal
7 toilet/sink unit. During each of my inspections of the four stations, I observed numerous
8 bubblers that did not work or had extremely low water pressure. One example of a
9 malfunctioning bubbler is shown in the picture below:

20 84. In general, I believe that the problem with the bubblers is the same as with
21 the toilets—they are subject to overuse as there are not enough of them for the numbers of
22 detainees placed in the holding cells⁶ and they are not regularly inspected and repaired.
