IN THE UNITED STATES DISTRICT COURT  
FOR THE DISTRICT OF ARIZONA

Case No. 4:15-cv-00250-TUC-DCB

**DECLARATION OF ELDON VAIL  
IN SUPPORT OF PLAINTIFFS'  
MOTION FOR PRELIMINARY  
INJUNCTION**

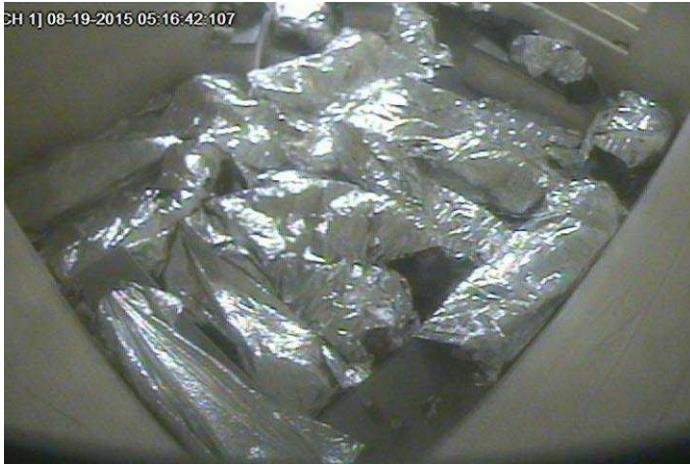
9 (Ex. 188).

16 32. Surveillance video from Tucson Station reveals that Defendants routinely  
17 pack so many individuals into holding cells that detainees are commonly forced to lie  
18 down on the concrete floors beneath the toilet stalls. Others are crammed so tightly, they  
19 look like sardines in a can, with no room to move in any direction without rolling over  
20 someone else:

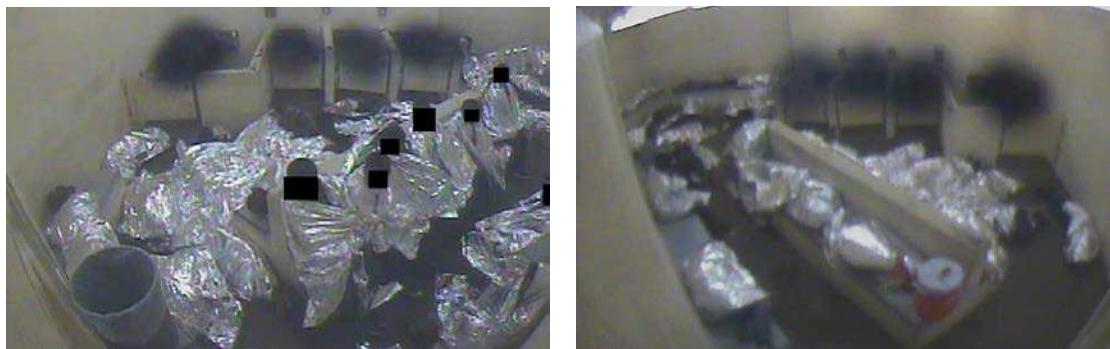
3 52. Although CBP apparently has no policies with respect to how often the Hold  
 4 Rooms must be cleaned, surveillance footage from Casa Grande station shows hold rooms  
 5 being cleaned once per 48 hours, if that. (Coles Decl. ¶ 41.) There are no cleaning  
 6 supplies in the hold rooms and, according to detainees, the rooms often lacked a trash can.  
 7 (ECF No. 2-1, Ex. 8 ¶ 11; *id.*, Ex. 16 ¶ 25; *id.*, Ex. 43 ¶ 15.) This means, effectively, that  
 8 the Hold Rooms are hardly ever clean and that the areas around the toilets are generally  
 9 dirty. (ECF No. 2-1, Ex. 8 ¶ 11 (diapers, toilet paper and other trash was strewn around  
 10 the bathroom area); ECF No. 2-3, Ex. 35 ¶ 24 (1 toilet backed up and smelled terrible).)  
 11 Unfortunately, this fact does not stop the overcrowding of the cells which makes it  
 12 necessary for some detainees to lie down very close to those toilets in order to find a place

13 to sleep:

14  
 15  
 16  
 17  
 18  
 19 (Ex. 173, 174; Ex. 152; *see also* ECF No. 2-2, Ex. 32 ¶ 10 (people were so tightly packed  
 20 into the cell some had to sleep in the bathroom area); *id.*, Ex. 17 ¶ 7 (same); ECF No. 2-1,  
 21 Ex. 7 ¶ 13 (one detainee sat upright on the concrete floor for two nights, finding it  
 22 impossible to sleep more than a couple of hours during the time he was detained); *id.*,  
 23 Ex. 11 ¶ 12 (several detainees explained that in order to find space to sleep on the floor,  
 24 some detainees resorted to sleeping next to toilets.).) In essence, the design of the Hold  
 25 Rooms mean that the person using the toilet and the person trying to sleep both experience  
 26  
 27  
 28

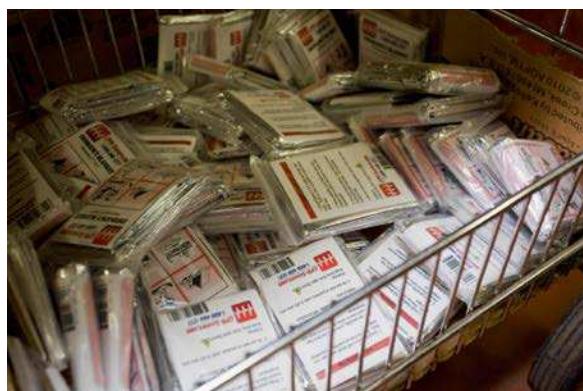
21 (Ex. 4.)

11       55. The only coverings I found were thin sheets made of Mylar, a material  
 12 similar in appearance to, but more durable than, aluminum. These sheets are almost paper  
 13 thin, but are referred to by CBP agents as “Mylar blankets”:

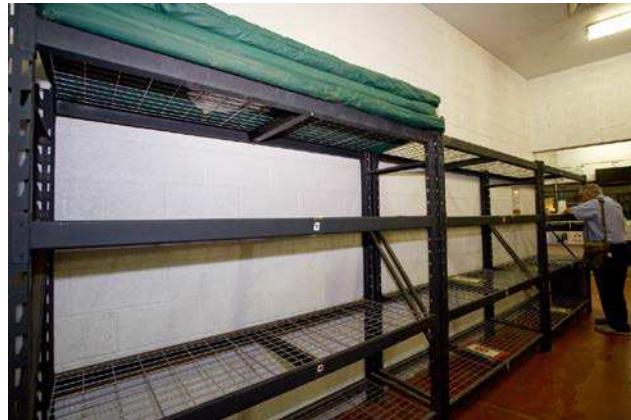
(Ex. 3.)

25       57. During my inspection of Casa Grande station, there were only three mats in  
 26 the entire facility:

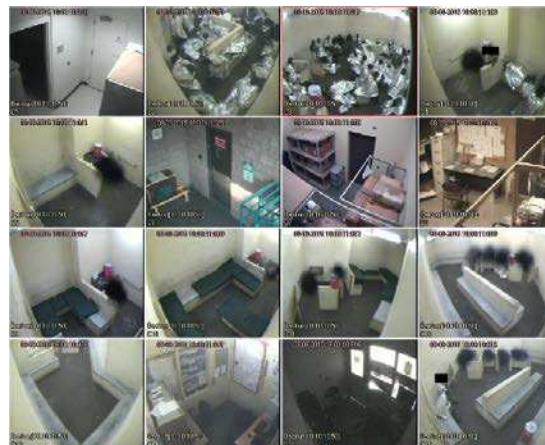
(Ex. 170; *see also* Ex. 147.)

59. Surveillance video from some of these stations often shows detainees lying on the concrete floors while, at the exact same moment in time in the same station, mats go unused in other unoccupied or less occupied cells:

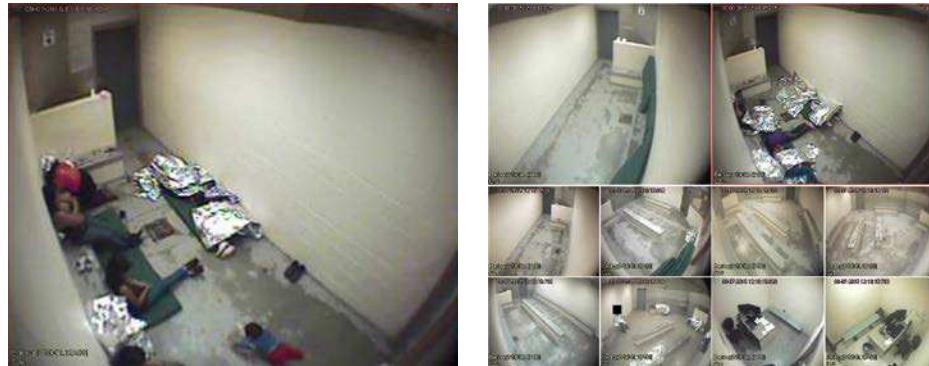
(Ex. 146, 147; *see also* Ex. 155.)

60. Surveillance video also shows families and children confined in cells with too few or no mats:

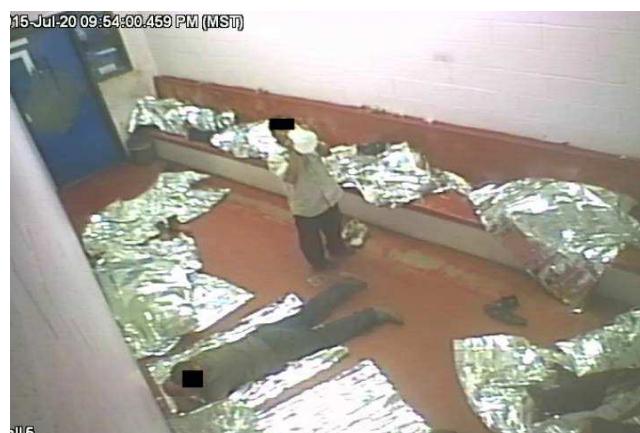
1 (Ex. 130; *see also* Exs. 125, 129, 130, 133, 141.)

18       81. This testimony is confirmed by surveillance video of the Casa Grande which  
 19 shows at least a dozen different detainees drinking from the same 1-gallon water jug over  
 20 the course of 5 days:

2 82. The jug was never replaced or cleaned, despite the cell being swept by  
 3 maintenances crews on several occasions over the course of the 5 days it was used.  
 4 (Coles Decl. ¶ 46.)

1 regularly and repaired quickly when they are broken. If they wish to continue using water  
 2 jugs as part of their water delivery system, the regular cleaning and refilling of those jugs  
 3 should be scheduled and logged. In no case should detainees be expected to share the  
 4 same cups or drink from the same gallon jug as they present an obvious risk of the spread  
 5 of contagious disease.

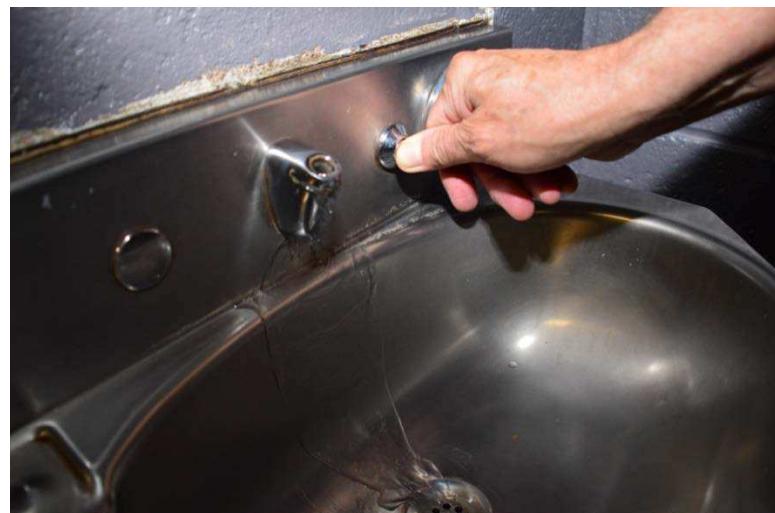
10  
 11  
 12  
 13  
 14  
 15  
 16  
 17  
 18 (Ex. 31.)

5 83. In hold rooms with “bubblers” to dispense drinking water, these were  
 6 usually located just above or adjacent to the toilets, often as part of the same metal  
 7 toilet/sink unit. During each of my inspections of the four stations, I observed numerous  
 8 bubblers that did not work or had extremely low water pressure. One example of a  
 9 malfunctioning bubbler is shown in the picture below:

19 84. In general, I believe that the problem with the bubblers is the same as with  
 20 the toilets—they are subject to overuse as there are not enough of them for the numbers of  
 21 detainees placed in the holding cells<sup>6</sup> and they are not regularly inspected and repaired.  
 22
