Re: **World View Balloon Rupture on December 19, 2017**

### WORLD VIEW DAMAGE ASSESSMENT REPORT

RE: World View Head Quarters Blast Damage Report  
Tucson, AZ  
SSE Project number: 116013

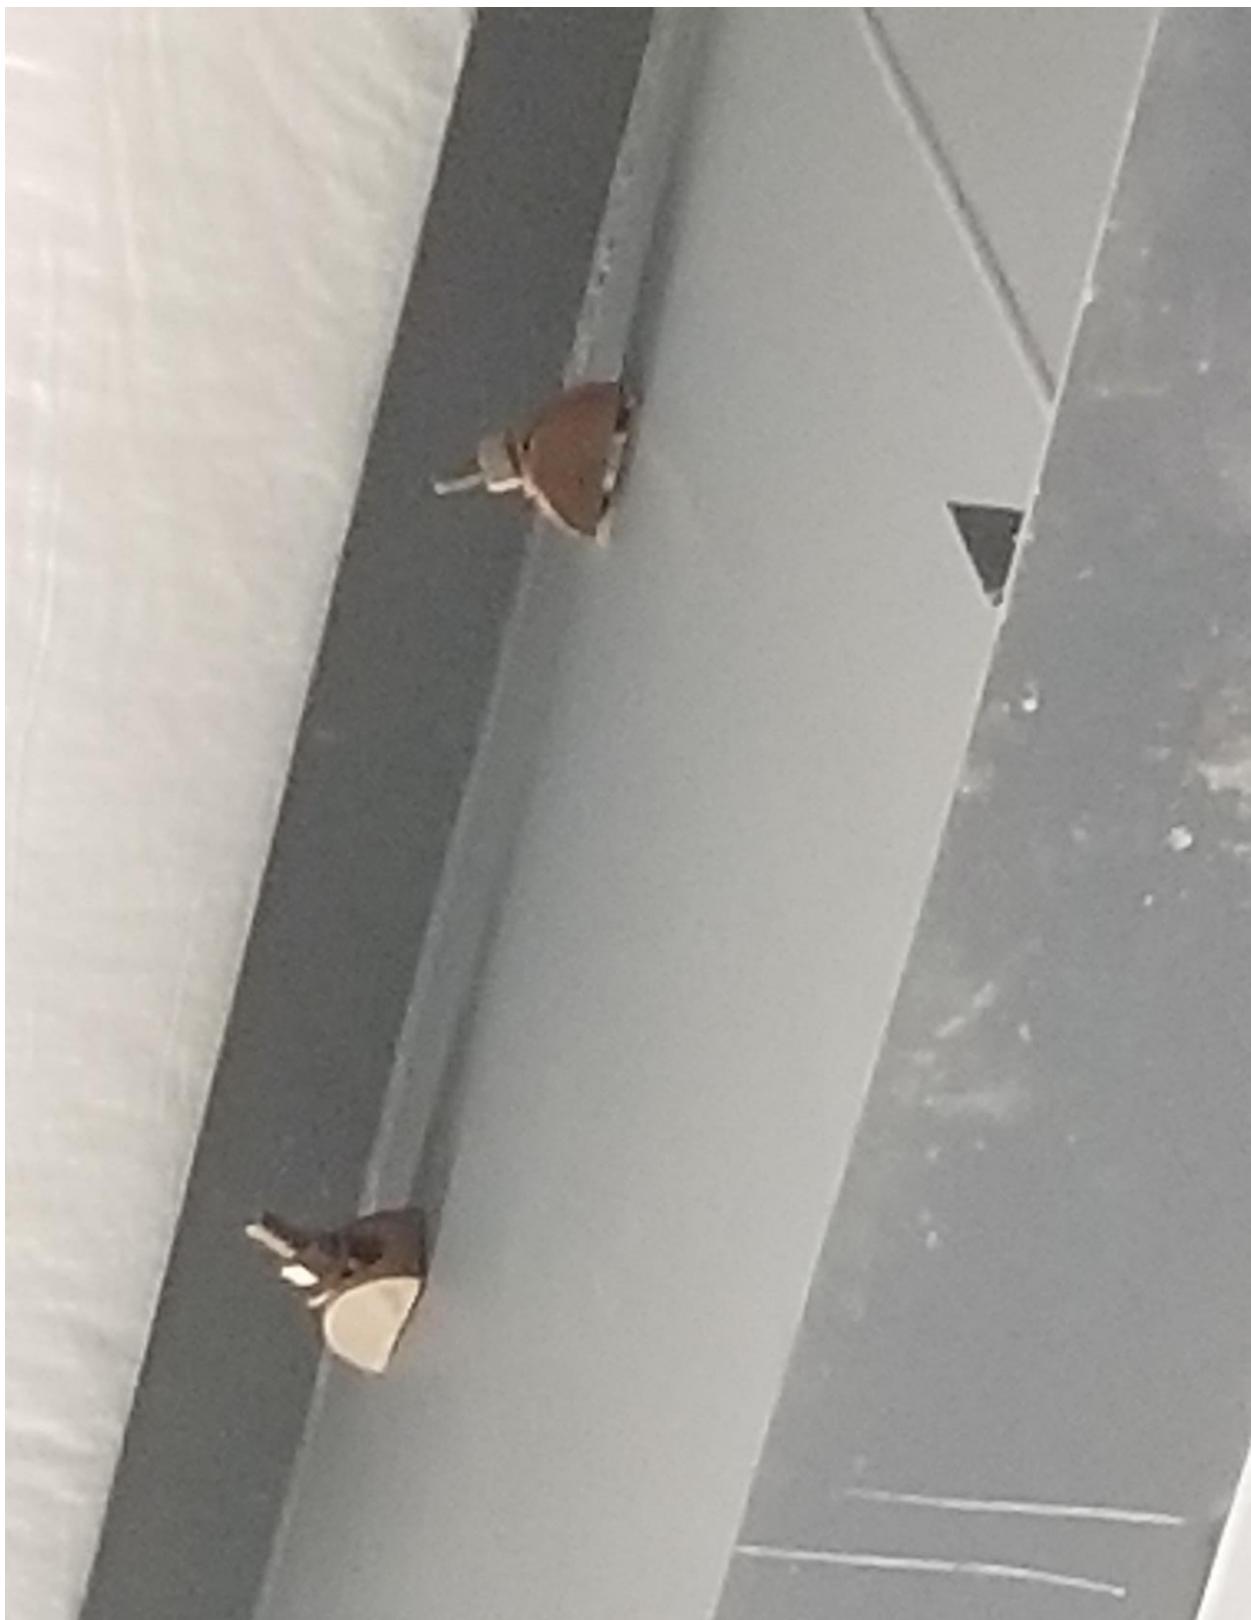
Photo #1 – Hillside washer displaced

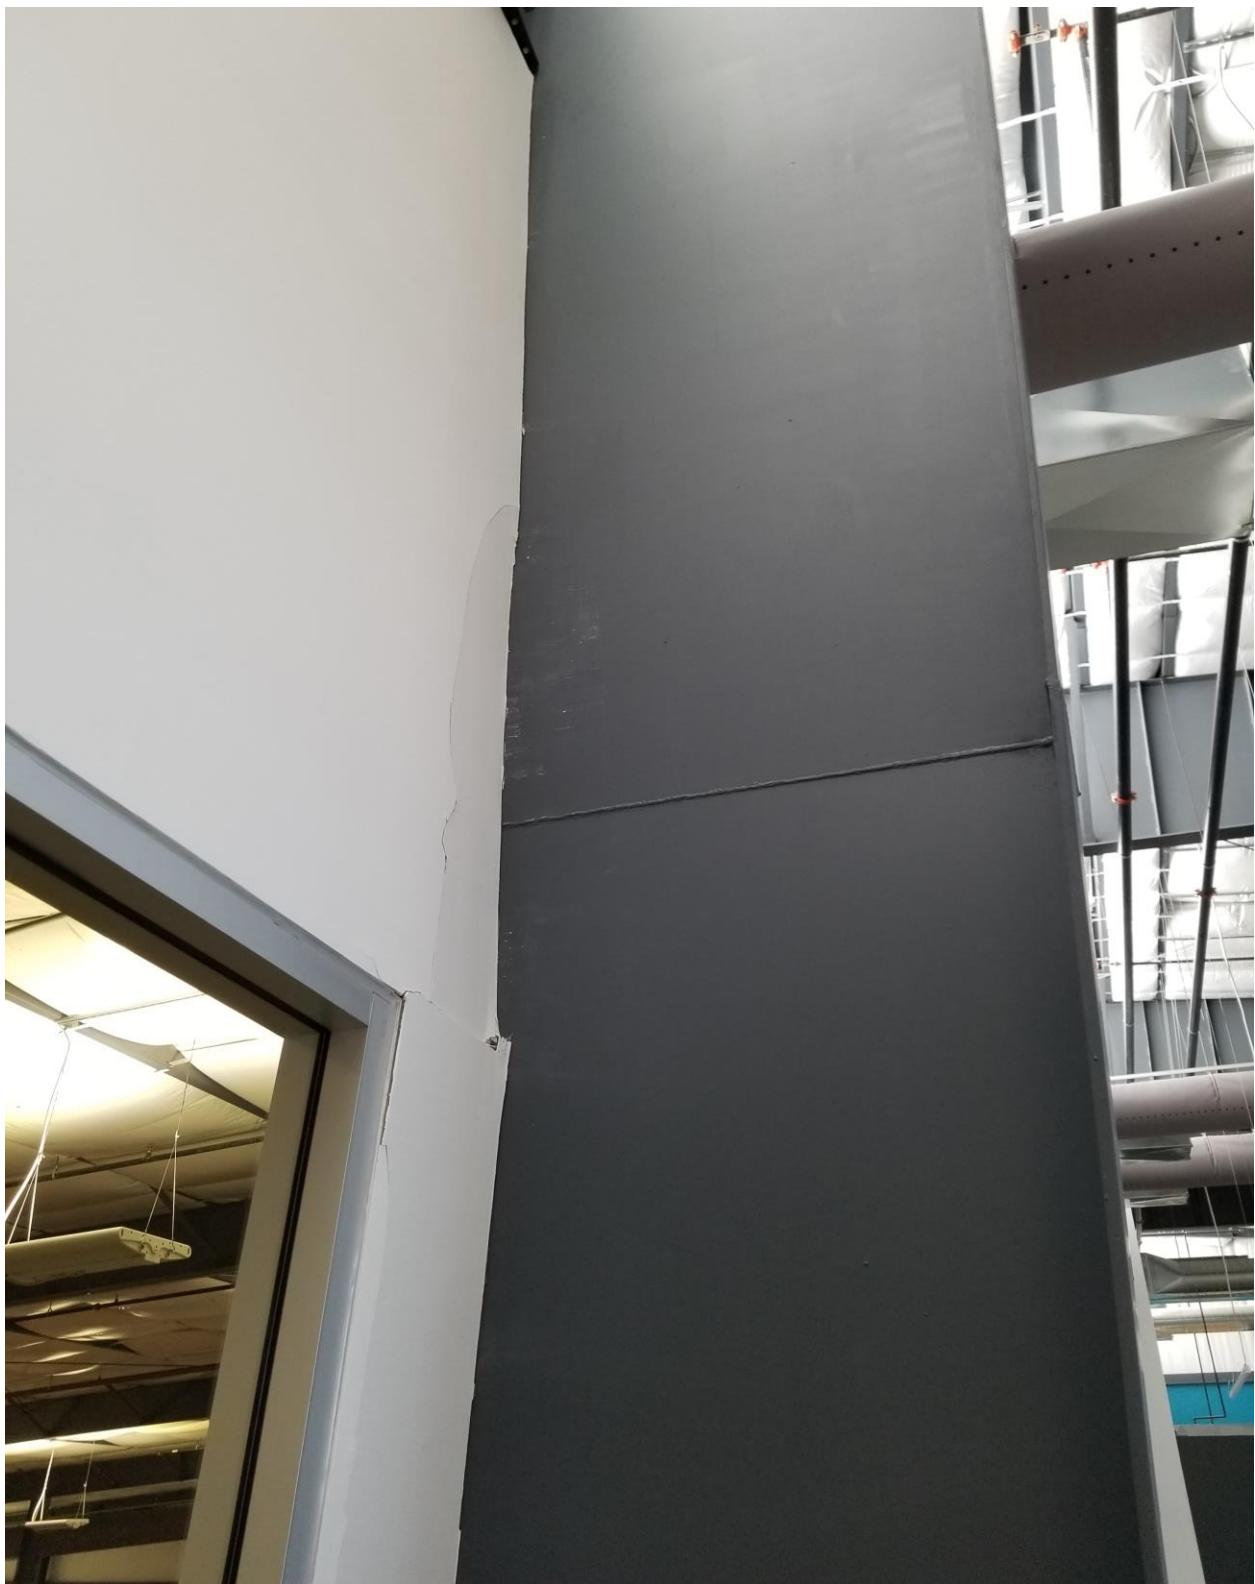
Light gage interior non-bearing walls overstressed and damaged. See photos 2 and 3.

Photo #2 – Interior non-bearing wall failure with marks on column showing amount of movement experienced.

Dismantle all interior walls at the mezzanine edges that look over the balloon and assemble bays and inspect and replace damaged drywall studs.

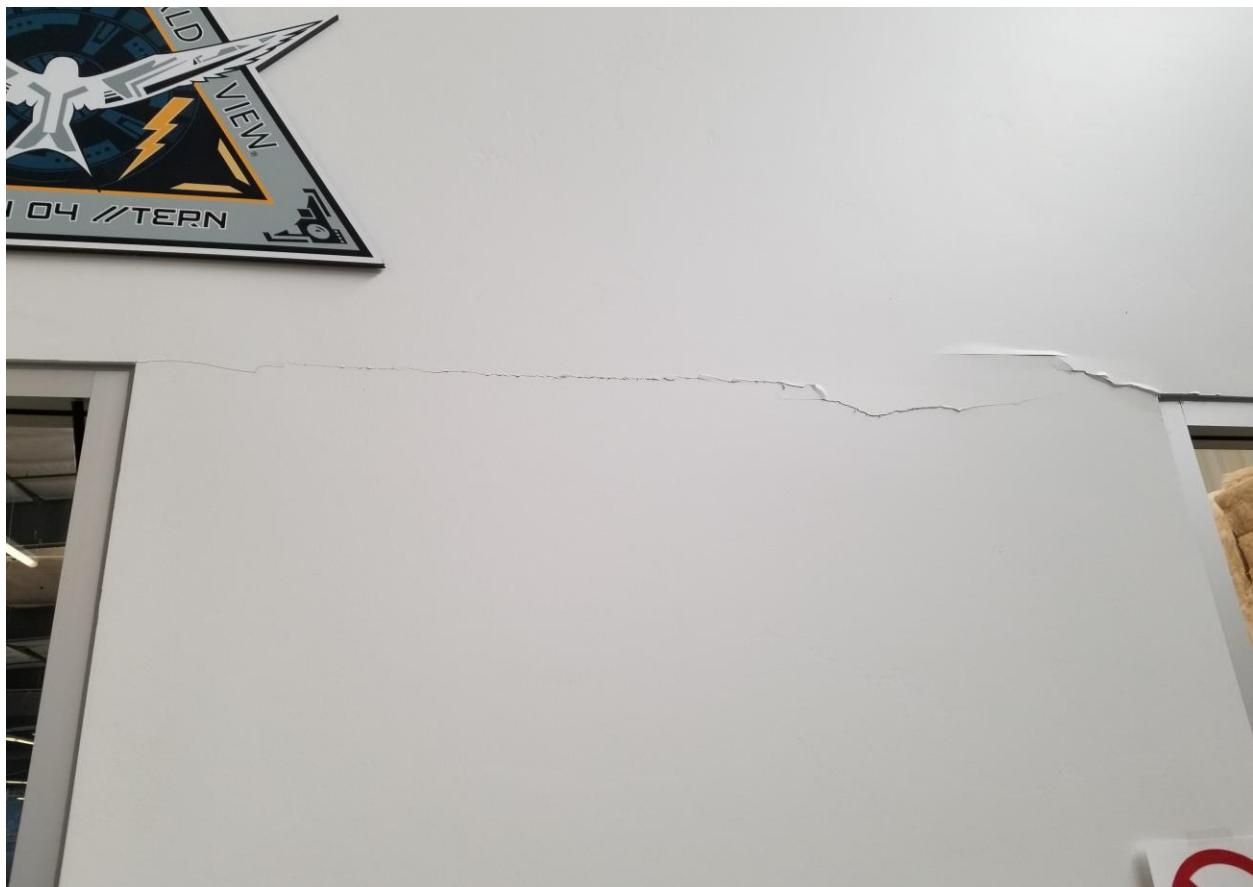
Photo #3 – Crack in observation wall failure

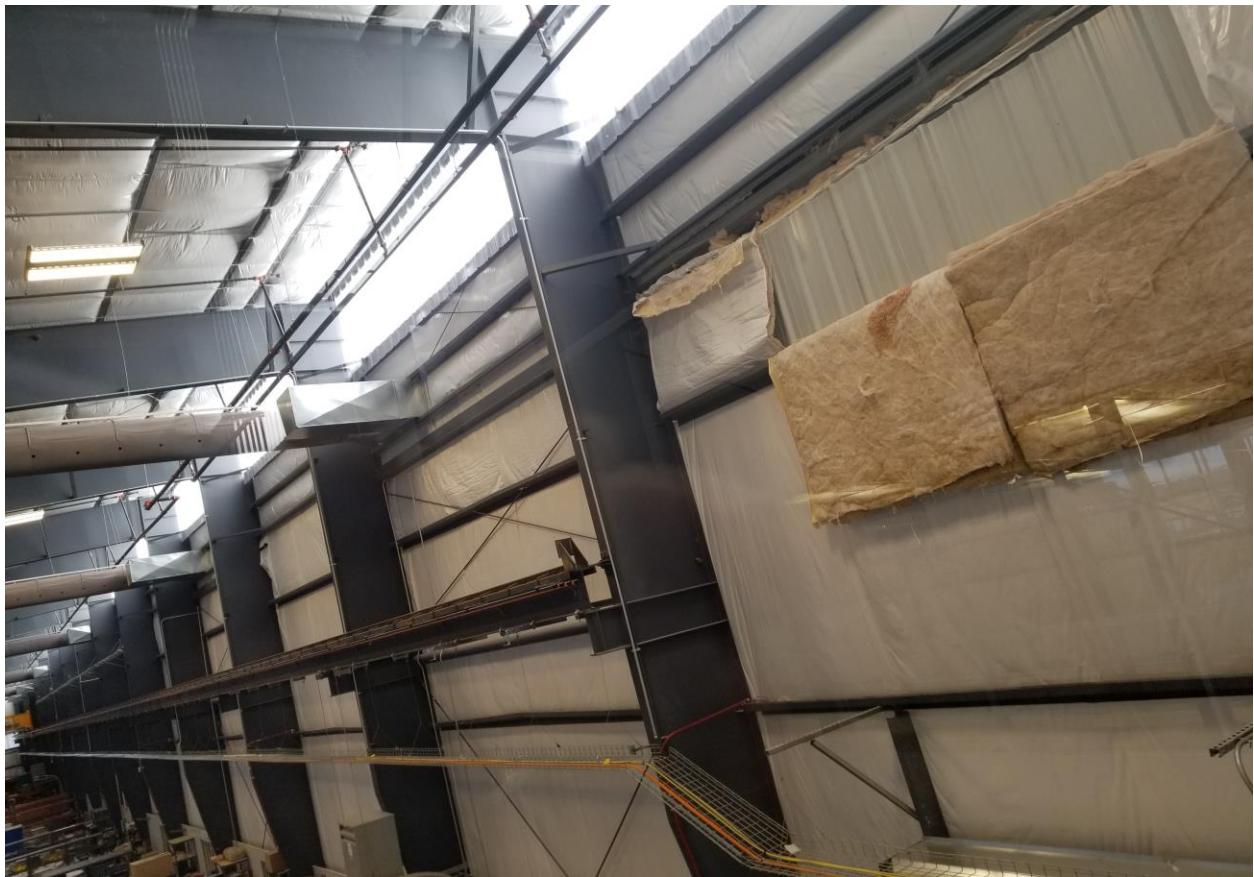
Photo #4 - Damage in high bay area showing girt damage

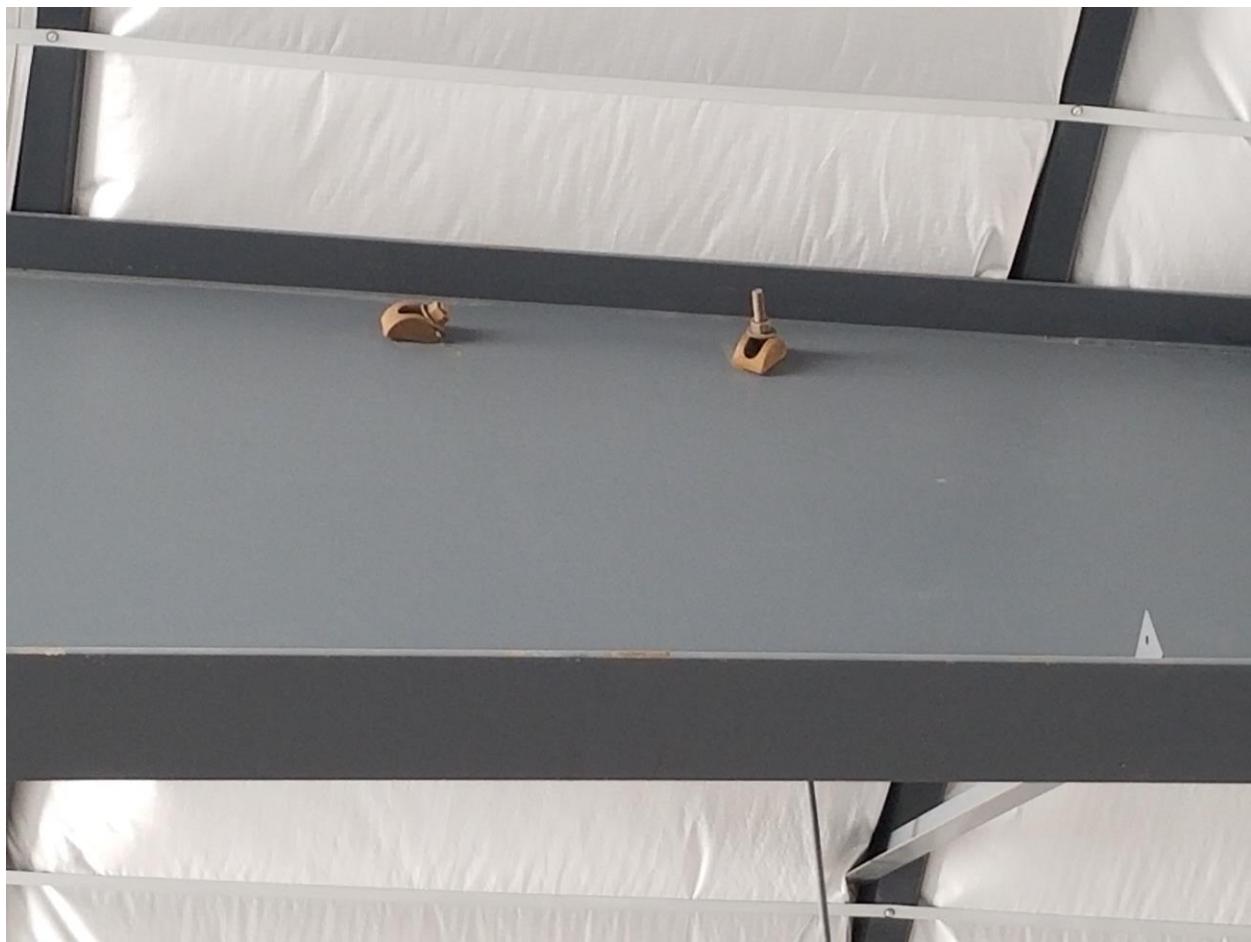
Photo #5 – More hillside washers displaced

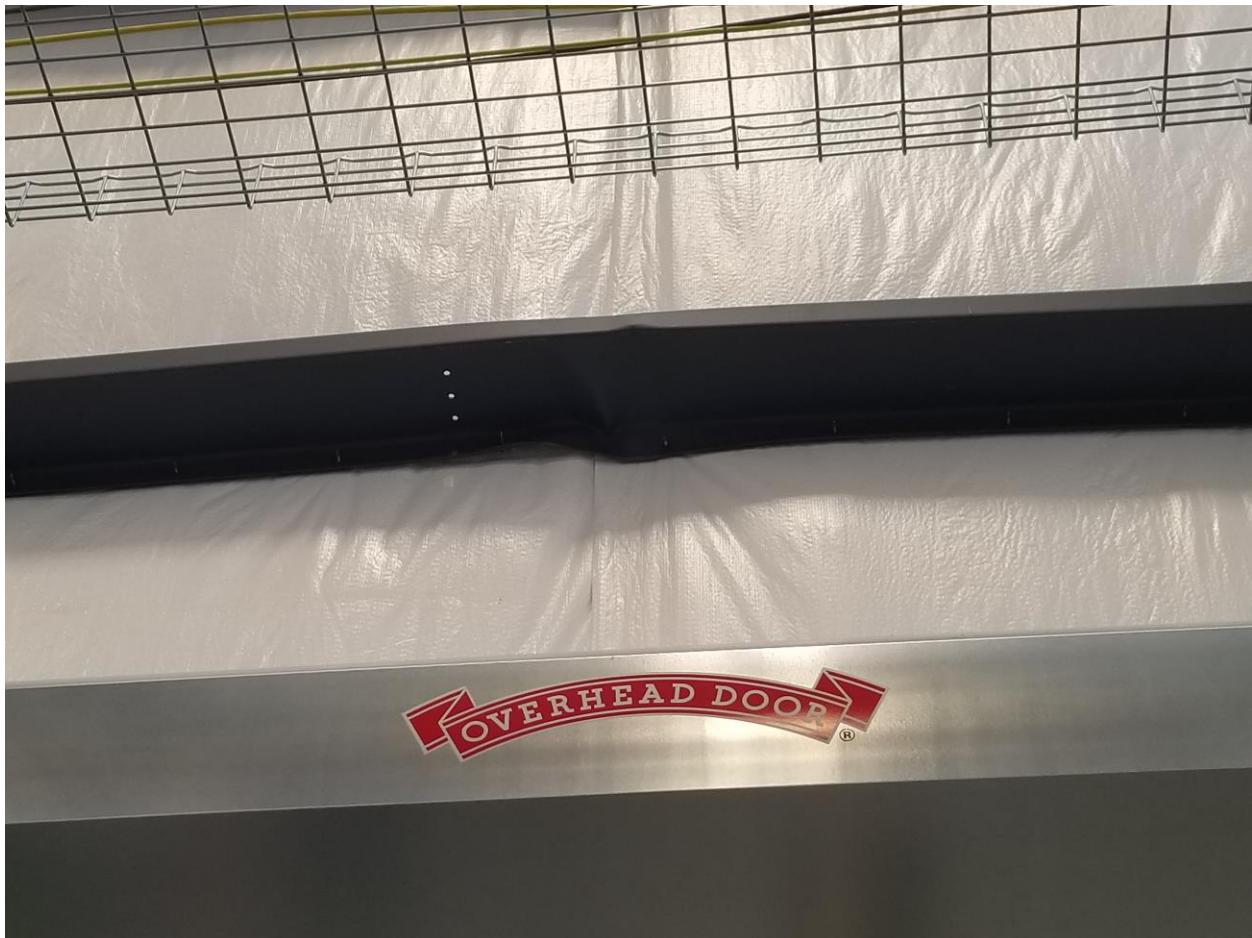
Photo #6 – Girt failure due to high internal pressures

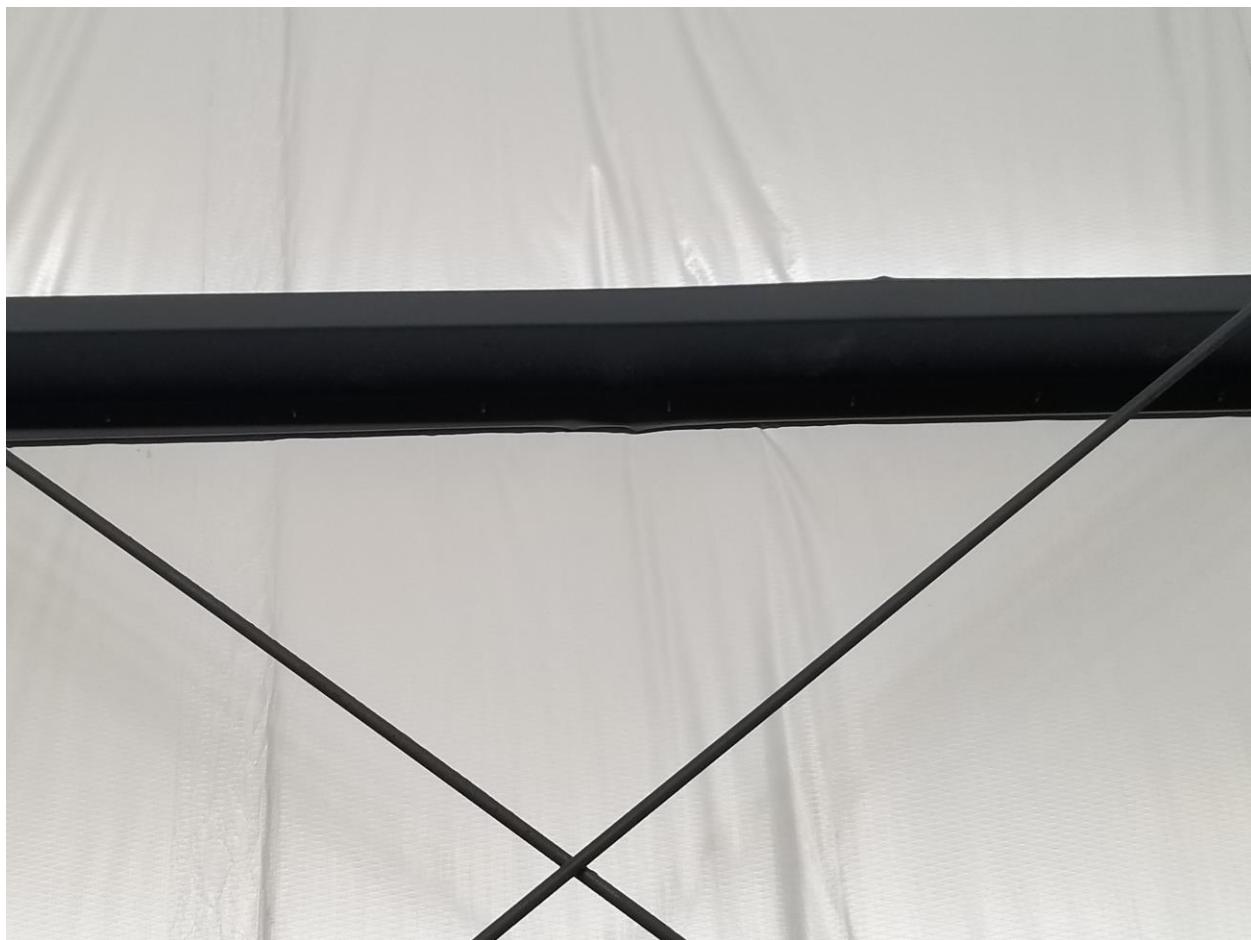
Photo #7 – More girt issues

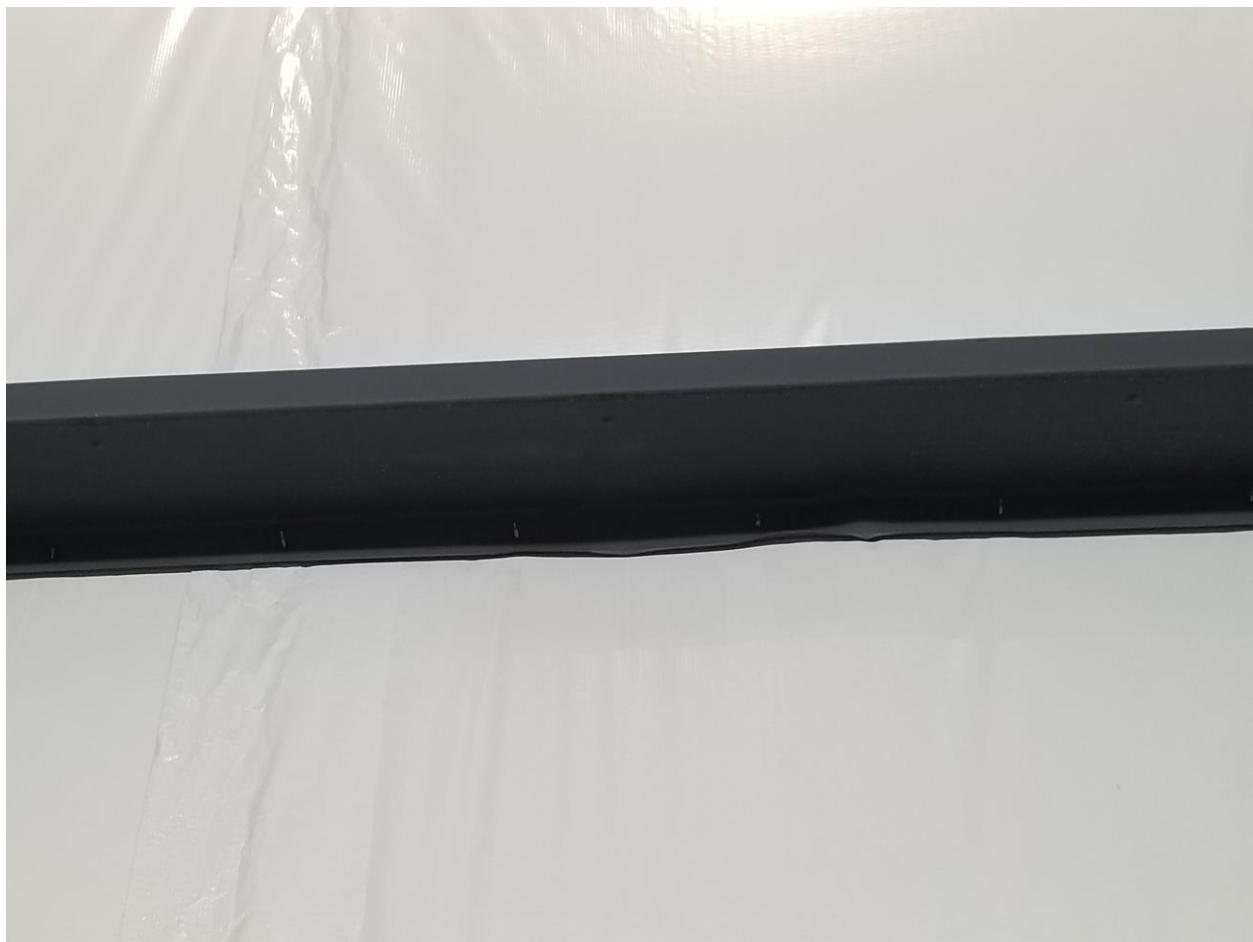
Photo #8 – More girt issues

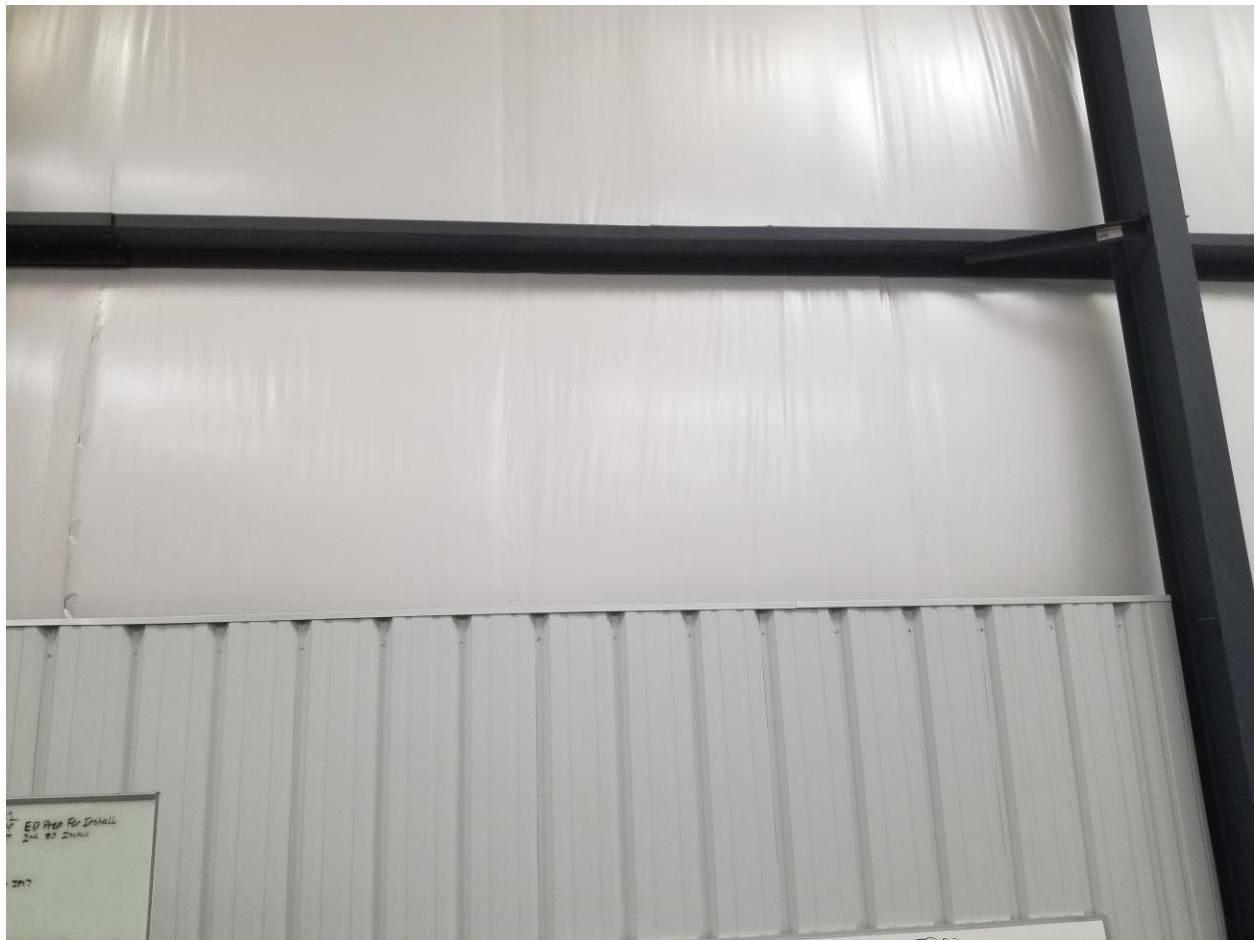
Photo #9 – More girt issues

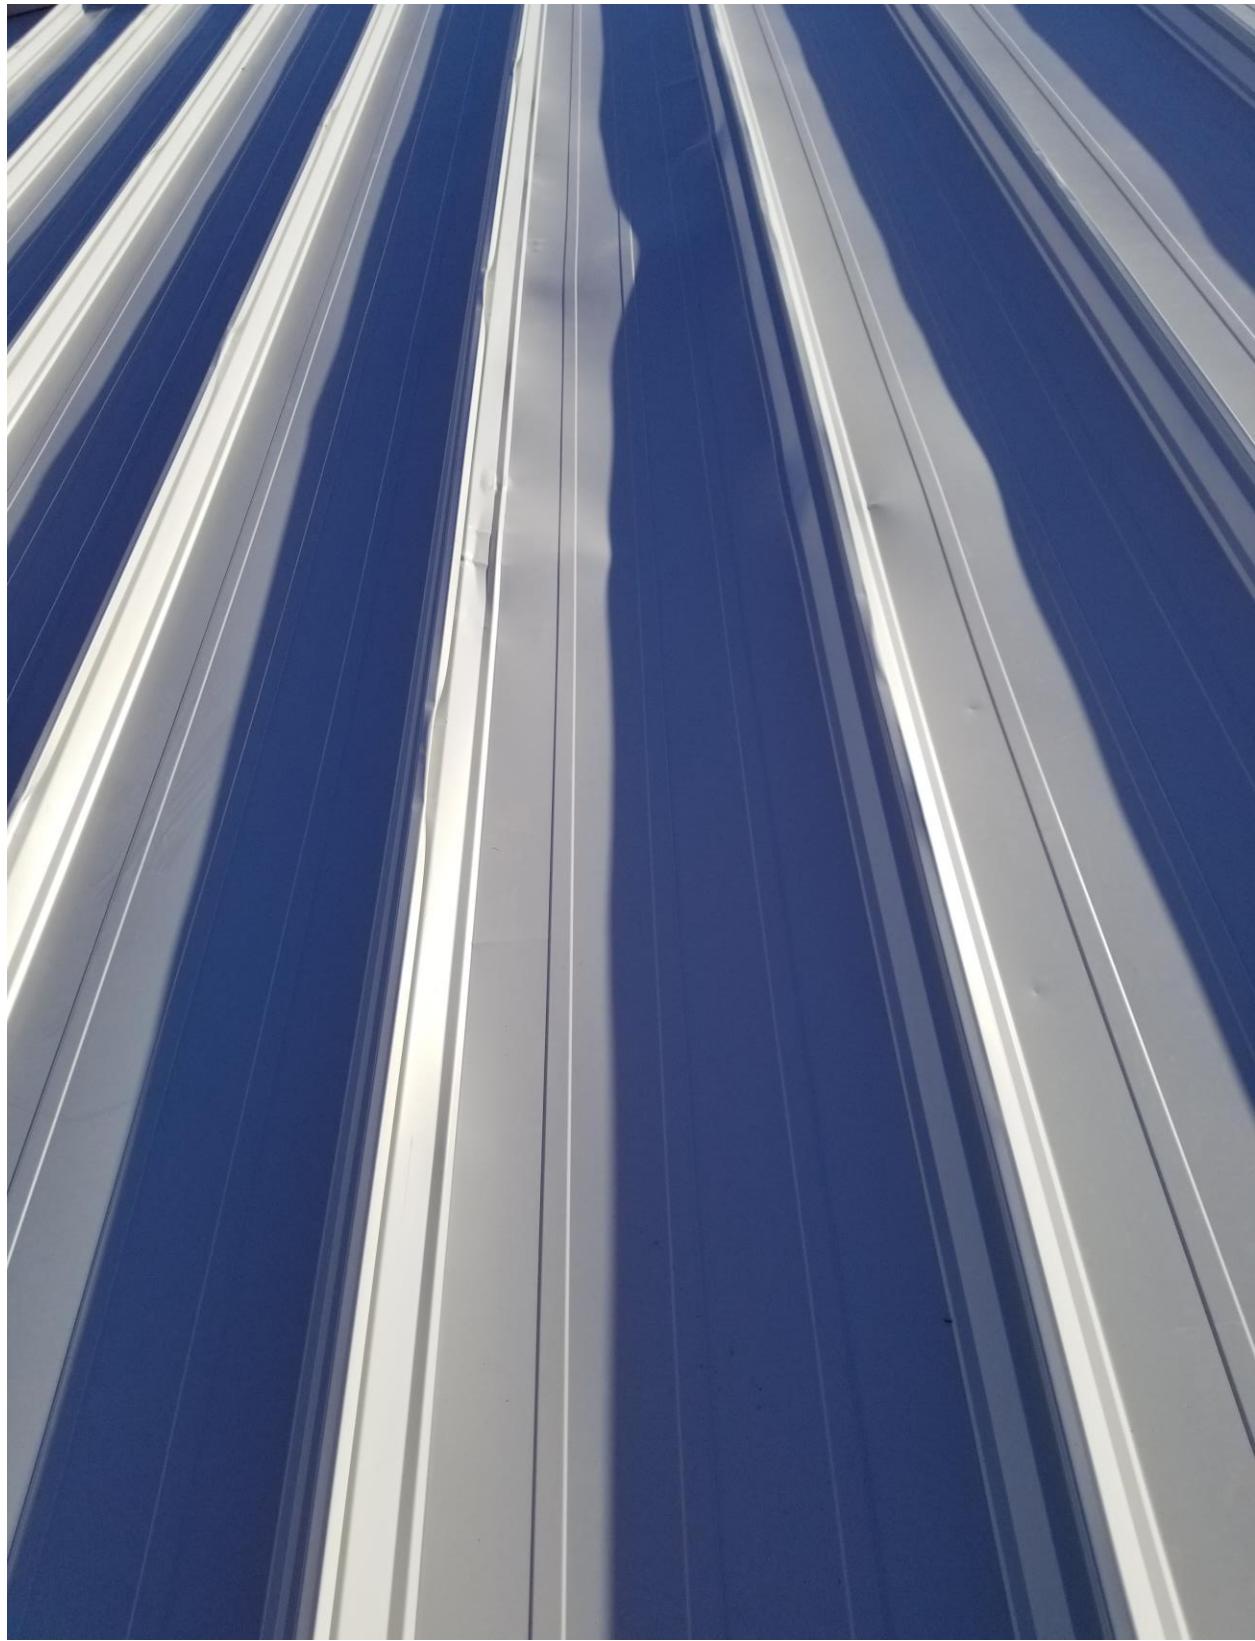
Roof panels damaged between and at roof supports due to uplift. See photos 10 – 13.

Photo #10 – Roof Panel issue due high internal pressures

Have metal building manufacturer review damaged roof panels to make sure that their waterproof features are still effective with the damage they experienced. If not, then the panels need to be repaired or replaced.

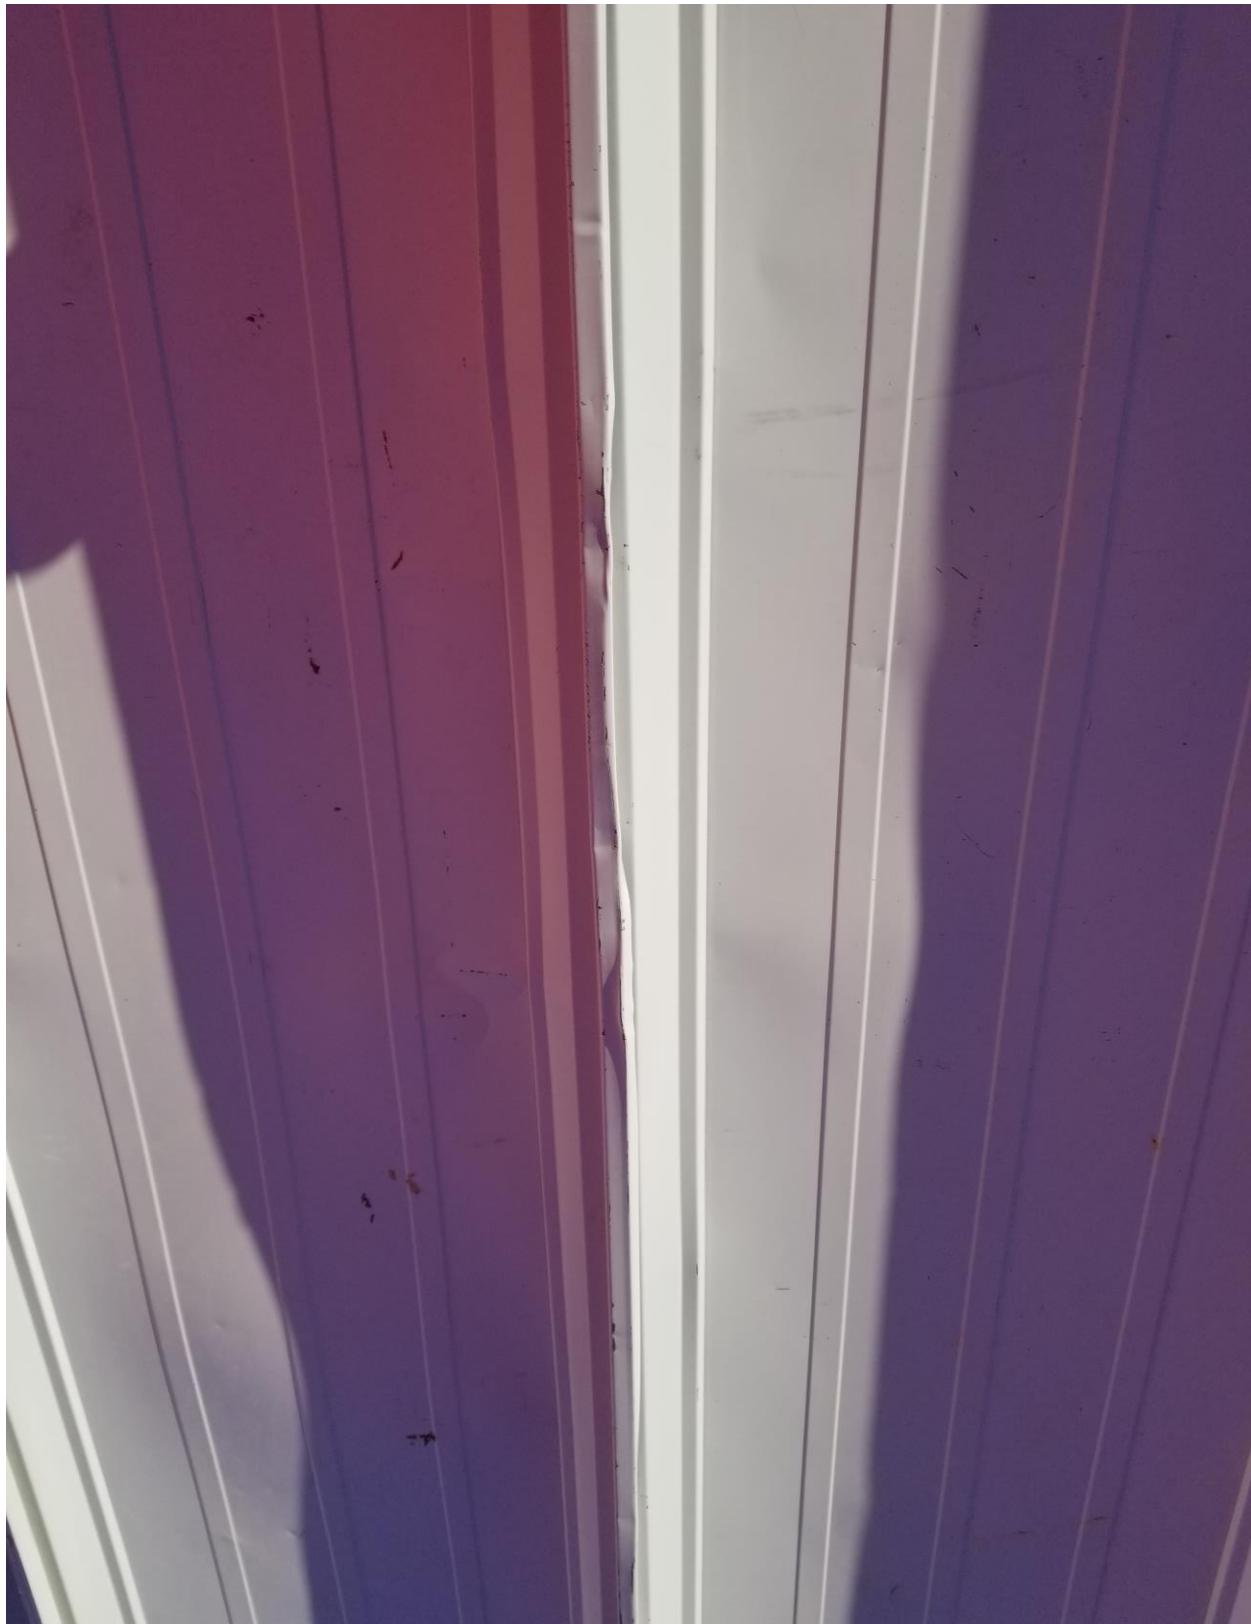
Photo #11 – More Roof Panel issues

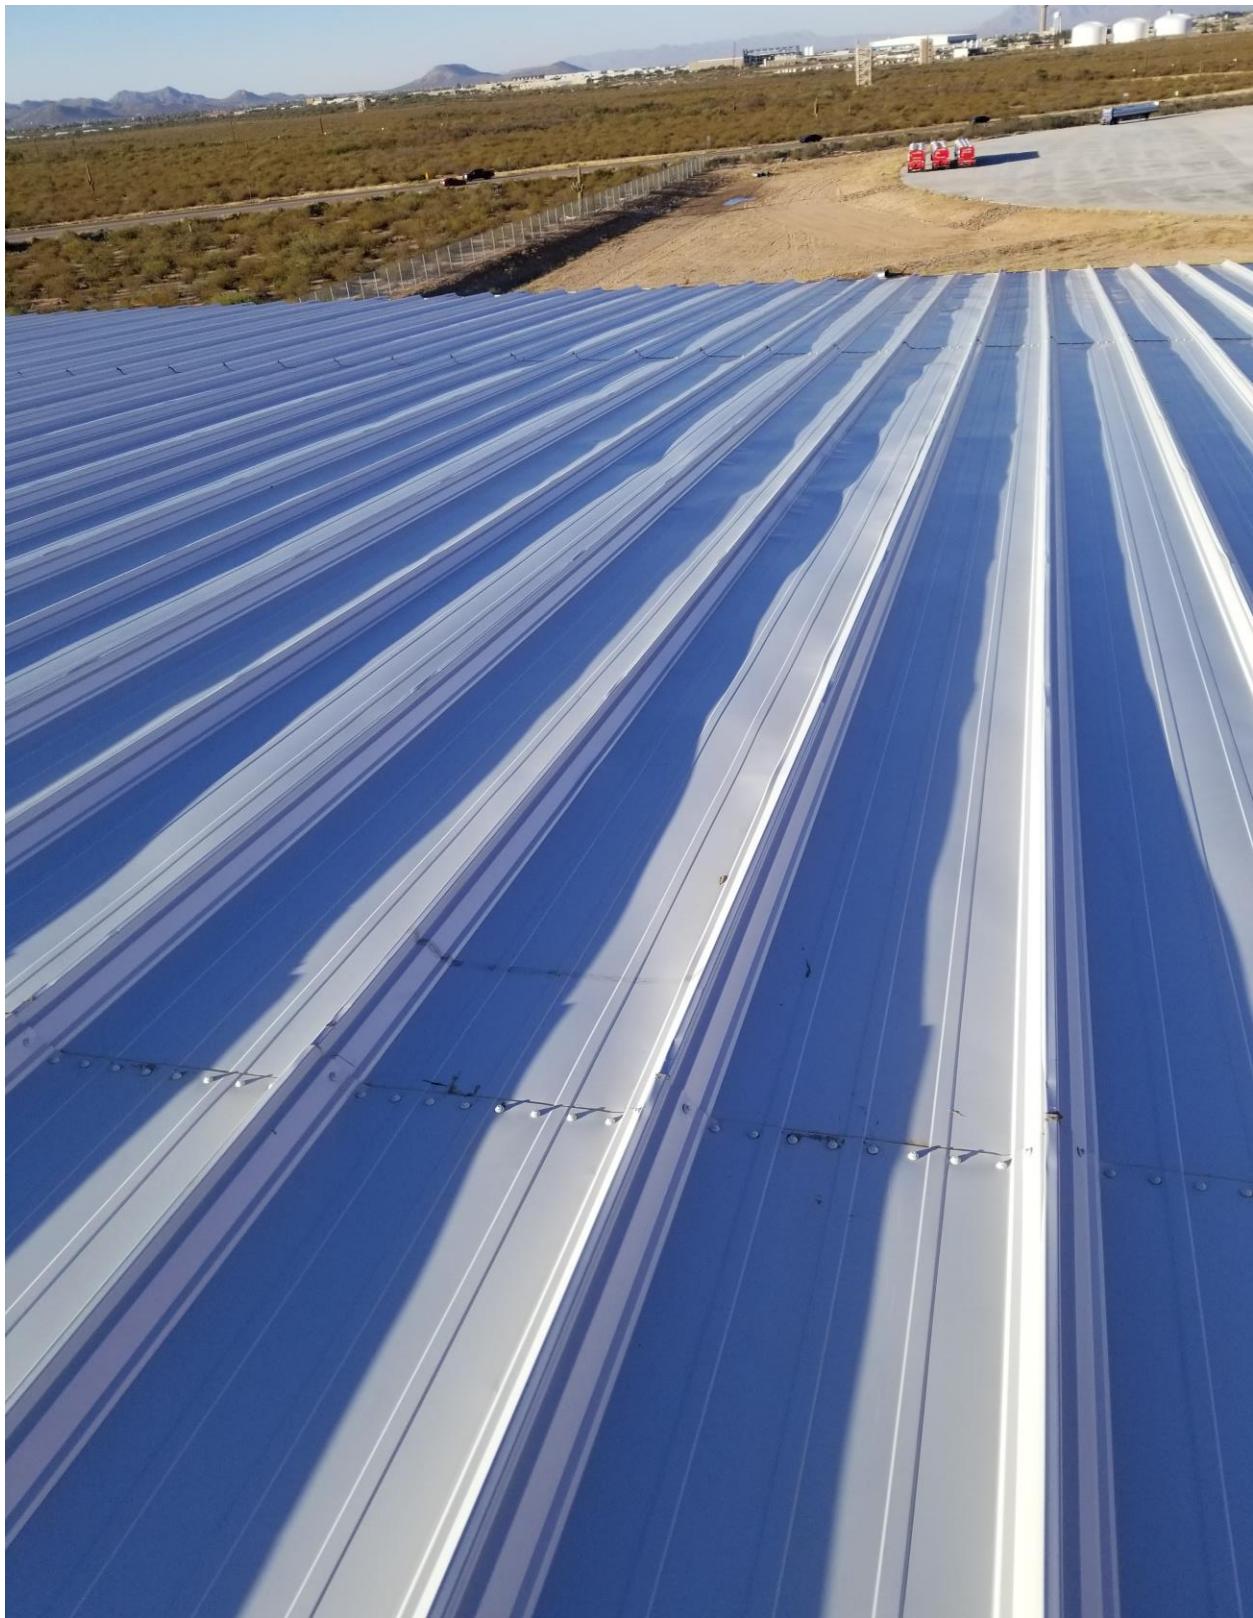
Photo #12 – More Roof Panel issues

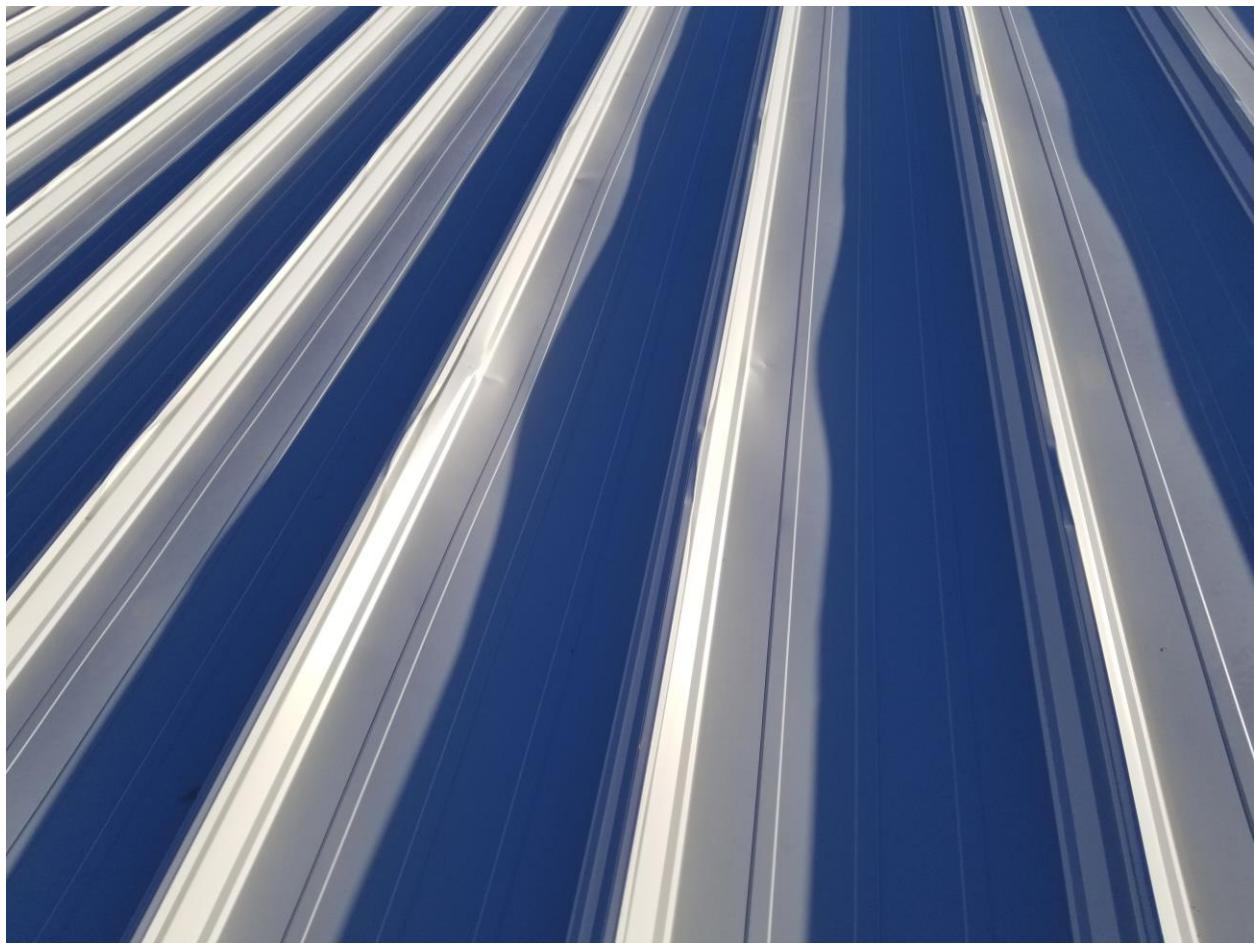
Photo #13 – More Roof Panel issues
