Progress Report

Evaluation of Measures to Reduce Wildlife-Vehicle Collisions and Promote Connectivity in a Sonoran Desert Environment – State Route 77

Santa Catalina – Tortolita Mountain Corridor

Presented to the: Regional Transportation Authority

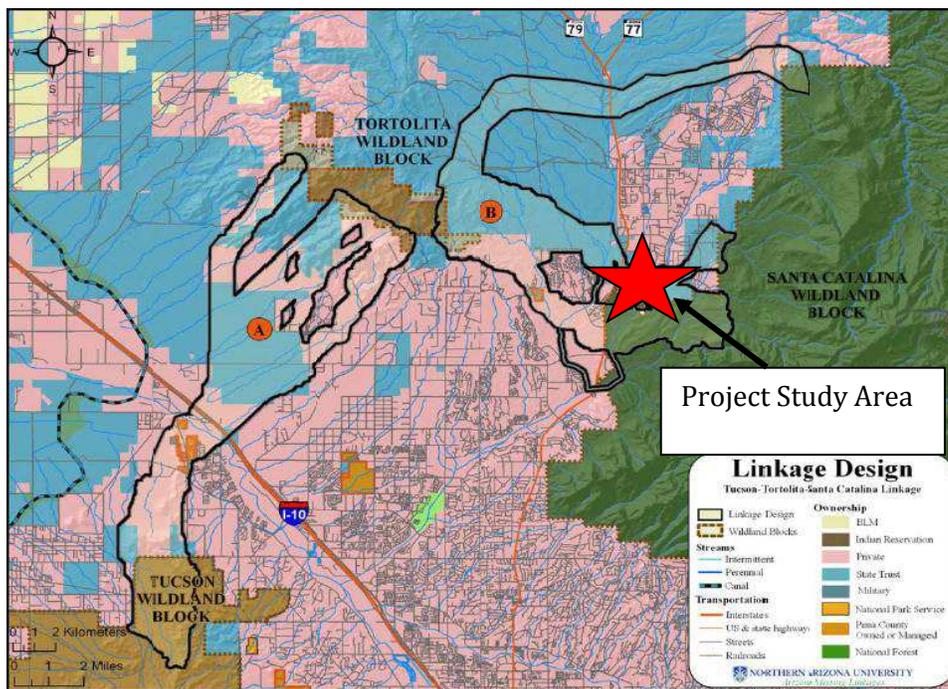
Figure 1. Least-cost linkage design for the Tucson, Tortolita, and Santa Catalina mountains and location of study area. Map from Beier et al. 2006.

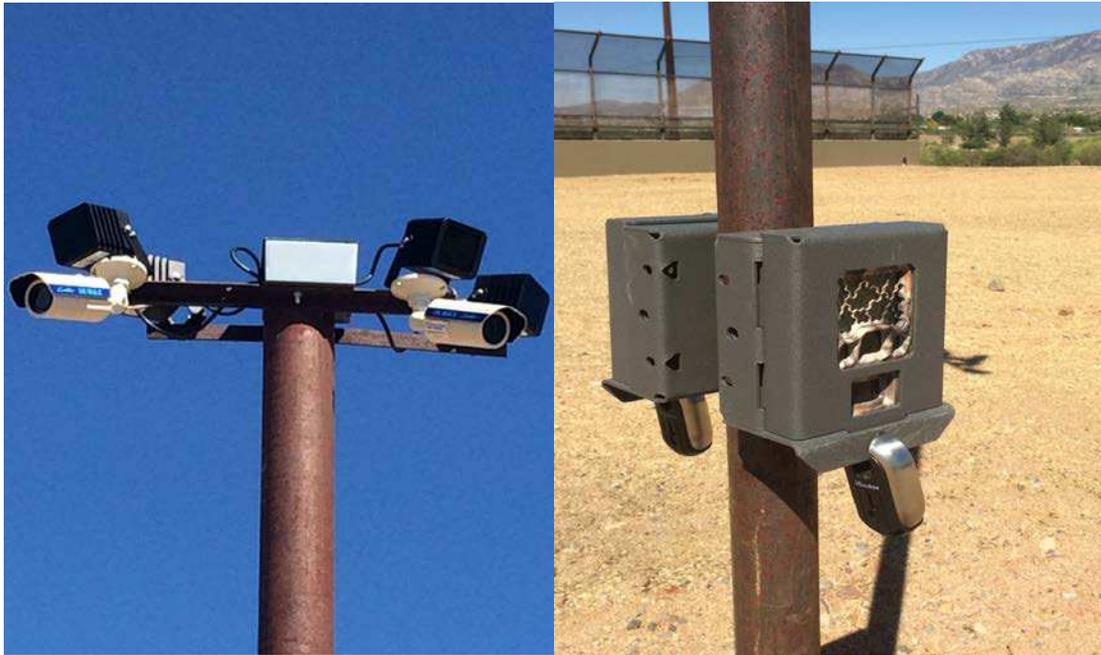
Figure 2. Structure surveillance system components: video camera with infra-red lights (left) with still camera (right) as backup documentation at the overpass and to capture wildlife use at the underpass.

objective, we are using 8-camera video (overpass) and rapid-still frame cameras (e.g., Reconyx®, underpass). Video and still cameras provide detailed documentation of wildlife use and behavior in and near the newly constructed wildlife crossings along SR. We also installed backup Reconyx® cameras on the overpass to ensure no loss of data, in the event of short term video system failures. Long-term evaluation of the wildlife crossings is essential for a proper evaluation and future recommendations (Gagnon et al. 2011). All surveillance equipment was installed by AGFD and ADOT during the highway construction.

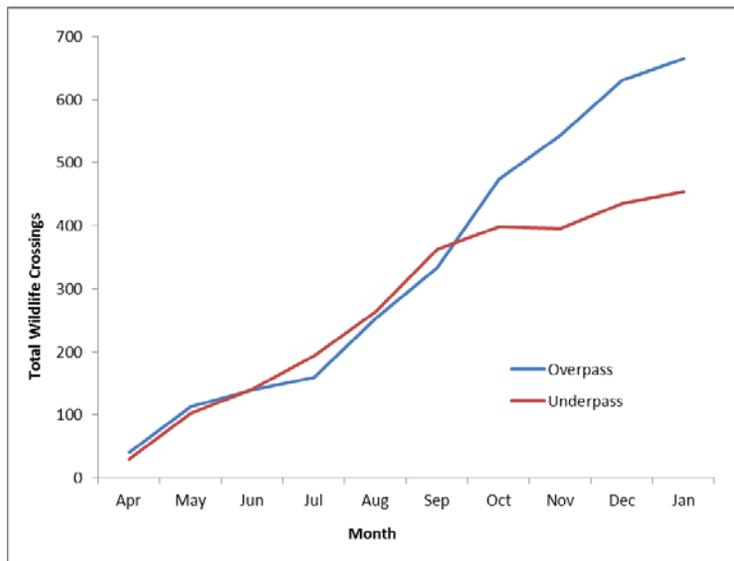
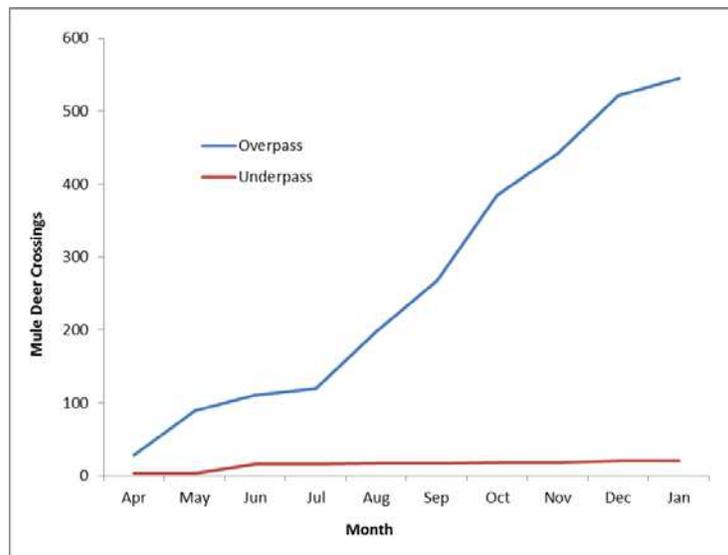
Figure 3. Total wildlife (top) and mule deer (bottom) use of the SR 77 overpass and underpass located on SR 77.

- **We have documented 1182 crossings and 13 wildlife species at the overpass and underpass (Table 1, Figures 3 and 4)**
- **All cameras were stolen from the underpass in late 2016 but have been replaced and mounted in vandal-resistant boxes to the ceiling of the underpass**
- **Overall use of the overpass is relatively similar to the underpass, however mule deer use of the overpass (545 crossings) is significantly higher than the underpass (20 crossings; Table 1, Figure 3)**
- **We documented 236 overpass crossings by cattle in late 2016. AGFD approached the owners of the cattle and access for cattle was addressed in early 2017 (Figure 4)**
- **We documented human use events on 37 and 183 occasions at the overpass and underpass, respectively (Figure 4)**

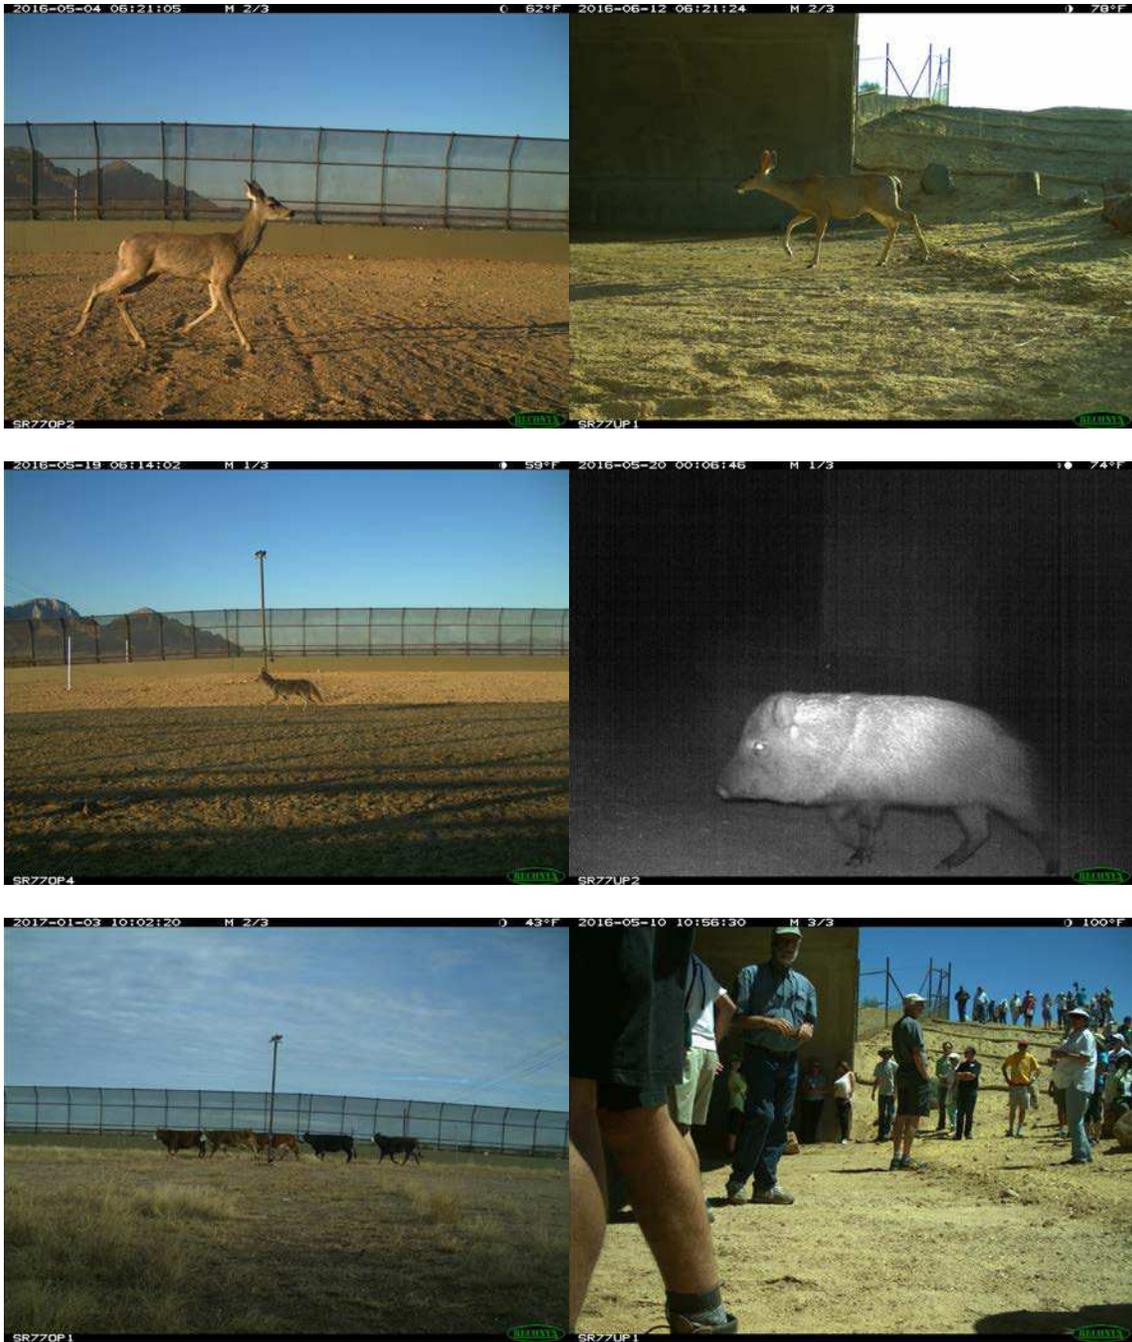
Figure 4. Examples of wildlife and non-wildlife events documented at the SR 77 overpass and underpass.

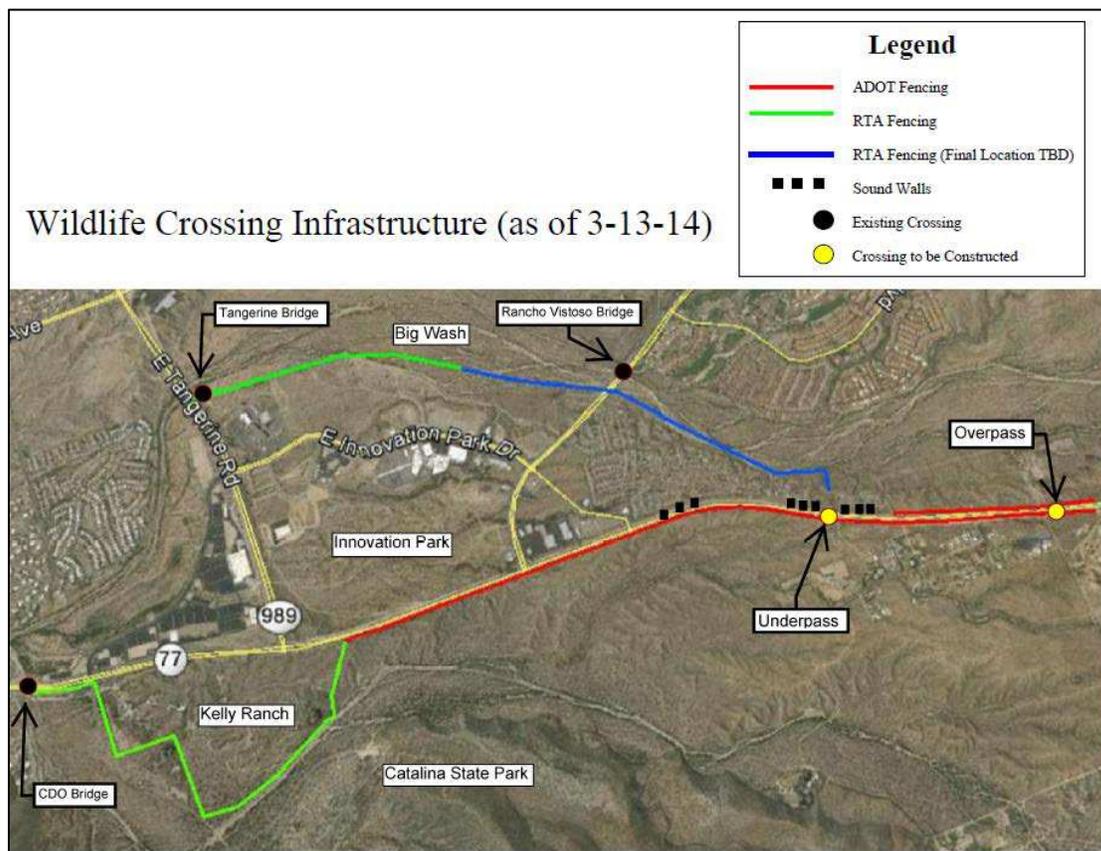
Figure 5. Map showing alignment of wildlife funnel-fencing and the complexities that will need to be accounted for (e.g. fencing distance from road) during road kill analysis. Map courtesy Coalition for Sonoran Desert Protection.

Funnel-fencing associated with most highway projects is generally placed along the right-of-way on each side of the road. Along the SR 77 project, designers have been directed to deviate from this traditional alignment and take the fencing away from the road to avoid local communities/business (Figure 5). This orientation provides a unique opportunity to evaluate the effectiveness of fencing as it is pulled away from the road and encompasses additional habitat. These differences will be accounted for during road kill analysis and we will compare their relative effectiveness.

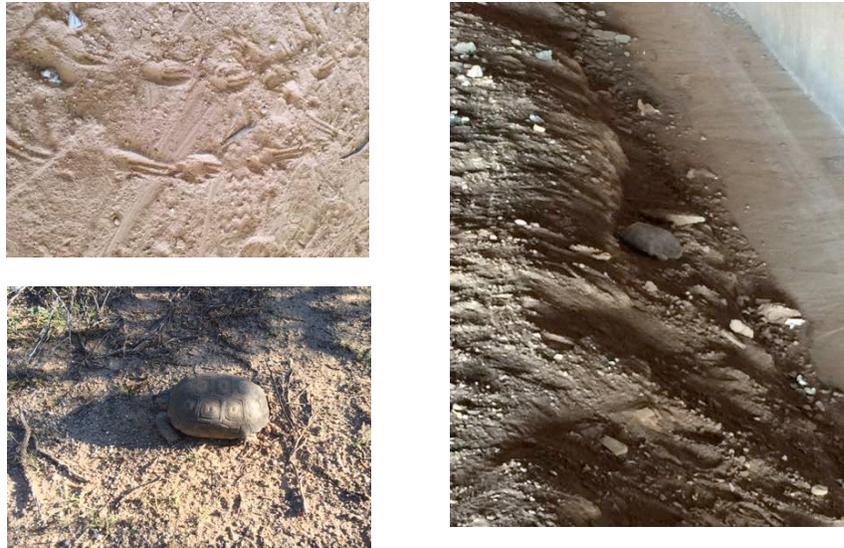
Figure 6. Sonoran desert tortoise found in the wildlife underpass during construction, tracks in underpass that alerted contractor (upper left), leading to location of tortoise in underpass (right) for safe removal from the site (lower left).

crossings can facilitate movement of desert tortoise across roads, however opportunities to evaluate the effectiveness of wildlife crossings for this species have been limited to date (Leavitt and Hoffman 2014). During the early stages of construction, project personnel removed several tortoises from the construction site, including one that attempted crossing through the underpass in October 2015 (Figure 6).

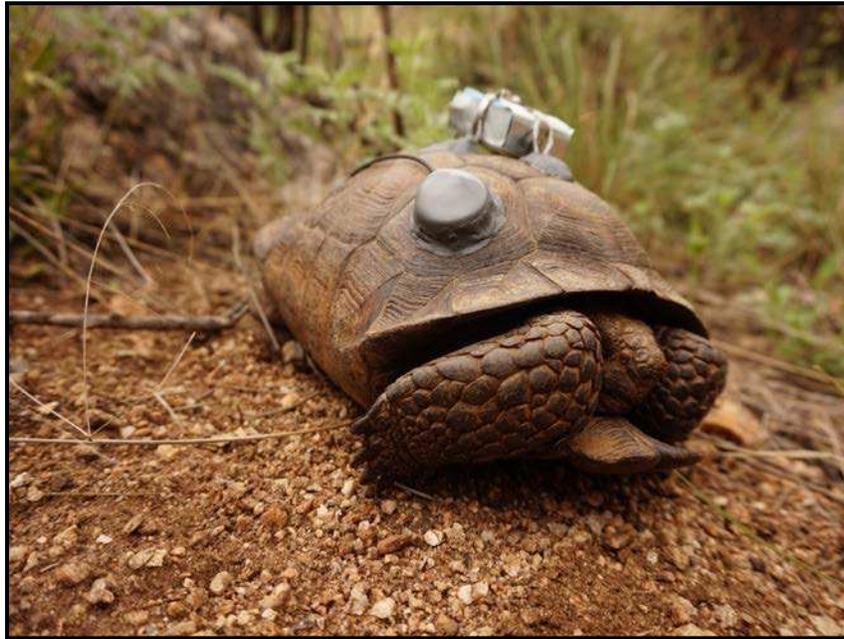
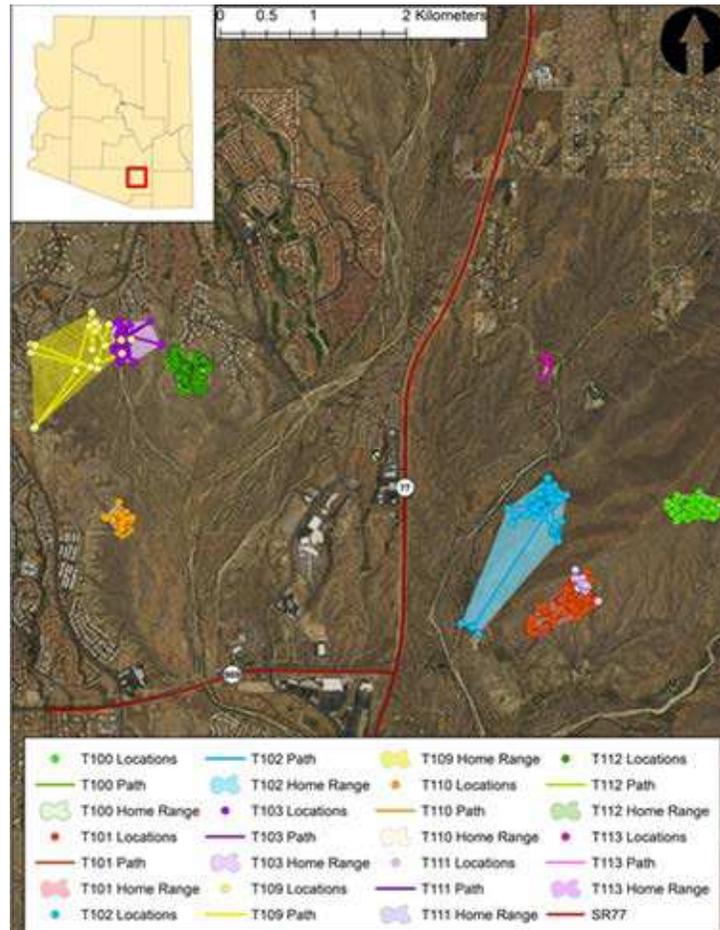
Figure 7. Sonoran Desert Tortoise with a VHF unit attached to front right and GPS unit attached on vertebral scutes (top). GPS position data from a Sonoran Desert Tortoise along SR 77 (bottom).

To evaluate SDT movements along SR 77 we conducted visual surveys for the presence of SDTs and their sign adjacent to SR 77. These surveys were conducted on foot by qualified AGFD biologists where rights-of-entry have been granted. Upon detecting a live SDT, we fit the tortoises with a VHF radio-transmitter (Holohil RI-2B) and a GPS tracking unit. GPS tracking units are replaced monthly and data will be downloaded into ArcGIS so that we may estimate home range size, activity patterns, and movement corridors for each individual.

- **13 individuals detected of which 9 individuals were outfitted with transmitters (5 east of 77, 4 west)**
- **1 outfitted individual deceased (1 of 5 eastern individuals)**
- **2,230 GPS locations have been collected to date (Figure 7)**
- **GPS transmitters removed from 5 individuals in October ahead of winter dormancy and remaining 3 individuals were too deep in winter shelters to retrieve units**
- **All 8 individuals retained VHF transmitters to allow relocation and outfitting with GPS transmitters in April/May 2017**
- **We intend to outfit an additional 12 individuals with transmitters in spring/summer 2017 for a total of 20**
